# Keystone RV Company

## SAFETY ADVISORY 25-465

### Kodiak Patio Lift

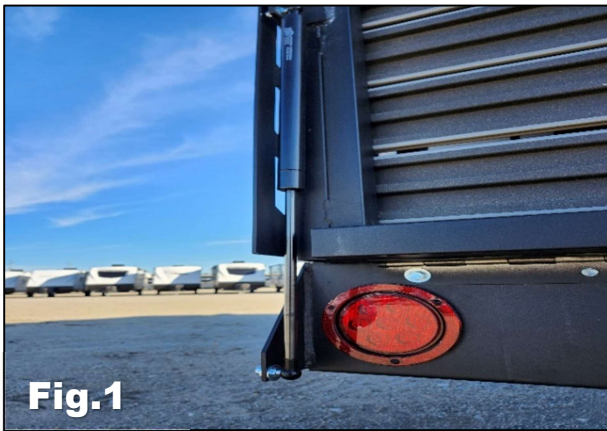
**Fig.1**

Remove the (2) current struts from unit using a small flat head screwdriver and discard. Install (2) new 300# struts. **Figure 1** shows new struts installed.

The remedy: Replace current struts with new 300# struts. Add (3) bolts to the bottom hinge of patio. Add (2) warning labels, 1 to each side of unit.

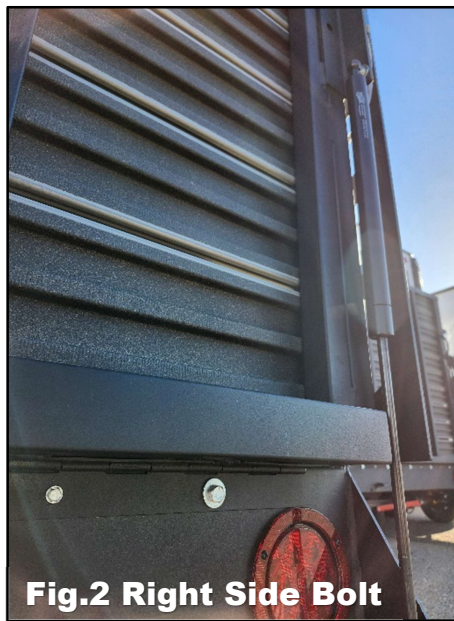
**Fig.2 Right Side Bolt**

Remove (3) of the self-tapping screws currently in hinge. Far right screw – Far left screw & a middle screw (above license plate area). Drill (3) holes using a 3/8 drill bit. Install washers, bolts, and lock nuts. **Figures 2, 3, and 4** show approximate locations of new bolts installed.

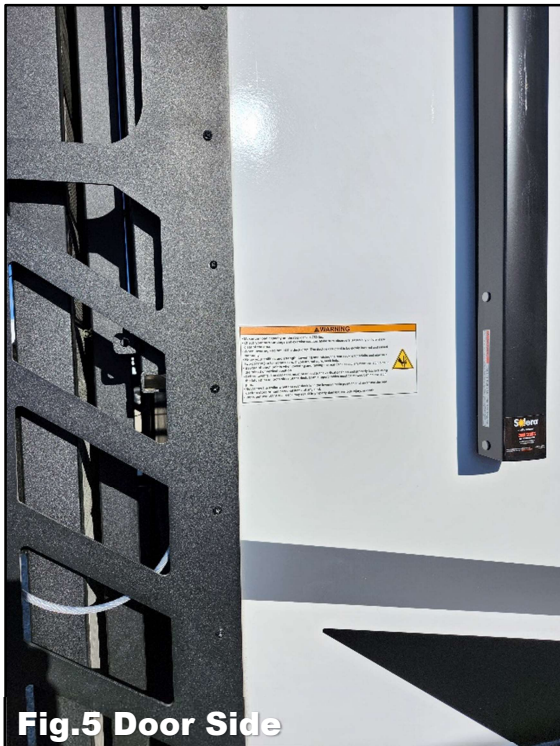
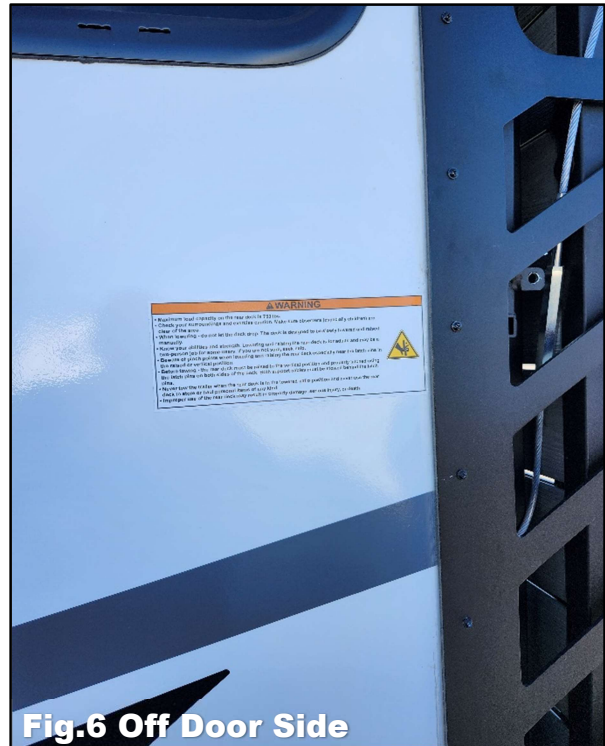
Add a warning label to both sides of unit. Placement should be roughly the same height as patio latches. (Do not apply over any unit decals) **Figure 5 and 6** shows warning labels applied.
