**HYUNDAI**  
**Technical Service Bulletin**

GROUP <b>RECALL</b>	NUMBER <b>25-01-036H</b>
DATE <b>MAY 2025</b>	MODEL(S) <b>PALISADE (LX2)</b>

**SUBJECT:** ELECTRONIC OIL PUMP (EOP) CONTROLLER REPLACEMENT  
(RECALL 278)

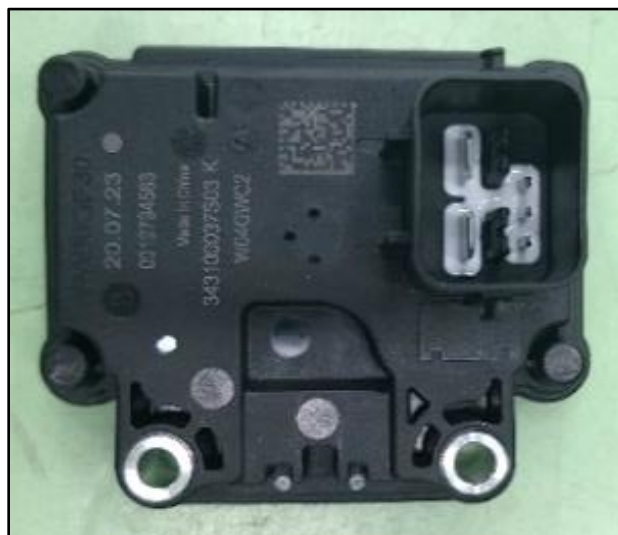
**Description:** The Idle Stop and Go Electronic oil Pump (ISG EOP) used in certain 2025MY Palisade (LX2) vehicles may have been produced with insufficient hermetic sealing on the controller housing due to damaged tooling. An insufficient seal could allow moisture ingress and contamination on the controller PCB, increasing the risk of electrical shorting and subsequent thermal damage. Thermal damage to the EOP controller circuitry can increase the risk of a vehicle fire if unaddressed. Follow the procedures in this TSB to replace the EOP controller.

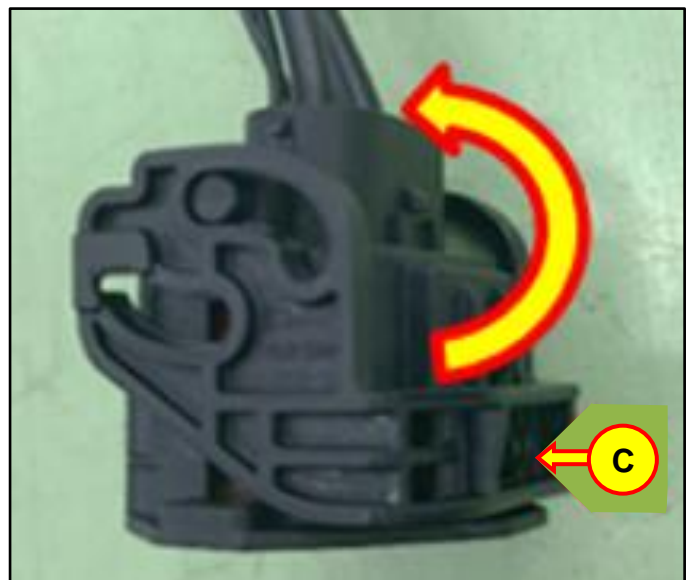
**i Information**

Release the connector hook (C) and then pull it upward.

**NOTICE**

Ensure the connector remains clean and is covered after it is disconnected.

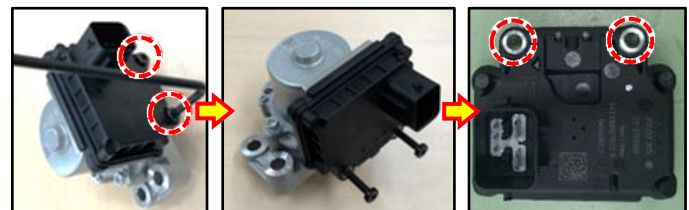
**i Information**

Refer to the bolt locations shown in the photos on the right.

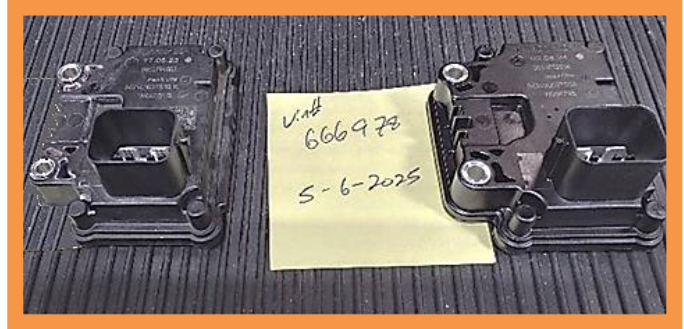
Using STUI, take a photo of the original EOP controller and new EOP controller side by side, clearly showing the stamped lot numbers, with the last 6 digits of the VIN and the date of repair on a piece of paper.

Upload the photo to STUI.

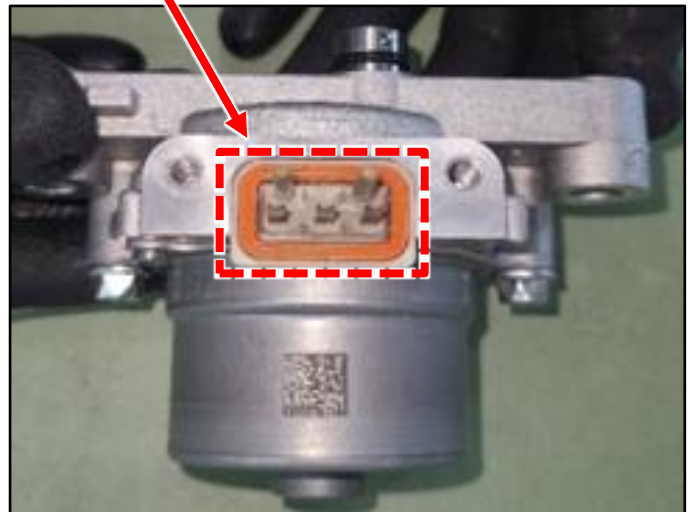
6. Install the new EOP Controller (G) onto the EOP. Then tighten the **2 bolts** and connect the EOP connector.

**NOTICE**

If the seal (H) remained attached to the original EOP Controller during removal, reinstall it to its correct sealing position on the EOP housing prior to installing the new EOP Controller.
