# SAFETY RECALL

## Side Curtain Airbag

Reference: 55C / NHTSA 25V-302

2022-2025 (RU) Chrysler Pacifica  
2022-2025 (RU) Chrysler Voyager

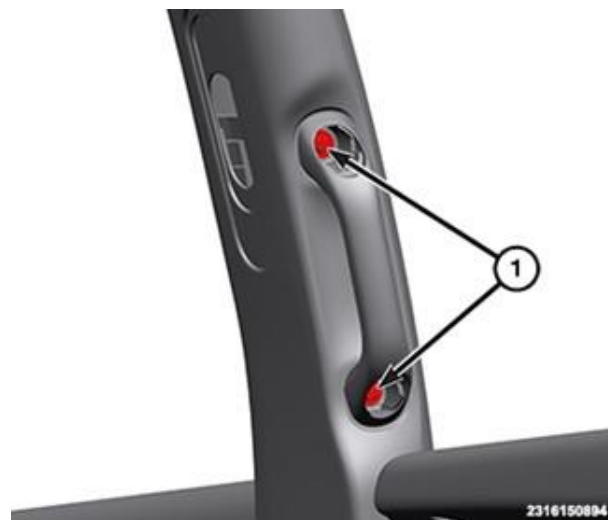
**Figure 6 – Grab Handle**

1 - Grab Handle Bolts

16. Using a small flat bladed tool, remove the bolt covers then the grab handle bolts (Figure 6).
