# SAFETY RECALL

## Side Curtain Airbag

Reference: 55C / NHTSA 25V-302

2022-2025 (RU) Chrysler Pacifica  
2022-2025 (RU) Chrysler Voyager

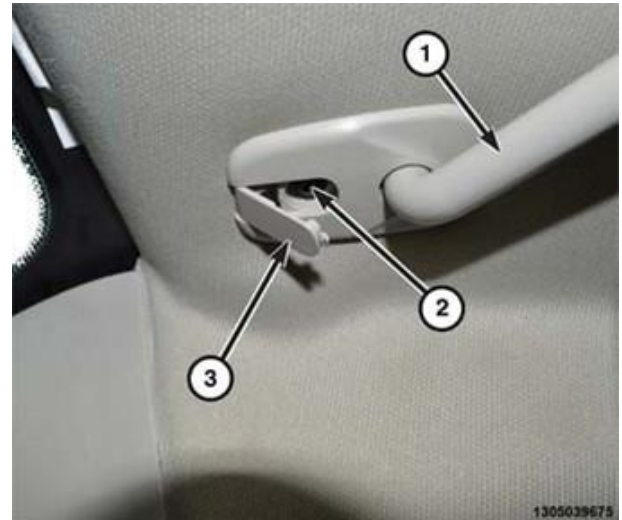
**Figure 17 – Sun Visor**

- 1 - Sun Visor
- 2 - Screw
- 3 - Screw Cover

39. Using a small pry tool, open the visor screw cover and remove the screw (Figure 17).
40. Rotate the visor upward towards the roof to remove it from the opening (Figure 17).
41. If equipped, disconnect the harness connector from the visor (Figure 17).

73. If equipped with grab handles, position the grab handle to the headliner, install the screws and tighten securely then install the screw covers (Figure 22).
74. Position the coat hook to the headliner, install the screw and tighten securely then close the screw cover (Figure 21).
75. Connect the wire harness connectors to the lamp and camera, install the rear dome lamp / camera to the headliner (Figure 20).
76. Install the two screws securing the front overhead console (Figure 19).
77. Close the front overhead console rear observation mirror (Figure 19).
78. Position the sun visor support and install the screw, tighten securely then close the screw cover (Figure 18).
79. Connect the harness connector to the visor (Figure 17).
80. Install the visor to the roof and install the screw, tighten securely then close the screw cover (Figure 17).

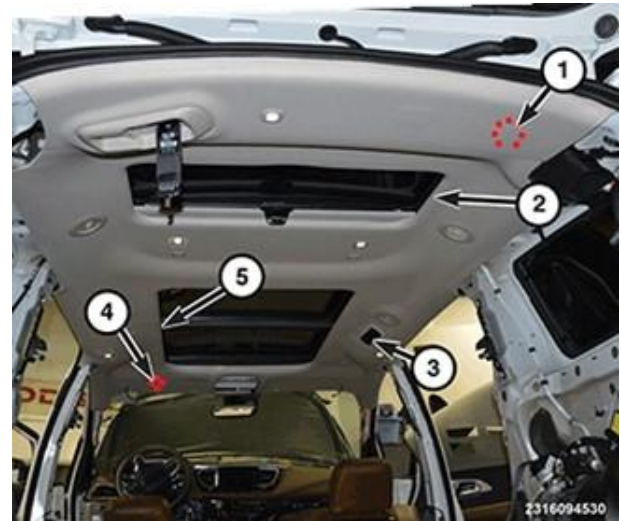
**Figure 23 – Headliner**

- 1 - Push Fastener
- 2 - Sunroof Opening
- 3 - Rear Heater Controls
- 4 - Push Fastener
- 5 - Sunroof Opening

49. Using a trim stick or equivalent, release the push fastener at the location at the rear of the headliner (Figure 23).
50. With the help of an assistant starting at the rear of the vehicle, release the hook and loop fasteners by hand, then around the sunroof openings, if equipped (Figure 24).
51. Using a long trim stick, reach up above the headliner and release the three steel retainers that retain the rear heater controls bracket to the roof panel (Figure 23).

70. Connect the rear window washer hose (Figure 24).
71. Attach all the hook and loop fasteners (Figure 24).
72. Attach the three steel retainers that retain the rear heater controls bracket to the roof panel (Figure 23).
