**SAFETY RECALL**  
NORTH AMERICA  
**Side Curtain Airbag**

Reference: 06C / NHTSA 25V-302

FCA US LLC

2022-2025 (RU) Chrysler Pacifica  
2022-2025 (RU) Chrysler Voyager

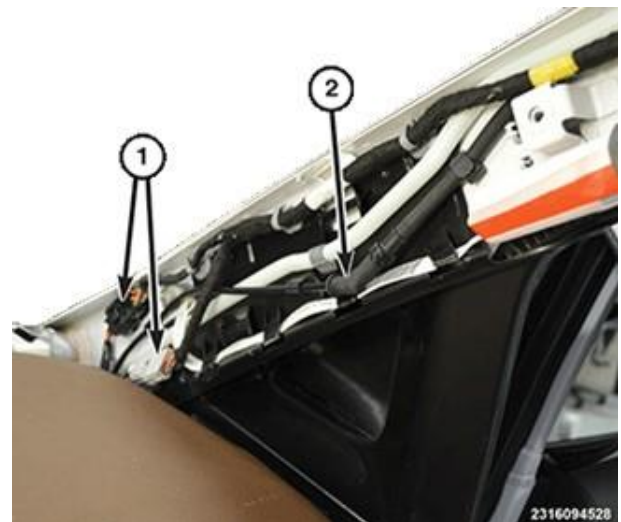
**Figure 3 – A-Pillar**

10. Disconnect the wire harness connectors and unclip the wire harness from the passenger side A-pillar (Figure 3).
11. Disconnect the rear washer hose (and unclip the hose from the passenger side A-pillar, if equipped (Figure 3).

- 1 - Wire Harness Connectors  
2 - Washer Hose

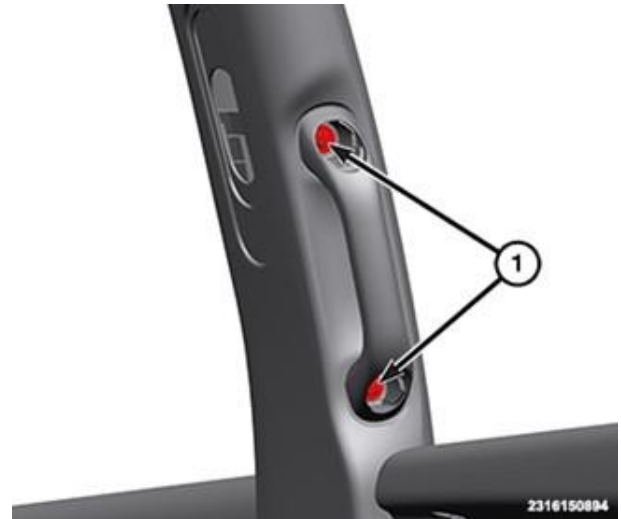
**Figure 6 – Grab Handle**

16. Using a small flat bladed tool, remove the bolt covers then the grab handle bolts (Figure 6).

1 - Grab Handle Bolts

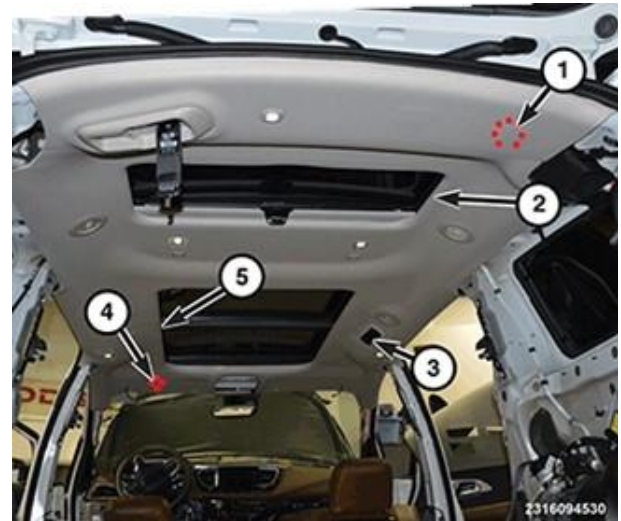
**Figure 23 – Headliner**

49. Using a trim stick or equivalent, release the push fastener at the location at the rear of the headliner (Figure 23).
50. With the help of an assistant starting at the rear of the vehicle, release the hook and loop fasteners by hand, then around the sunroof openings, if equipped (Figure 24).
51. Using a long trim stick, reach up above the headliner and release the three steel retainers that retain the rear heater controls bracket to the roof panel (Figure 23).

- 1 - Push Fastener
- 2 - Sunroof Opening
- 3 - Rear Heater Controls
- 4 - Push Fastener
- 5 - Sunroof Opening

70. Connect the rear window washer hose (Figure 24).
71. Attach all the hook and loop fasteners (Figure 24).
72. Attach the three steel retainers that retain the rear heater controls bracket to the roof panel (Figure 23).
