**NHTSA Safety Recall 25V-320**

**SUBJECT: Campaign # 196 – MorRyde Removal Steps May Detach While In Use**

# Removable Steps May Detach While in Use (MORryde)

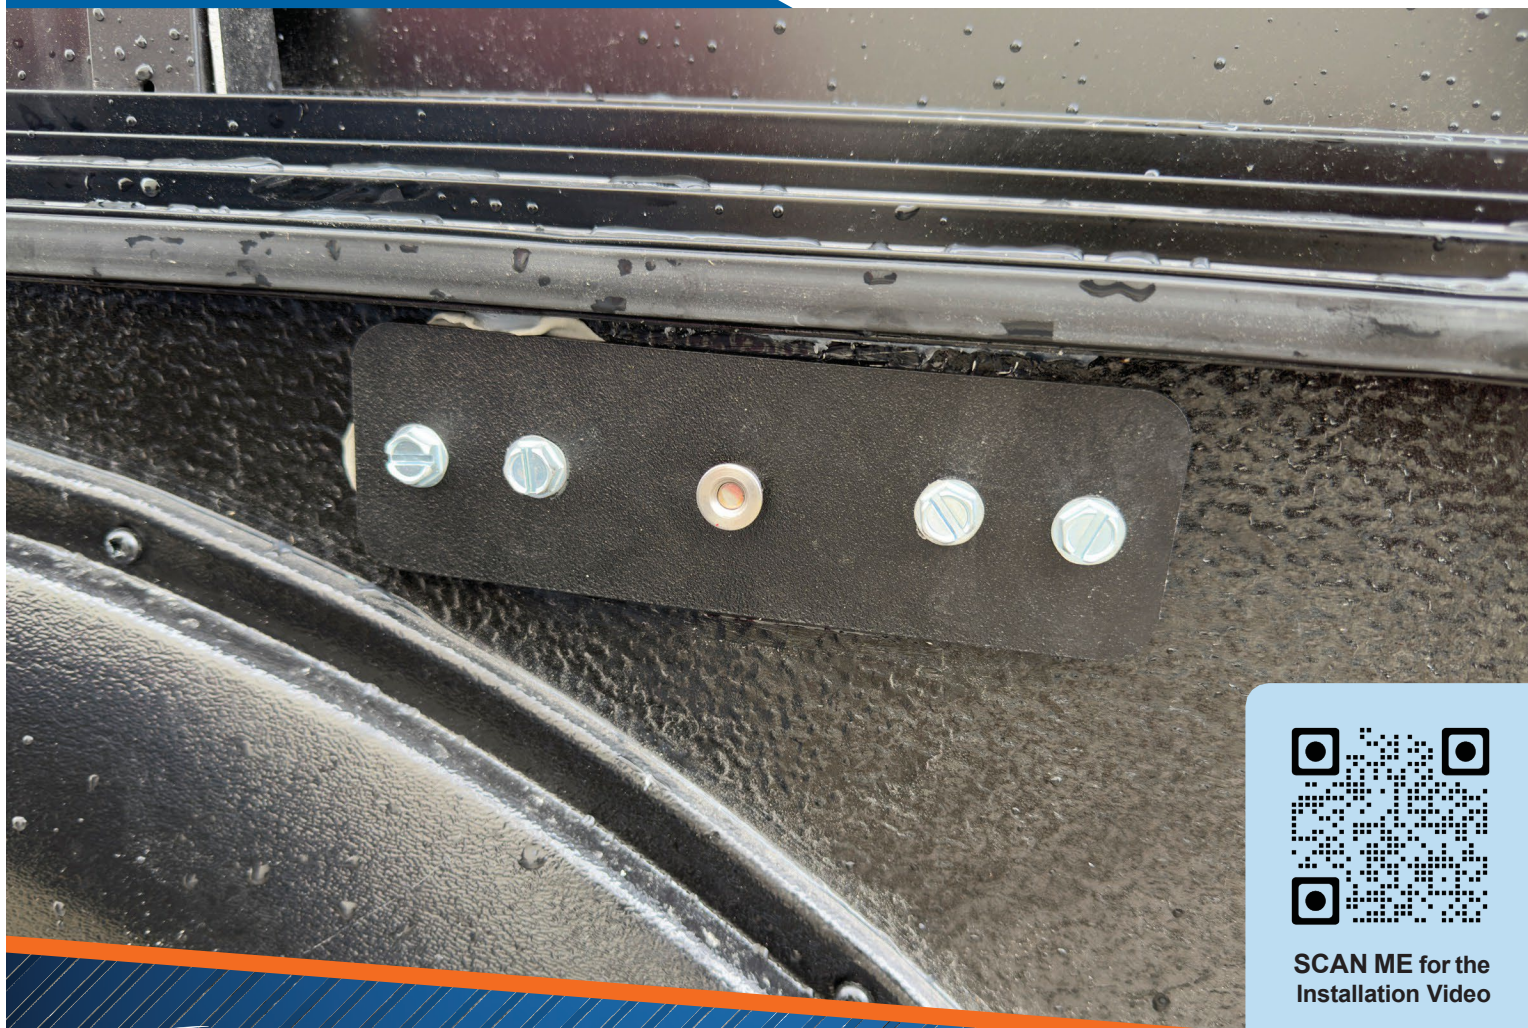
REPLACEMENT INSTRUCTIONS FOR STP57-515

REPLACEMENT KIT | **STP54-078**

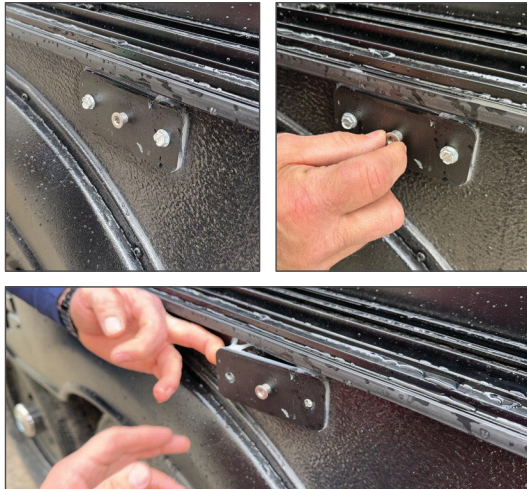
### STEP 1

Remove the two mounting screws that secure each of the two STP54-515 mounting brackets. Once removed, discard both original mounting brackets.

**Note:** It is OK to use a drill/impact gun for the removal of each of the brackets.

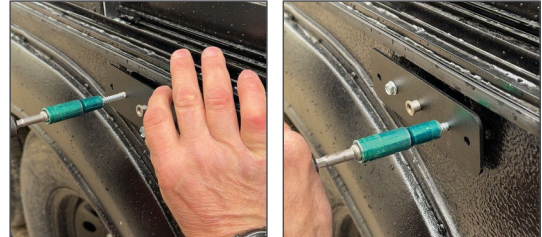
### STEP 2

Use the replacement kit (STP54-078) to attach the new mounting brackets. To install the new brackets, start by installing two mounting screws into the two innermost holes.

**Note:** The above mentioned innermost holes will line up with the holes from the bracket that was removed.

**Note:** To avoid over-torquing these screws, it is necessary that final tightening be by hand with a 3/8" wrench.

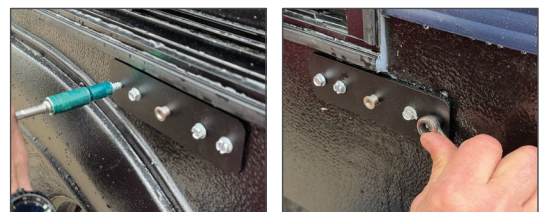
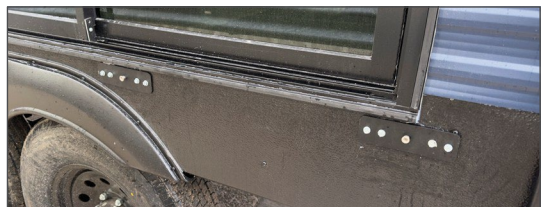
### STEP 4

Use an impact driver and 3/8" sockets to install the outer two mounting screws in each of the two mounting brackets.

**Note:** To avoid over-torquing these screws, it is necessary that final tightening be by hand with a 3/8" wrench.
