# Keystone RV Company

## SAFETY ADVISORY # 25-468

### MORryde Clip-on Step Brackets

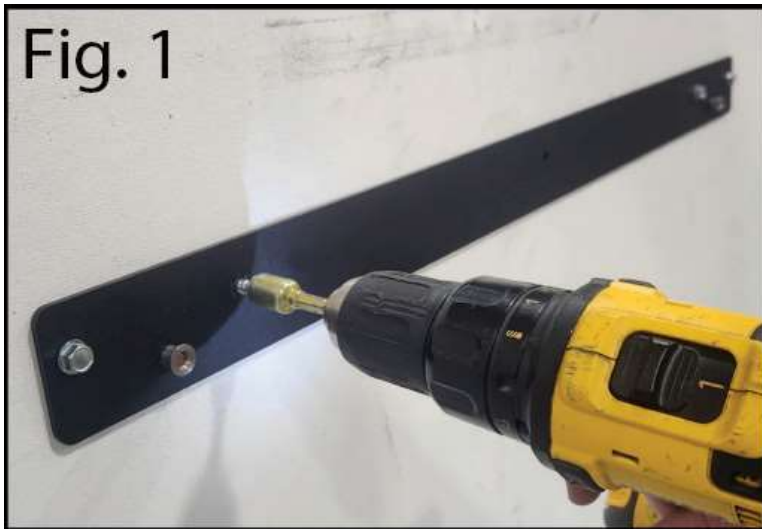
Remove the four mounting screws that secure the mounting bracket. Once removed, discard the original mounting bracket. See Figure 1.

Note: It is OK to use a drill/impact with 3/8" bit for the removal of each of the brackets.

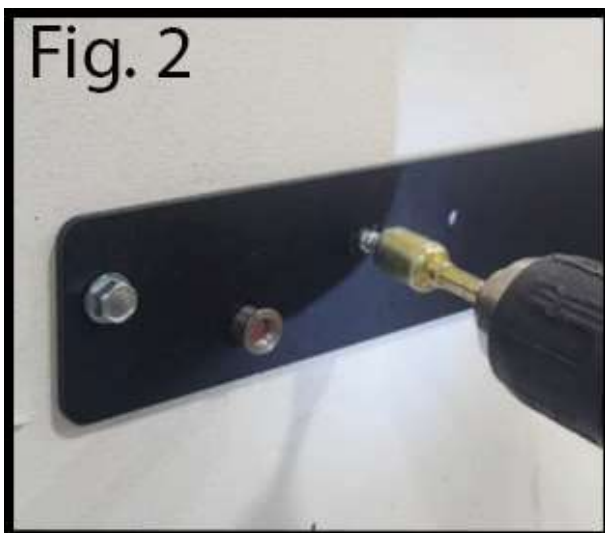
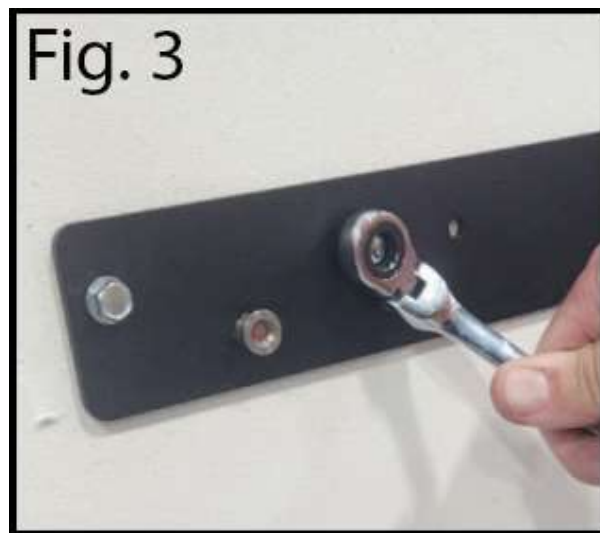
Use the replacement kit KRV # 768047 to attach the new mounting bracket. To install the new bracket, start by installing four mounting screws into the four original holes. The above-mentioned holes will line up with the holes from the bracket that was removed. See Figures 2 & 3.

Note: To avoid over-torquing these screws, it is necessary that final tightening be by hand with a 3/8" wrench.

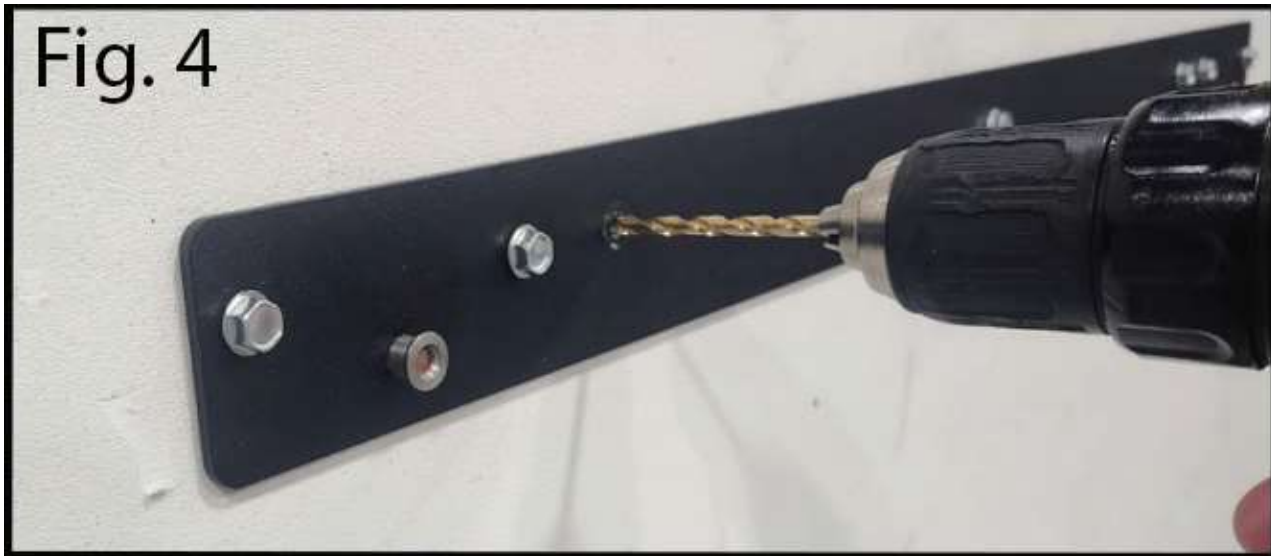
Use a drill and 3/16" drill bit to pre-drill pilot holes for the three new holes. See Figure 4.

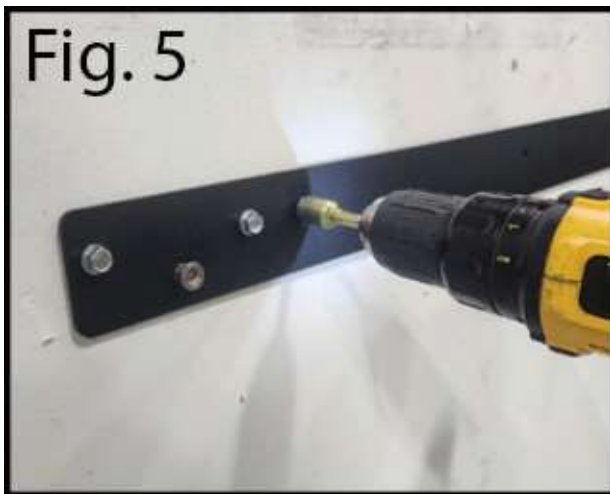
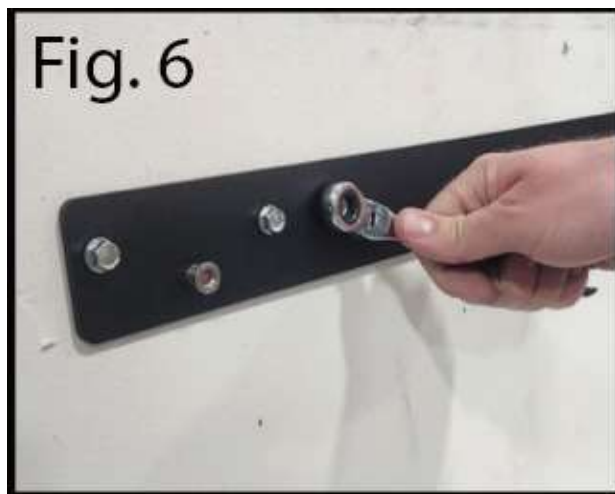
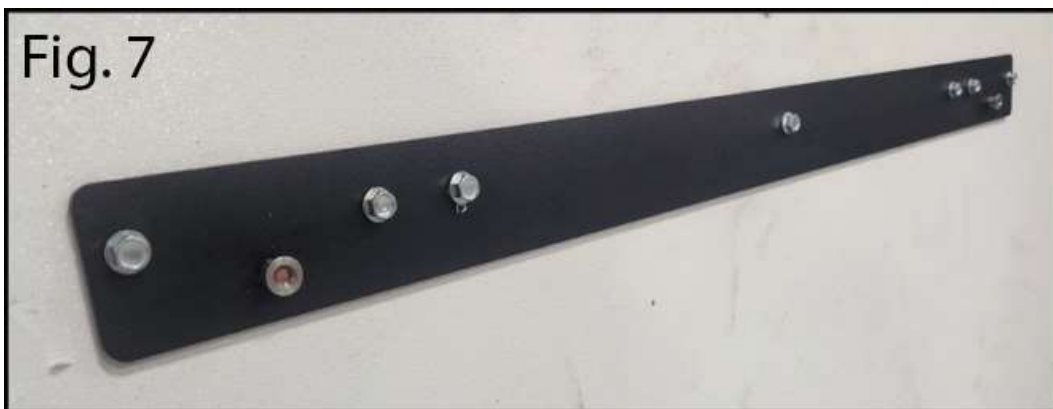
Use an impact driver and 3/8" sockets to install the three new screws in the mounting bracket. This completes the repair for KRV # 768047. See Figure 5 – Figure 7.

Note: To avoid over-torquing these screws, it is necessary that final tightening be by hand with a 3/8" wrench.

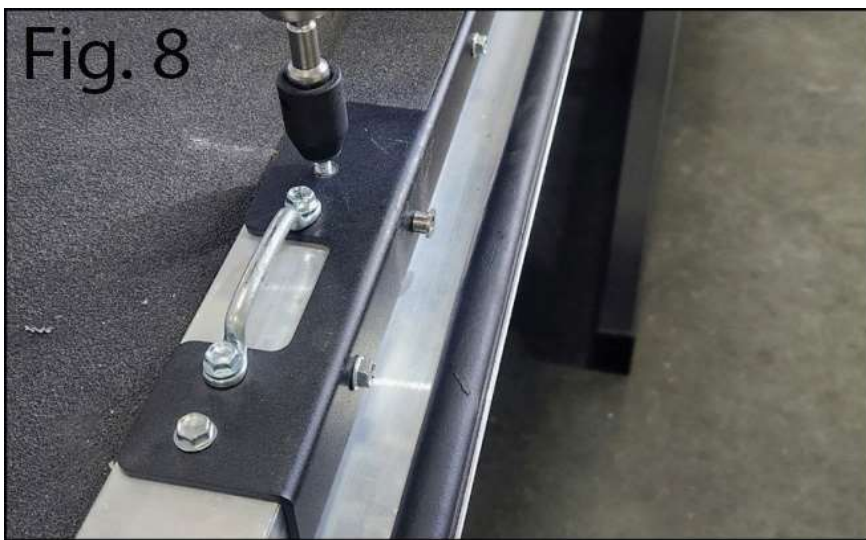
Remove the 12 mounting screws that secure the mounting bracket. Once removed, discard the original mounting bracket. See Figure 8.

Note: It is OK to use a drill/impact with 3/8" bit for the removal of each of the screws.

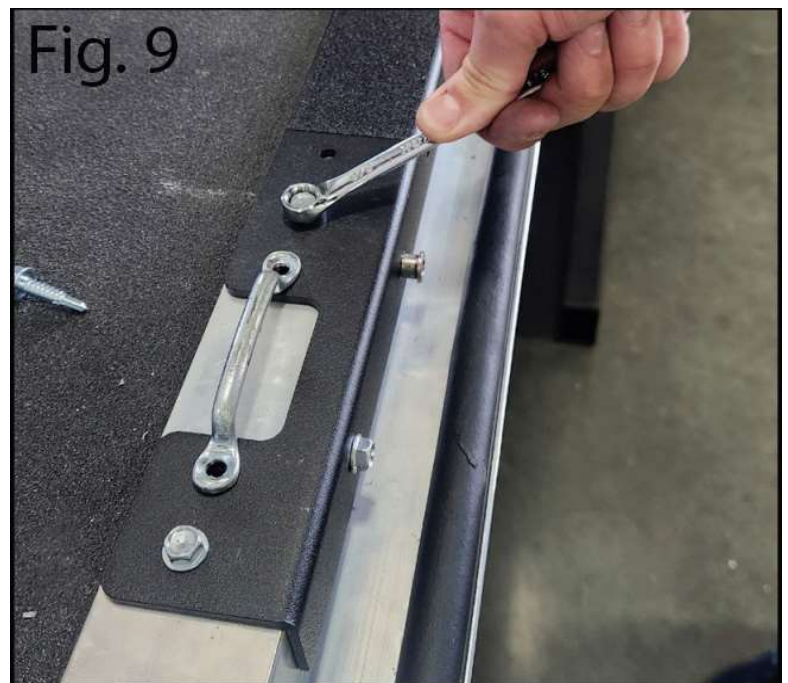
Use the replacement kit KRV # 768048 to attach the new mounting bracket. To install the new bracket, start by installing 12 mounting screws into the 12 original holes. The above-mentioned holes will line up with the holes from the bracket that was removed. See Figure 9.

Note: To avoid over-torquing these screws, it is necessary that final tightening be by hand with a 3/8" wrench.

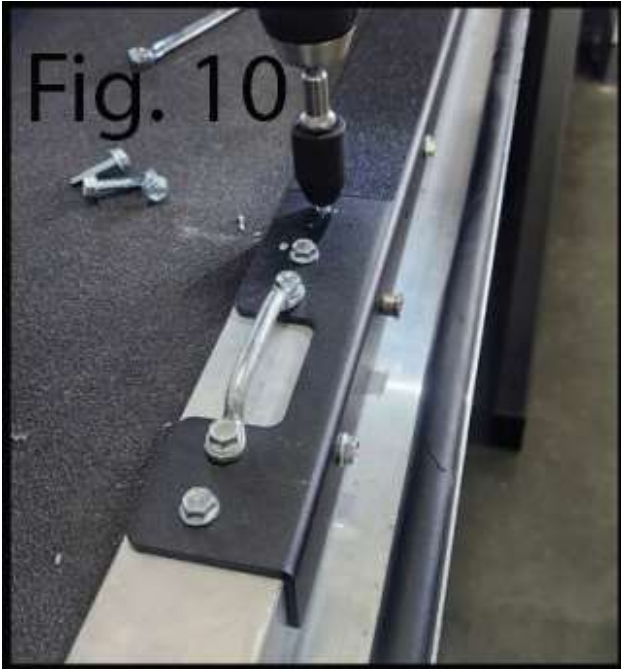
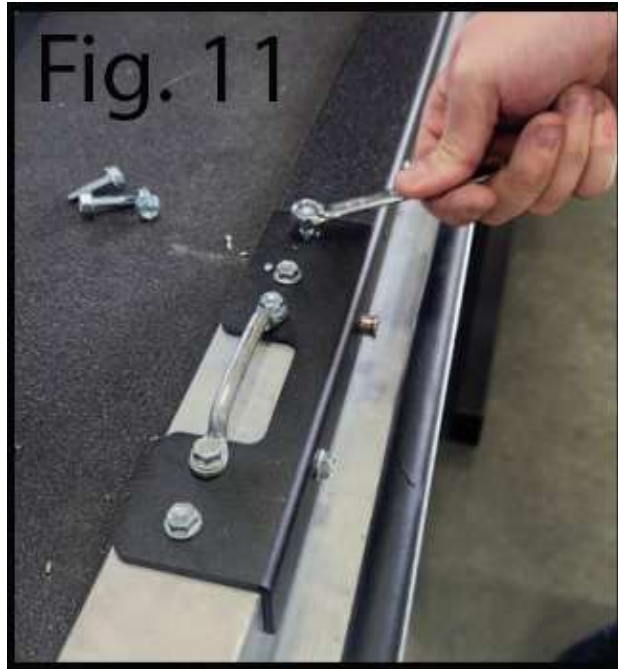
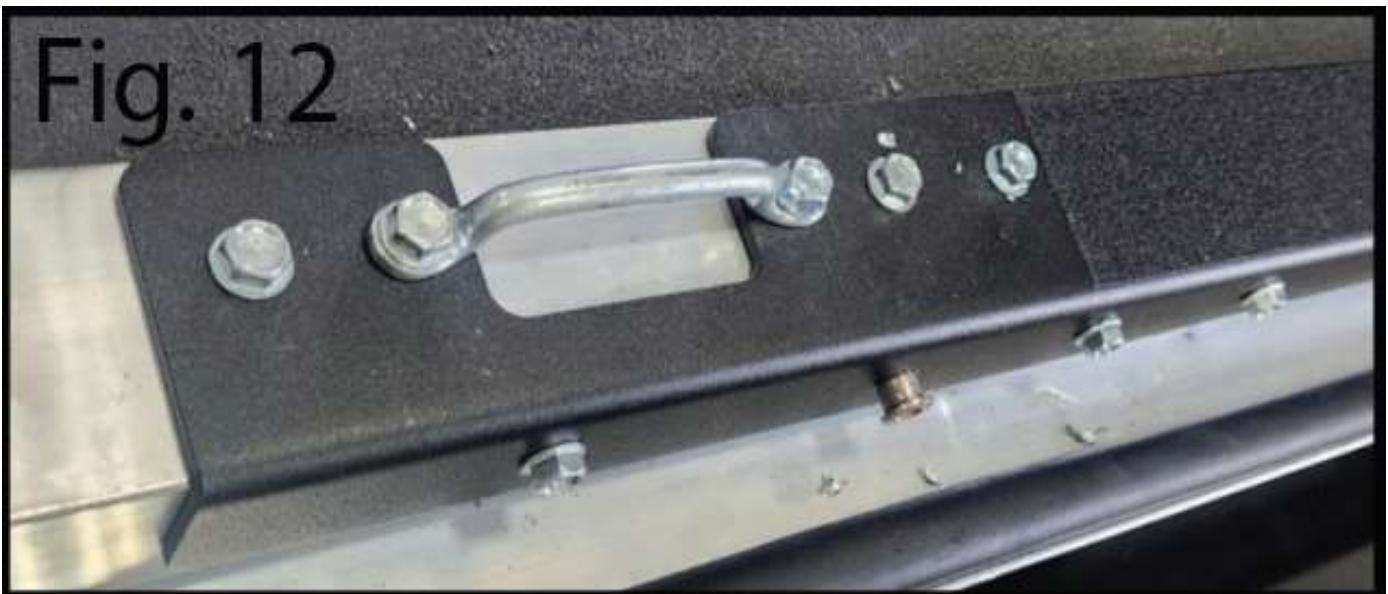
Use a drill and 3/8" bit to install the four new screws in the mounting brackets. See Figure 10 – Figure 11. This completes the repair for KRV # 768048.

Note: To avoid over-torquing these screws, it is necessary that final tightening be by hand with a 3/8" wrench.
