# Keystone RV Company

6/12/25

## SAFETY ADVISORY # 25-468

### MORryde Clip-on Step Brackets

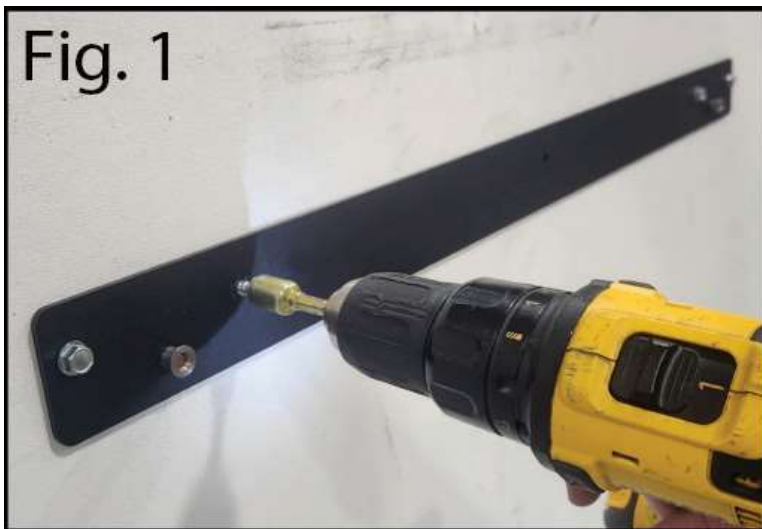
Remove the four mounting screws that secure the mounting bracket. Once removed, discard the original mounting bracket. See Figure 1.

Note: It is OK to use a drill/impact with 3/8" bit for the removal of each of the brackets.

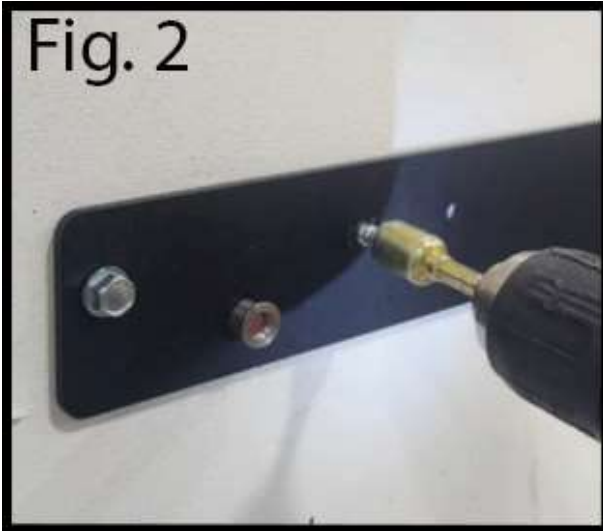
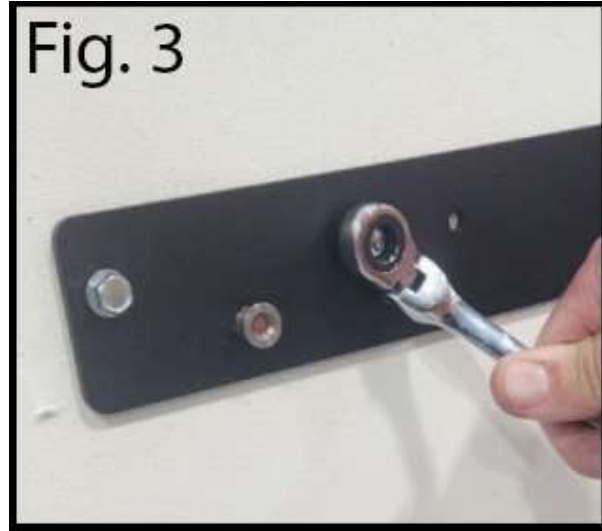
Use the replacement kit KRV # 768047 to attach the new mounting bracket. To install the new bracket, start by installing four mounting screws into the four original holes. The above-mentioned holes will line up with the holes from the bracket that was removed. See Figures 2 & 3.

Note: To avoid over-torquing these screws, it is necessary that final tightening be by hand with a 3/8" wrench.

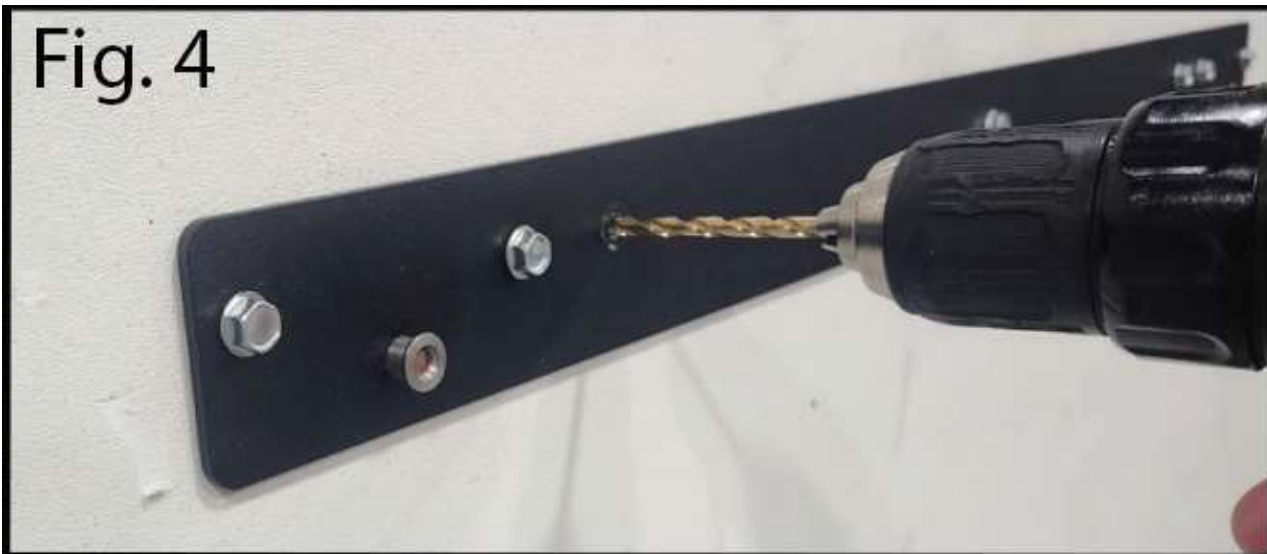
Use a drill and 3/16" drill bit to pre-drill pilot holes for the three new holes. See Figure 4.

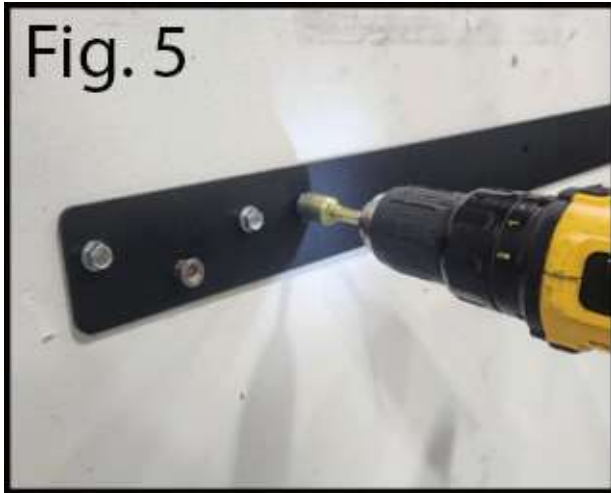
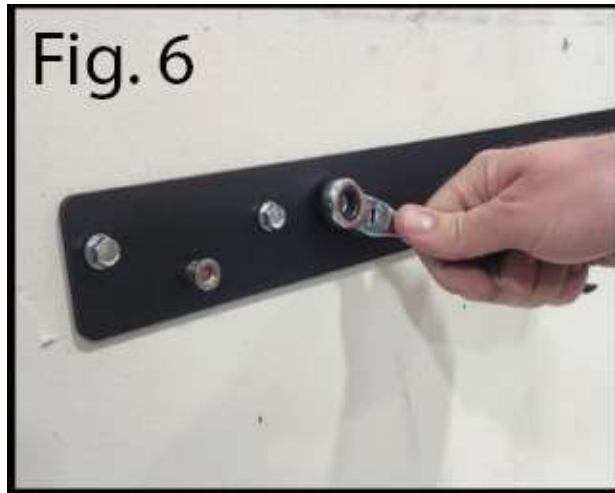
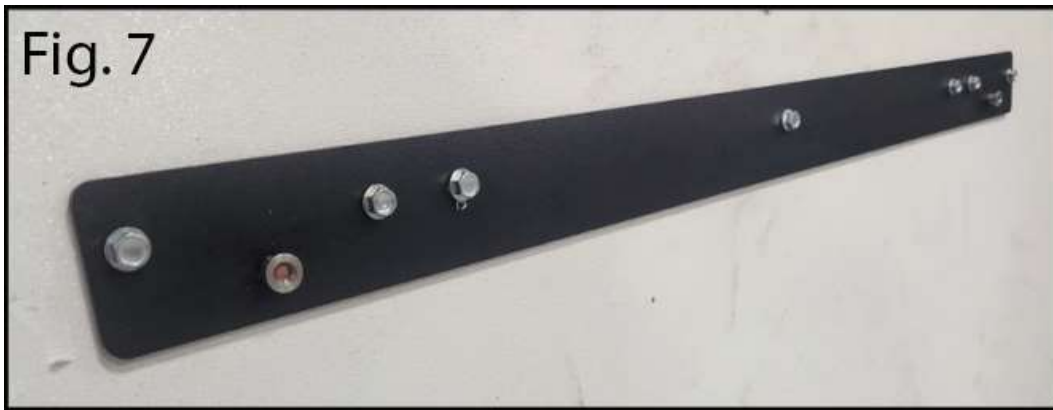
Use an impact driver and 3/8" sockets to install the three new screws in the mounting bracket. This completes the repair for KRV # 768047. See Figure 5 – Figure 7.

Note: To avoid over-torquing these screws, it is necessary that final tightening be by hand with a 3/8" wrench.

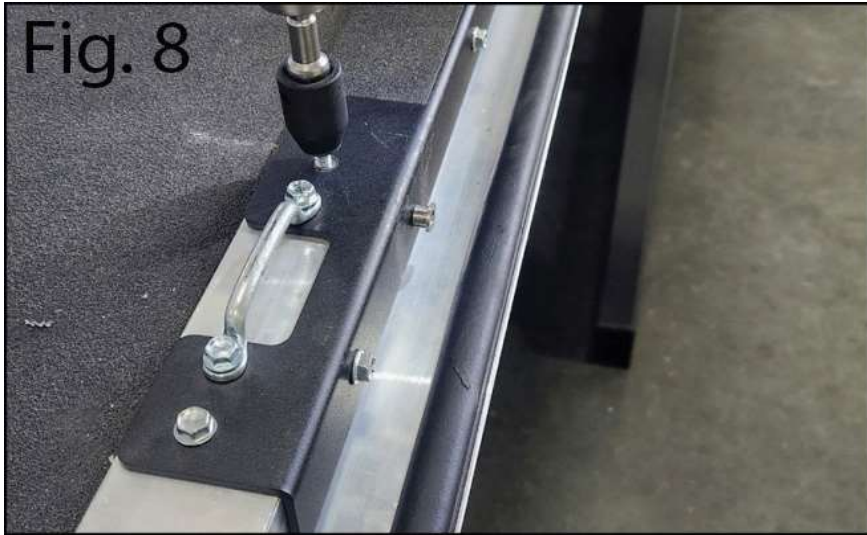
Remove the 12 mounting screws that secure the mounting bracket. Once removed, discard the original mounting bracket. See Figure 8.

Note: It is OK to use a drill/impact with 3/8" bit for the removal of each of the screws.

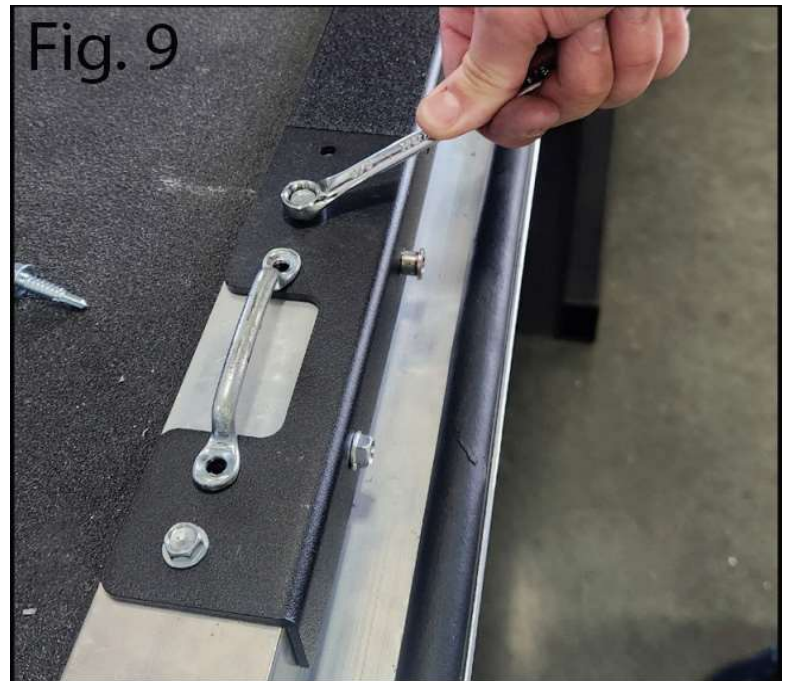
Use the replacement kit KRV # 768048 to attach the new mounting bracket. To install the new bracket, start by installing 12 mounting screws into the 12 original holes. The above-mentioned holes will line up with the holes from the bracket that was removed. See Figure 9.

Note: To avoid over-torquing these screws, it is necessary that final tightening be by hand with a 3/8" wrench.
