Safety Recall

N252500680 Instrument Panel Display May Go Blank

Release Date: June 2025

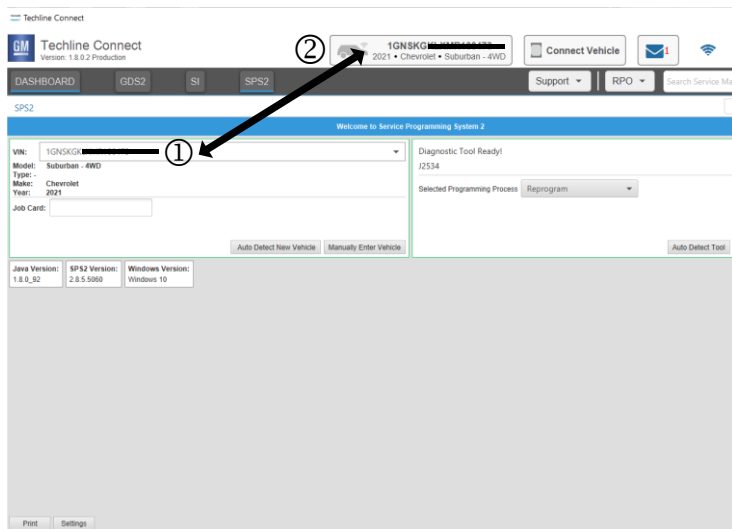
Caution: Be sure the VIN selected in the drop down menu (1) is the same as the vehicle connected (2) before beginning programming.

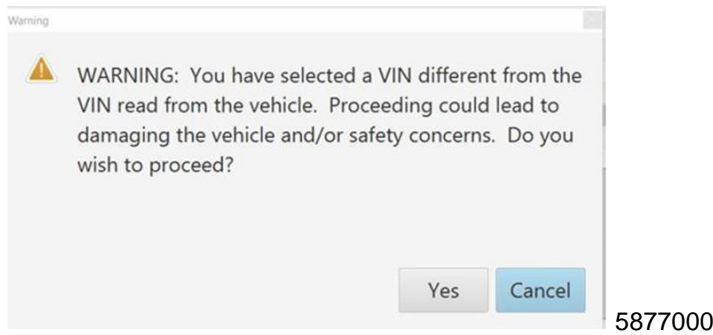
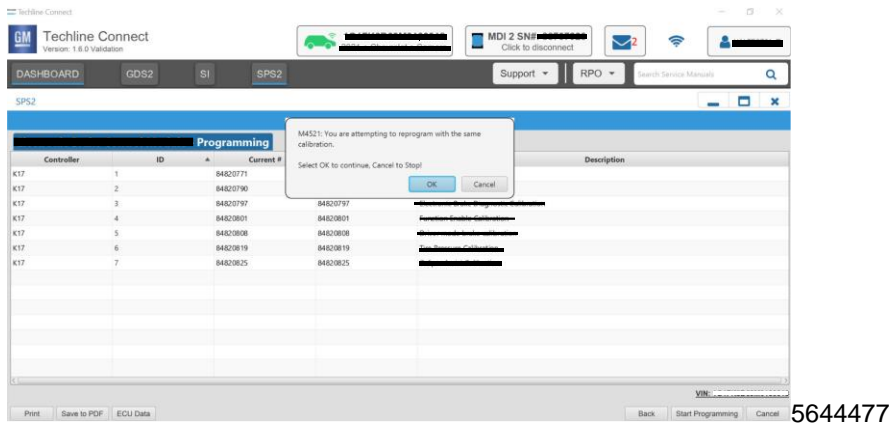
Important: If the vehicle VIN DOES NOT match, the message below will be shown.

Important: Techline Connect screens shown above.

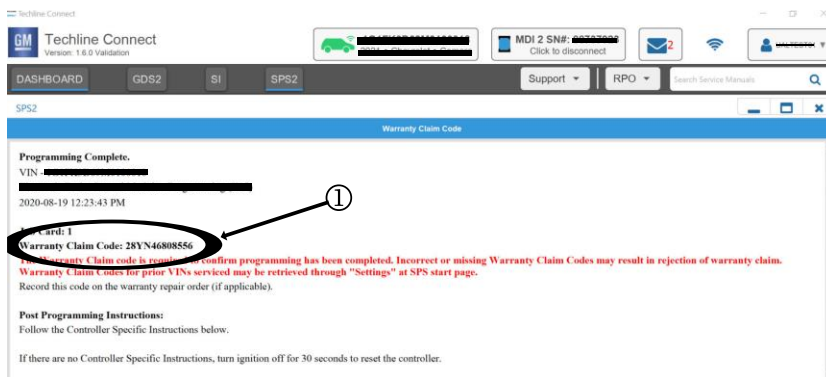
Note: The screenshot above is an example of module programming and may not be indicative of the specific module that is being programmed. Module selection and VIN information have been blacked out.

Important: To avoid warranty transaction rejections, you **MUST** record the warranty claim code provided on the Warranty Claim Code (WCC) screen shown above on the job card. Refer to callout 1 above for the location of the WCC on the screen.
