## Technical Service Bulletin

25-01-038H

IONIQ 5 (NEA EV)

PASSENGER-SIDE HEADLAMP MARKING INSPECTION AND  
STICKER APPLICATION (RECALL 279)

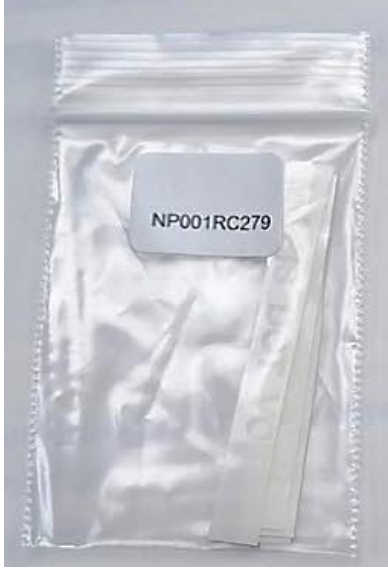
1

Model	Part Name	Part Number	Figure	Quantity
IONIQ 5 (NEA EV)	Headlamp Label Kit*	NP001-RC279

\*NOTE: Each kit has 4 stickers.

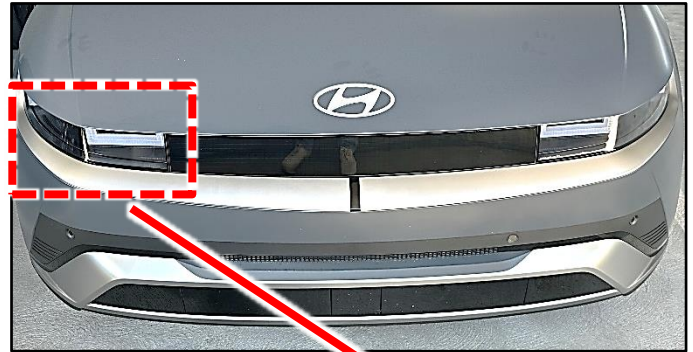
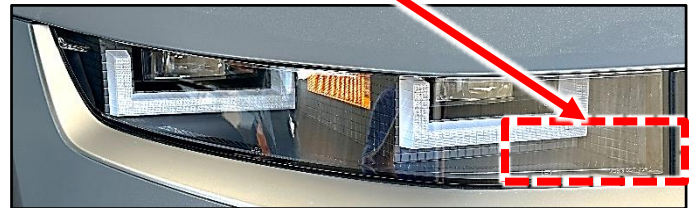
1. Locate the lower corner of the passenger-side headlamp and inspect the etched marking.

Verify the marking:

- If **GOOD**: MOBIS DOT VOR DRL
  - Proceed to step 2.
- If **NO GOOD**: MOBIS DOT VOP DRL
  - Proceed to the **Headlamp Marking Sticker Application** procedure.
  - Do **NOT** take a photo with STUI in step 2. Photos will be taken after the sticker application is completed on page 5.

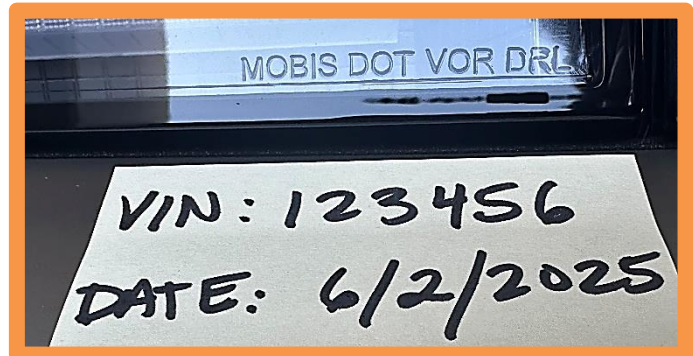
Using STUI, take a photo of the passenger-side headlamp marking with the last 6 digits of the VIN and the date of repair on a piece of paper.

Upload the photo to STUI.

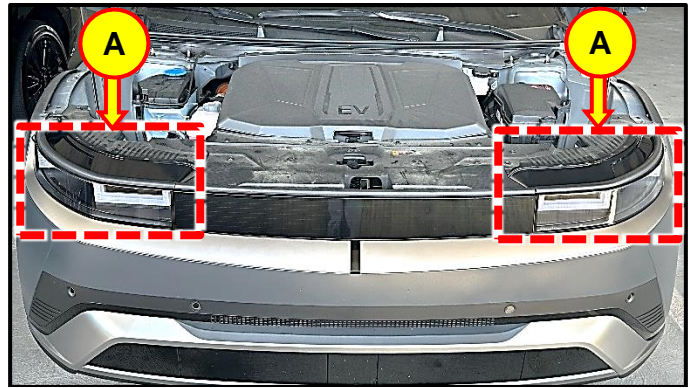
1. Open the hood. Clean the top and corners of both headlamps (A) using a clean microfiber cloth.

Ensure both headlamps are free of dust and debris.

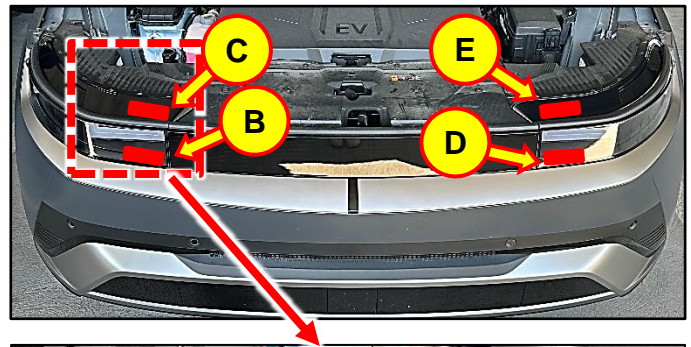
2. Apply the stickers in 4 locations:
  - **B:** Passenger-side headlamp lower corner (over the existing marking)
  - **C:** Passenger-side headlamp top corner
  - **D:** Driver-side headlamp lower corner (over the existing marking)
  - **E:** Driver-side headlamp top corner

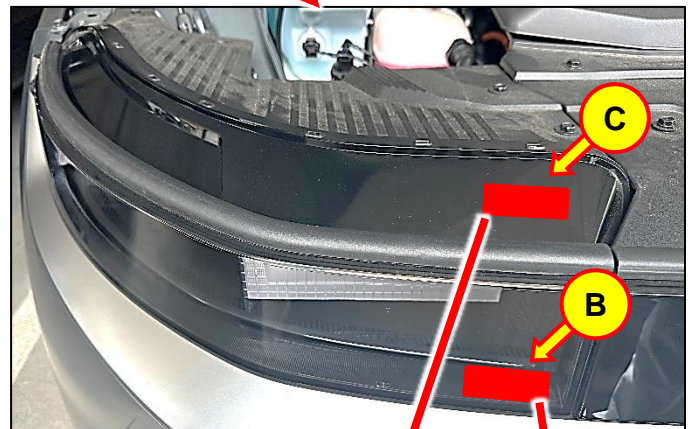
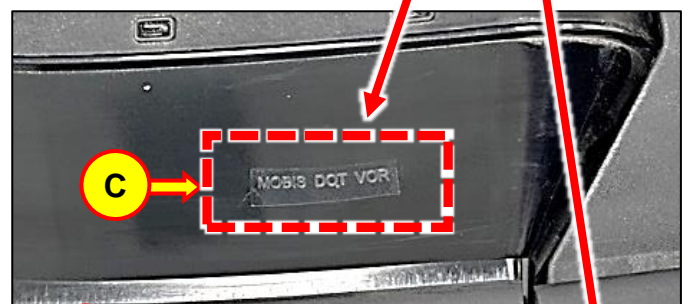
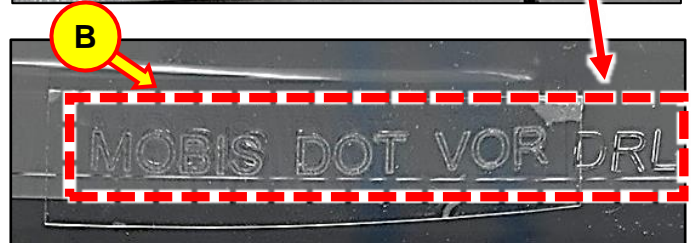
Avoid touching the adhesive side of each sticker.

Press firmly to remove air bubbles.

Sticker should adhere smoothly and align with vehicle contours.

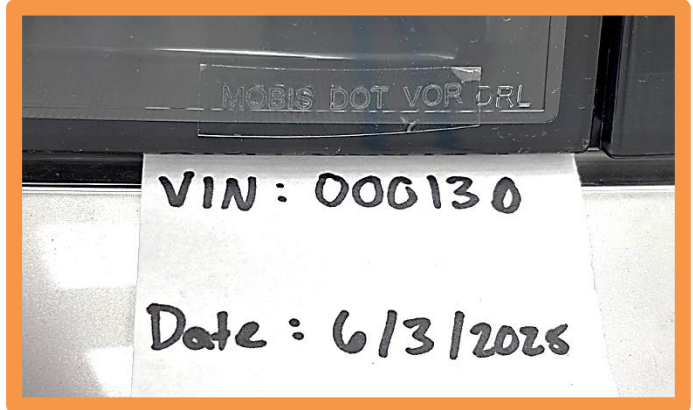
Passenger-Side Headlamp

Using STUI, take two photos; a passenger-side headlamp with sticker over the marking and a driver-side headlamp with sticker over the marking. Include the last 6 digits of the VIN and the date of repair on a piece of paper within the each picture.
