Recall Campaign Bulletin

CAMPAIGN NO.	2025060004
CAMPAIGN DESC.	25P6990005
NHTSA ID	25V379
SUBJECT	Rework Rear Headliner and C-Pillar Trim
MODEL(S)	GLC (254 platform)
MODEL YEAR(S)	2023 – 2025
CAMPAIGN POPULATION	92,851

Brief description of rework procedures (consisting of Work Procedure 1 and 2)

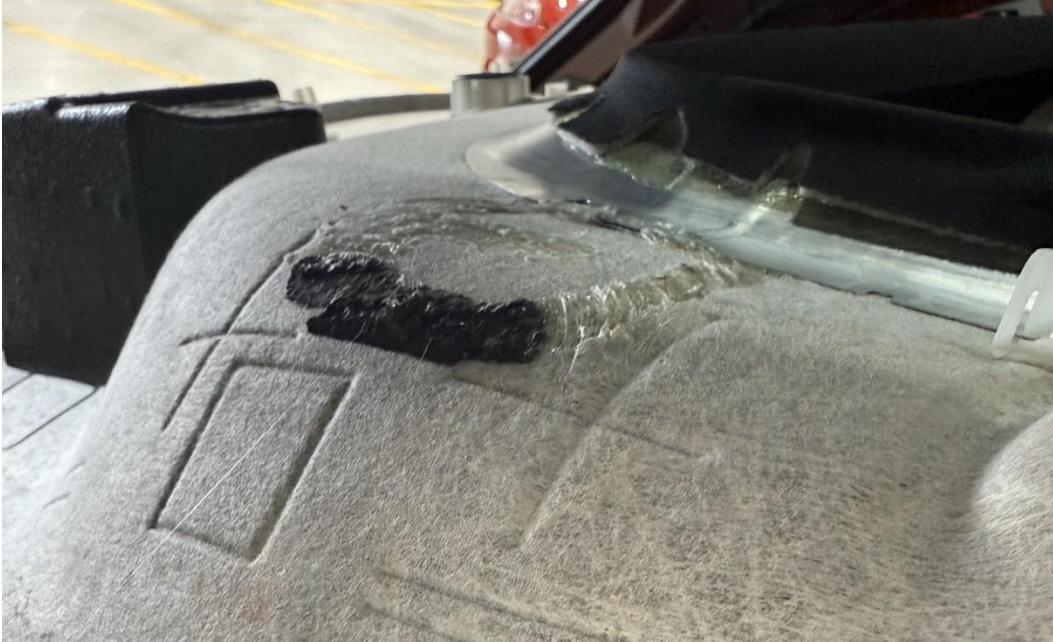
Figure 6 (Right side, looking toward rear load compartment, with foam block removed.)

9. Remove the foam block (**Figure 6**) and relieve pressure from the headliner.

i A small material protrusion (<5 mm/0.2 inches) may remain on the headliner.

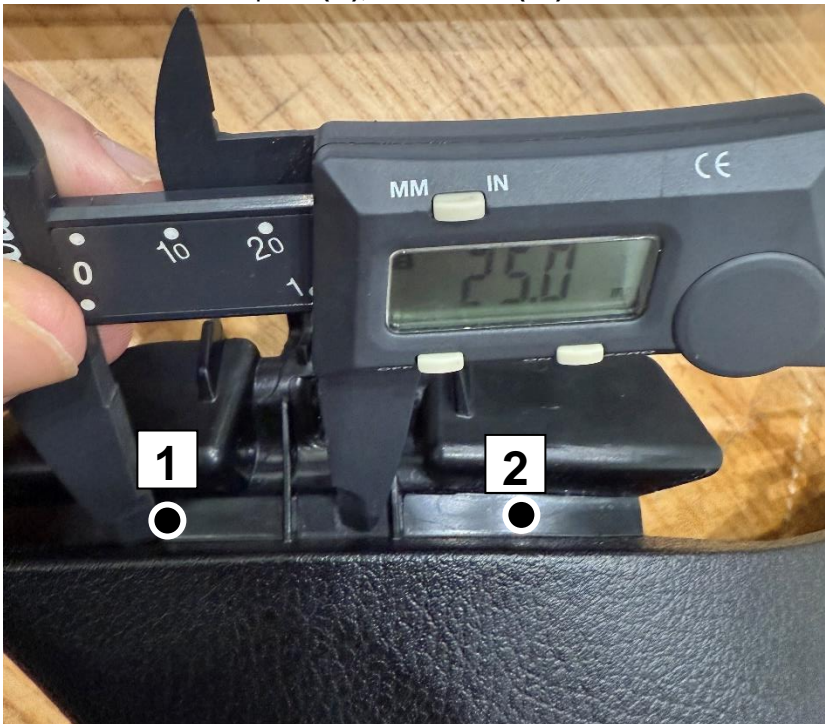
Figure 10 (End limits for area of cut)

- From the center point (**M**), measure 25(+5) mm in both directions and mark them (**Figure 10, 1 & 2**).

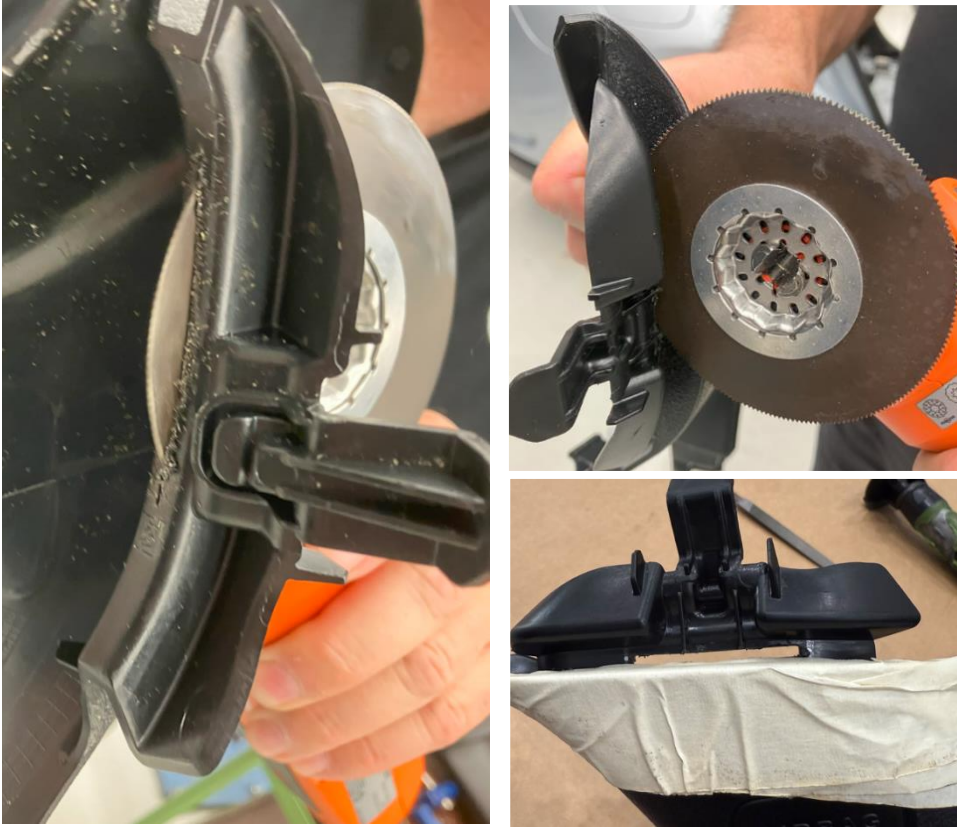
Figure 11

4. Make the cut along the marked area (**Figure 7, G**) using a circular cutoff wheel (**Figure 11**). Move the saw blade slightly up and down vertically when making the cut to remove the area marked in permanent marker.

i To avoid damaging the C-pillar trim, use scotch- or painters-tape to protect the front side surface (**Figure 11**).

i To avoid damaging the C-pillar trim, use scotch- or painters-tape to protect the front side surface (**Figure 11**).

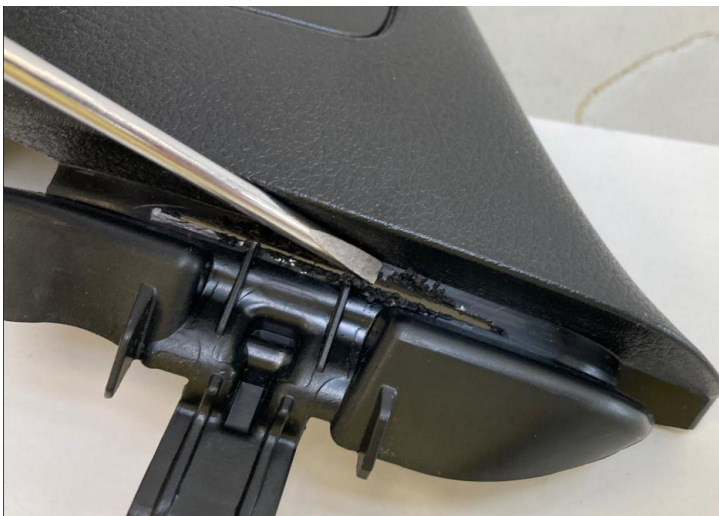
Figure 12

5. Rework cut edges by removing residual material debris (**Figure 12**).

i Use a small screwdriver to remove residual material debris.
