# Keystone RV Company

## SAFETY ADVISORY # 25-470

### Rear Gate Pins and Leg Support Bracket

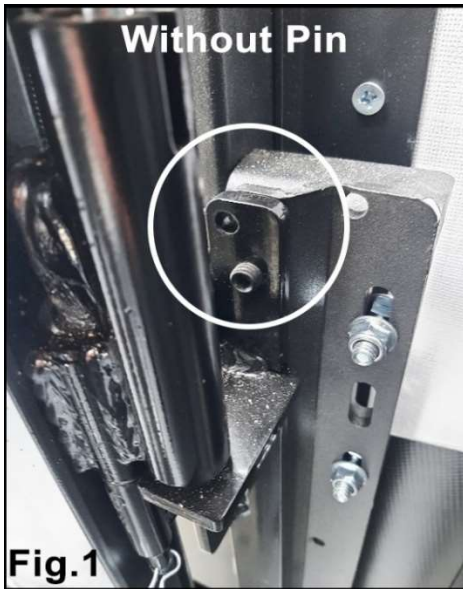
Fig. 1 shows no pin in the bracket.

Locate the patio gate corner brackets inside at the door frame on each side. If pins are missing, install both pins (KRV # 510418 - Bed lift - Pin - Wire Lock Pin), one on each side. See Fig. 1 – Fig. 2.

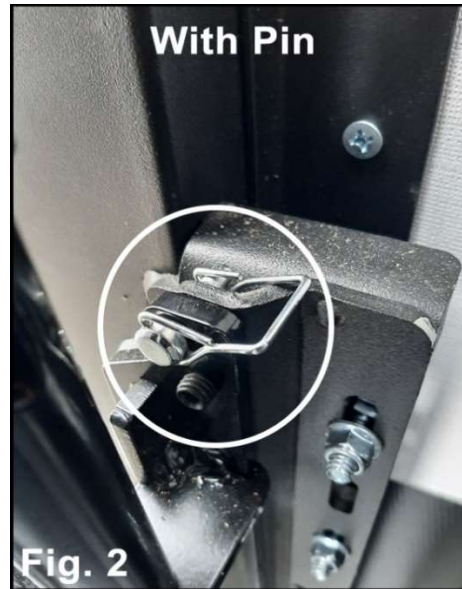
Fig. 2 shows the pin installed.

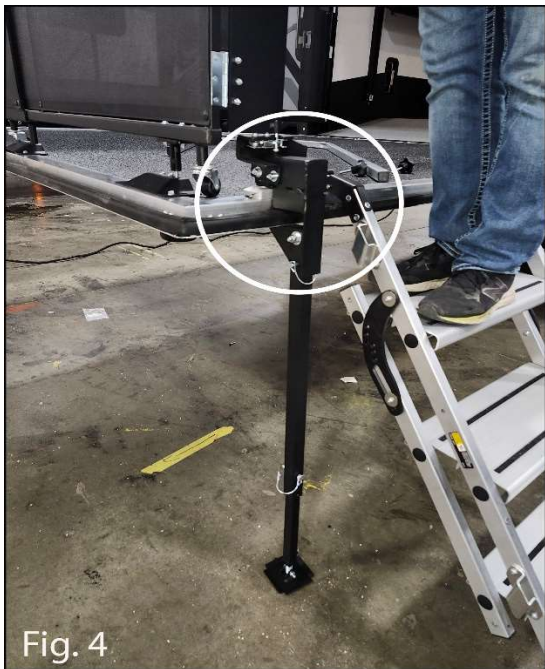
Fig. 4 shows the drop leg keeper assembly with the patio rail drop leg installed into the bracket.

Insert the patio rail drop leg into the keeper assembly bracket. See Fig. 4 – Fig. 5.

Note: Step brackets may need to be moved if they interfere with adjustable drop leg support operation.

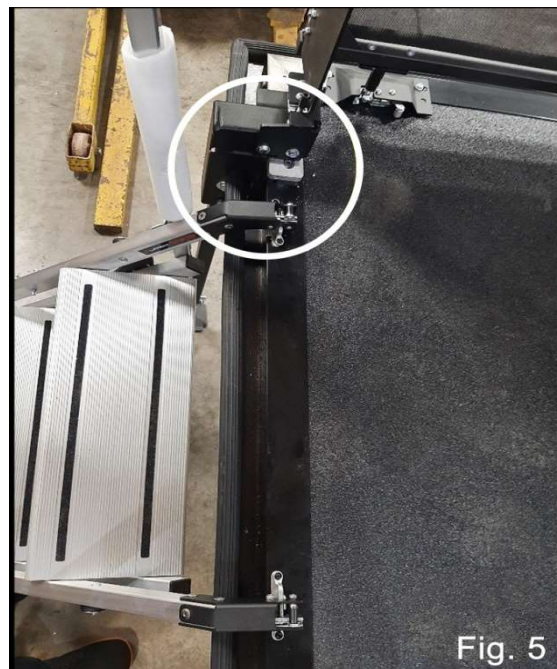
Fig. 5 shows the drop leg keeper assembly with the patio rail drop leg installed, from above.

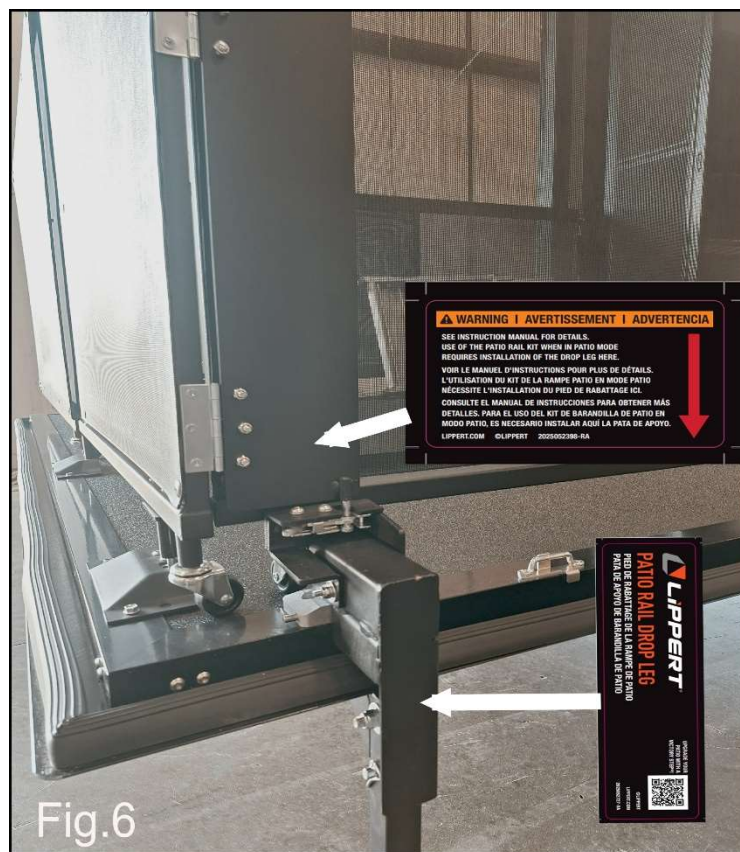
Fig. 6 shows the victory step wall mount warning label, and the patio rail drop leg label (enlarged for viewing) with arrows indicating proper placement.

Place the Victory step wall mount warning label - (KRV # 771710) and the Patio rail drop leg label - (KRV # 771707) to their proper locations. See Fig. 6.
