SERVICE PROCEDURE

25507R2

SUBJECT: SAFETY RECALL

Brake systems on certain 2019 thru 2025 International® CV™ Series trucks built 1/11/2018 thru 9/9/2024, manufactured without a silicone block harness, with feature codes 0004198, 0004240 (Brake system, hydraulic with Hydromax brake booster).

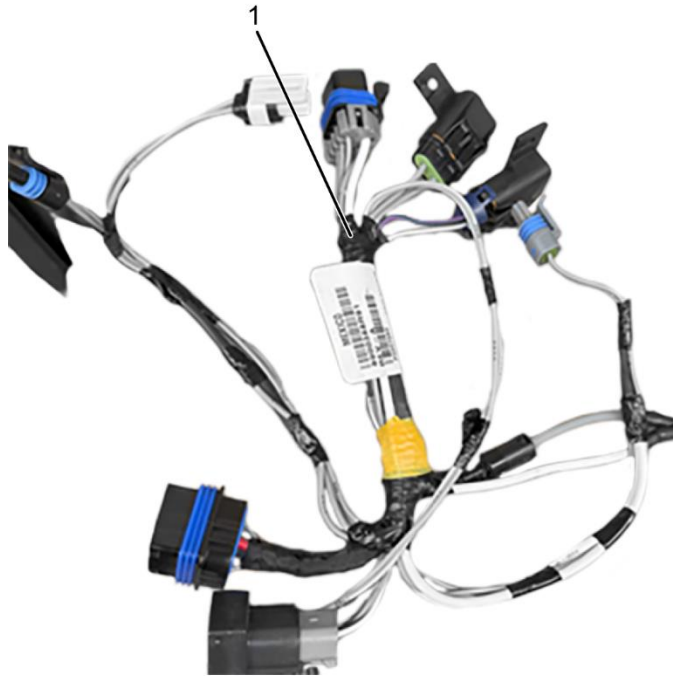
Figure 2. Harness Not Fully Taped

NOTE: Harness part number 8900388R91 will require the harness to have electrical harness tape installed, if it is not already fully taped. The tape is to prevent abrasion to the harness from other components.

1. Harness

7. Verify that the replacement harness is fully taped.
 - a. If the harness is not fully taped (Figure 2), proceed to Step 8.
 - b. If the harness is fully taped, proceed to Step 11.

8. When wrapping the harness start with three wraps around the harness and finish up with three wraps. The electrical tape should overlap the previous wrap and be half the width of the tape.
9. When taping the junction areas of the harness, the electrical tape should be wrapped around all wires going to the junction area and should overlap half the width of the previously installed wrap.

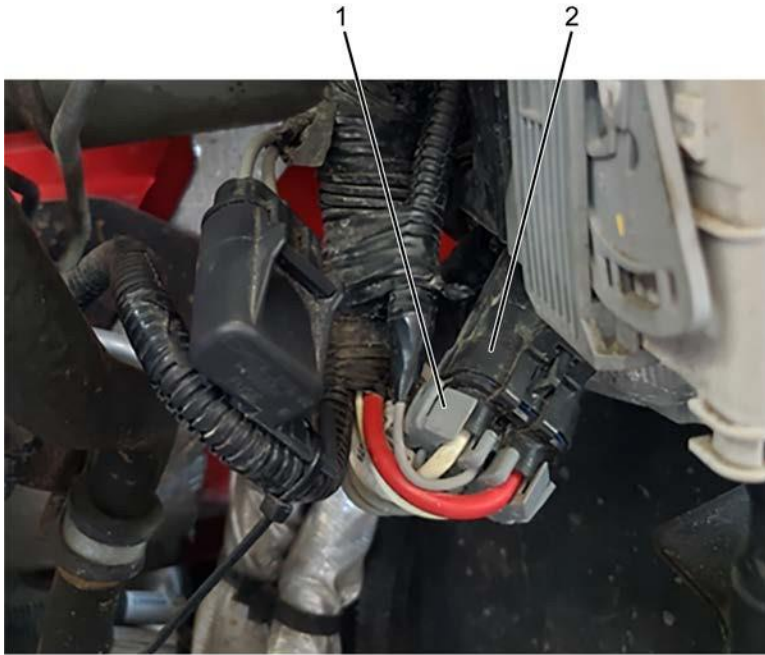
Figure 4. Booster Pump Motor Jumper Harness Connector

1. Booster pump motor jumper harness connector
2. Center chassis harness connector

12. Disconnect the booster pump motor jumper harness connector (Figure 4, Item 1) from the center chassis harness connector (Figure 4, Item 2).

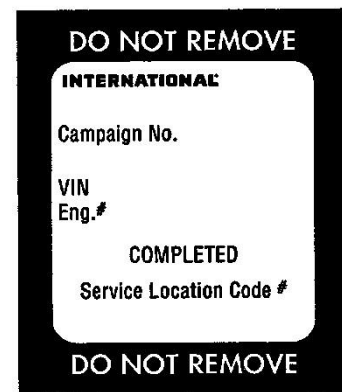
Each vehicle corrected in accordance with this campaign must be marked with a CTS-1075 Campaign Identification Label.

Complete the label and attach on a clean surface next to the vehicle identification number (VIN) plate.
