Recall Bulletin 250618REV

RECALL BULLETIN: 250618REV	<p>The purpose of this Recall Service Bulletin is to inform REV Recreation Group dealers of the need to install latch covers, a mudflap, wire grommet and seal certain 2025-2026 Fleetwood Altitude and Holiday Rambler Incline Class C motorhomes. A list of affected motorhome serial numbers appears at the end of this Recall Bulletin.</p> <p><u>CONDITION:</u> On motorhomes affected by this recall campaign the compartment below the house entry steps contains electrical components that may become inoperable due to water intrusion.</p> <p><u>DEALER CORRECTIVE ACTION:</u> Follow the attached repair bulletin to installing latch covers on the underside entry step compartment, installation of a mudflap and sealing all the compartment seams and openings to prevent water intrusion.</p> <p>Note: This REV RV repair is to be performed by a REV RV dealership technician.</p> <p>ATTENTION SERVICE, WARRANTY AND PARTS MANAGERS: All prior Authorization Approvals must go through REV RV Dealer Technical Support (800) 816-9825</p>

YEAR(S) AFFECTED: 2025-2026	
PRODUCT(S) AFFECTED: <u>FLEETWOOD ALTITUDE</u> <u>HOLIDAY RAMBLER INCLINE</u>	
MONTHS OF MANUFA

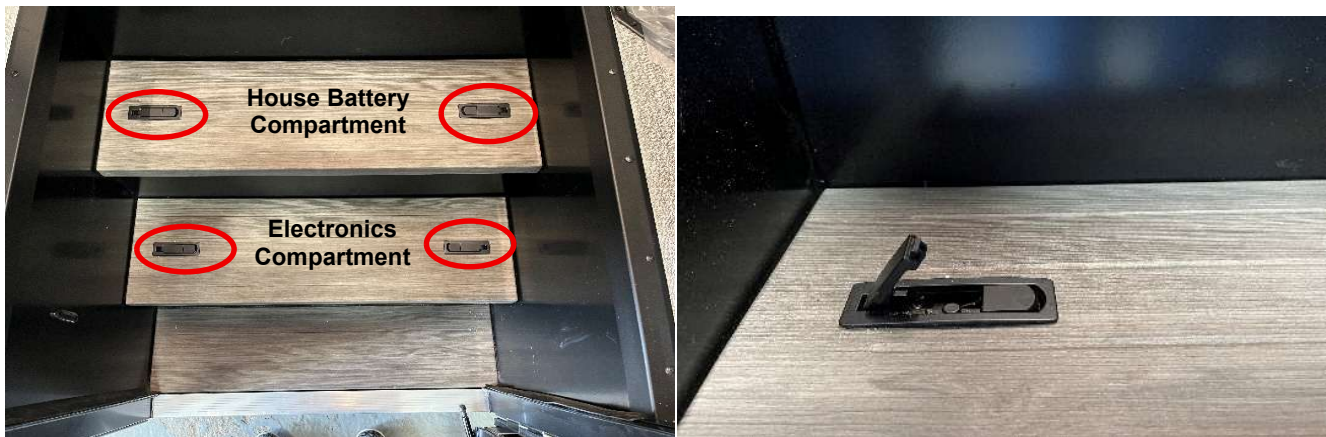
1. Open the entry door and remove the step treads (2 latches per tread) to perform an inspection of the area. **See Picture Below**

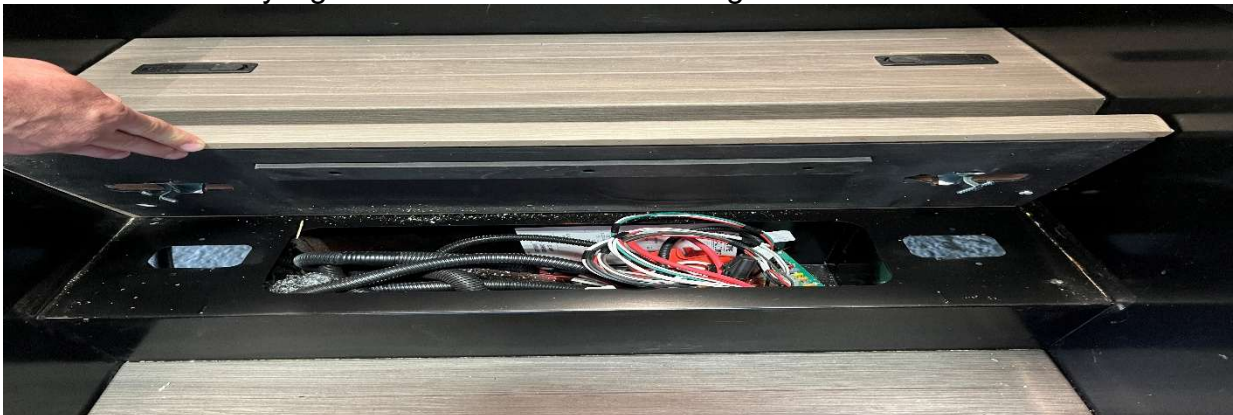
2. Look carefully at the electrical area. Observe the metal compartment with a flashlight to see if there are any signs of water or moisture sitting on the metal surfaces.

If water is determined to be in the electrical compartment under the step, use a shop vac, fans or rags to dry the area.

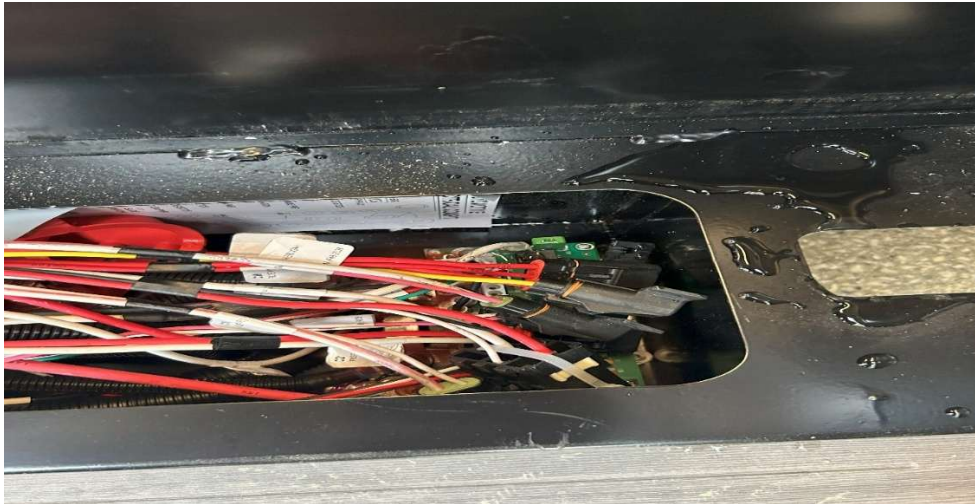
3. Next look carefully at the electrical connections and circuit boards to see if there are any signs of water damage or corrosion.

If the electrical connections or components in the entry step are corroded or there are signs of water damage, then replacement will be required.

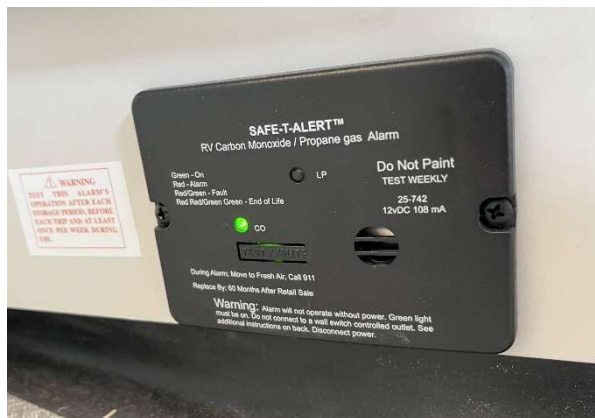
4. Check all fuses to ensure all are good. Note and replace any fuses that are blown.
5. Locate the CO/LP detector inside the motor home and make sure that it is functional and the operation lights are illuminated and test button functions as designed. Refer to the operations manual in the unit packet.

Replace any fuses that are blown. Test circuits to ensure there is not another issue.

If the CO - LP detectors are not working or if there are signs of unusual operation, the component should be replaced, and further diagnostics should be performed to ensure proper operation including checking the fuses. Call REV RV Dealer Technical Support with any questions or if you need guidance.

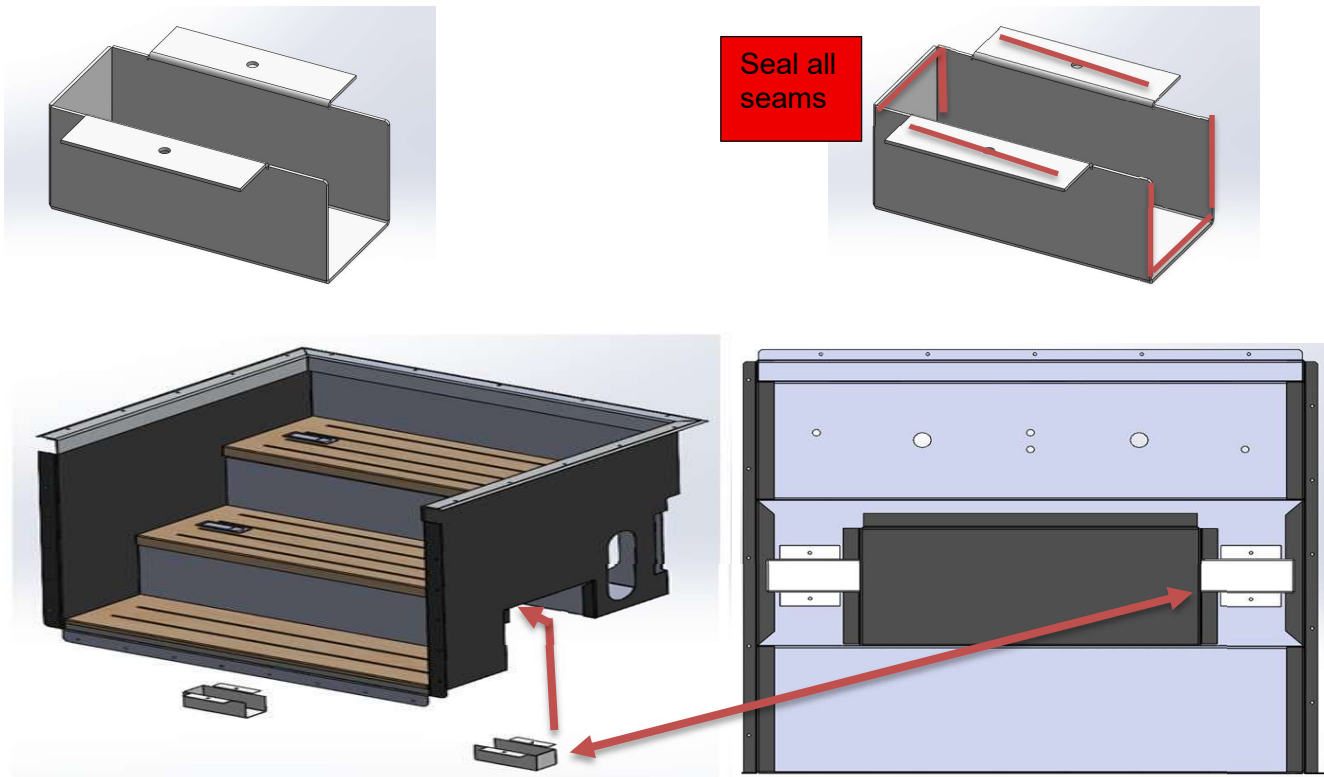
8. You should see the step tread latch openings to the electrical control center area from the underside of the motor home. There are one on each side.

In the **Parts Kit** locate the latch covers and test fit them as shown in the diagram while under the motor home. These are only installed with the latches to the electrical control center area, **not** the battery compartment.
