I N F I N I T I

VOLUNTARY RECALL CAMPAIGN

Classification: EM25-005B	Reference: ITB25-010B	Date: December 3, 2025
------------------------------	--------------------------	---------------------------

VOLUNTARY SAFETY RECALL CAMPAIGN 2019-2022 QX50 AND 2022 QX55; VCR ENGINE INSPECTION

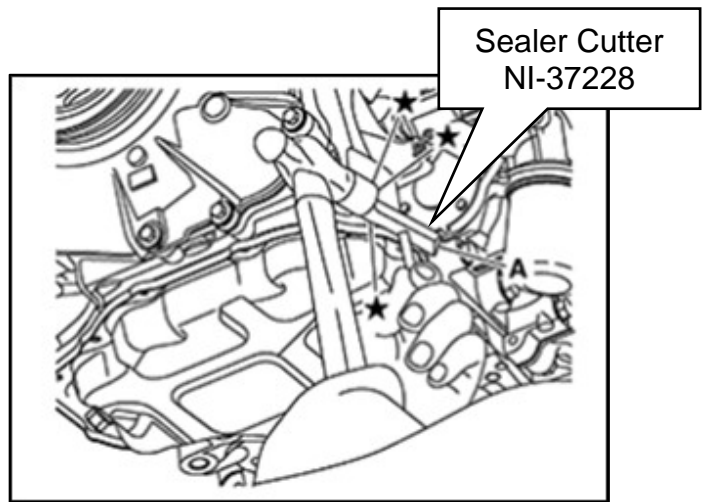
Figure 6

- c. Separate the lower engine oil pan from the upper engine oil pan using Sealer Cutter (NI-37228).

To avoid damage to the vehicle, do NOT separate the lower engine oil pan using a screwdriver. Tap the Sealer Cutter in, and then tap it on the side as shown to break the seal without damaging the mating surface.

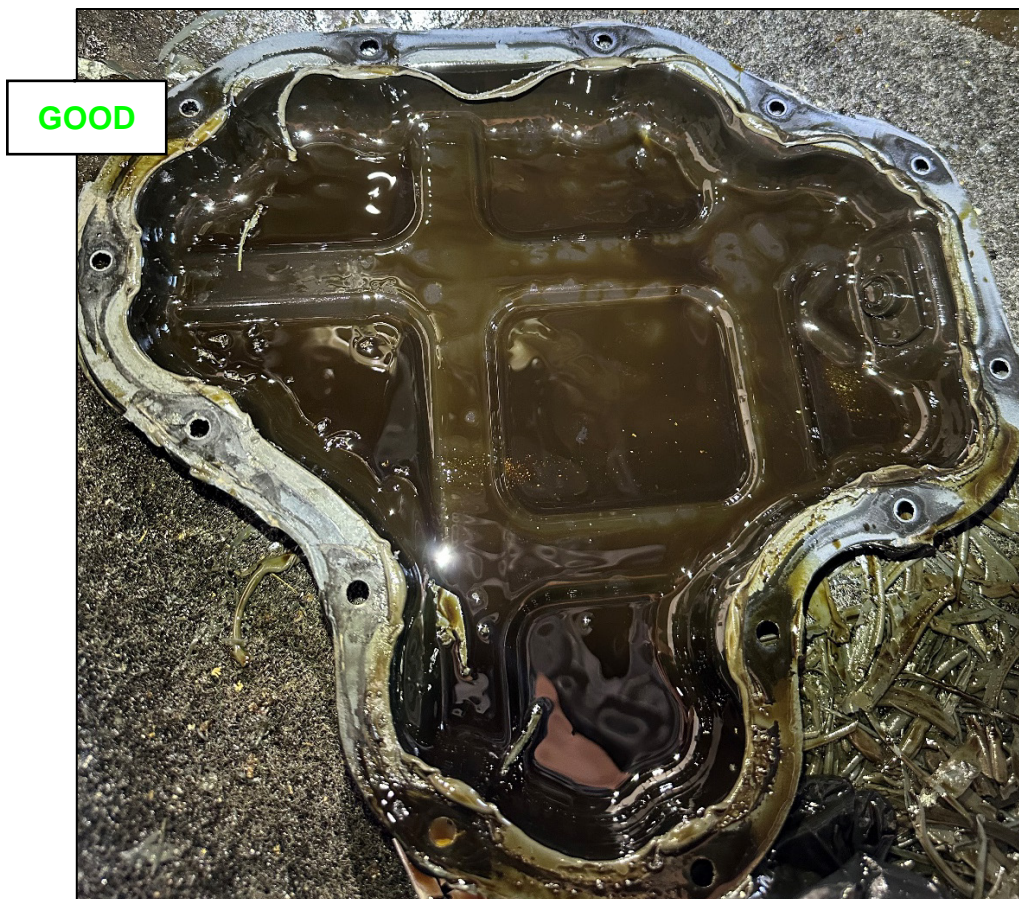
6. Inspect the lower engine oil pan for accumulated metallic copper-colored bearing debris and compare to the examples in Figure 7 through Figure 11 (pages 7 to 9). Bearing material will appear as sparkly fine copper-colored debris accumulated in recessed areas of the oil pan.
7. Is the lower engine oil pan clean with either no debris or only slight metallic debris, similar to what is shown in Figure 7 through Figure 11?

GOOD

YES: The lower engine oil pan has no debris or only slight metallic debris (**GOOD**) similar to what is shown in Figure 7 through Figure 11 (pages 7 to 9). Continue to step 8 on page 12.

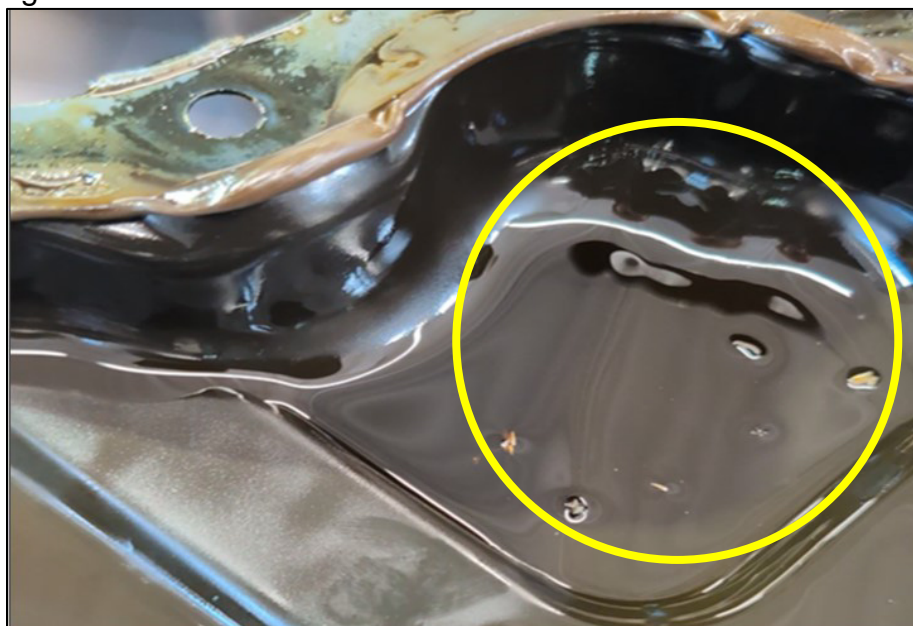
Figure 11

HINT: Gray RTV sealant debris migration is normal during oil pan removal (Figure 11). Do NOT replace the engine assembly for RTV debris. Remove the RTV sealant during normal oil pan cleaning.

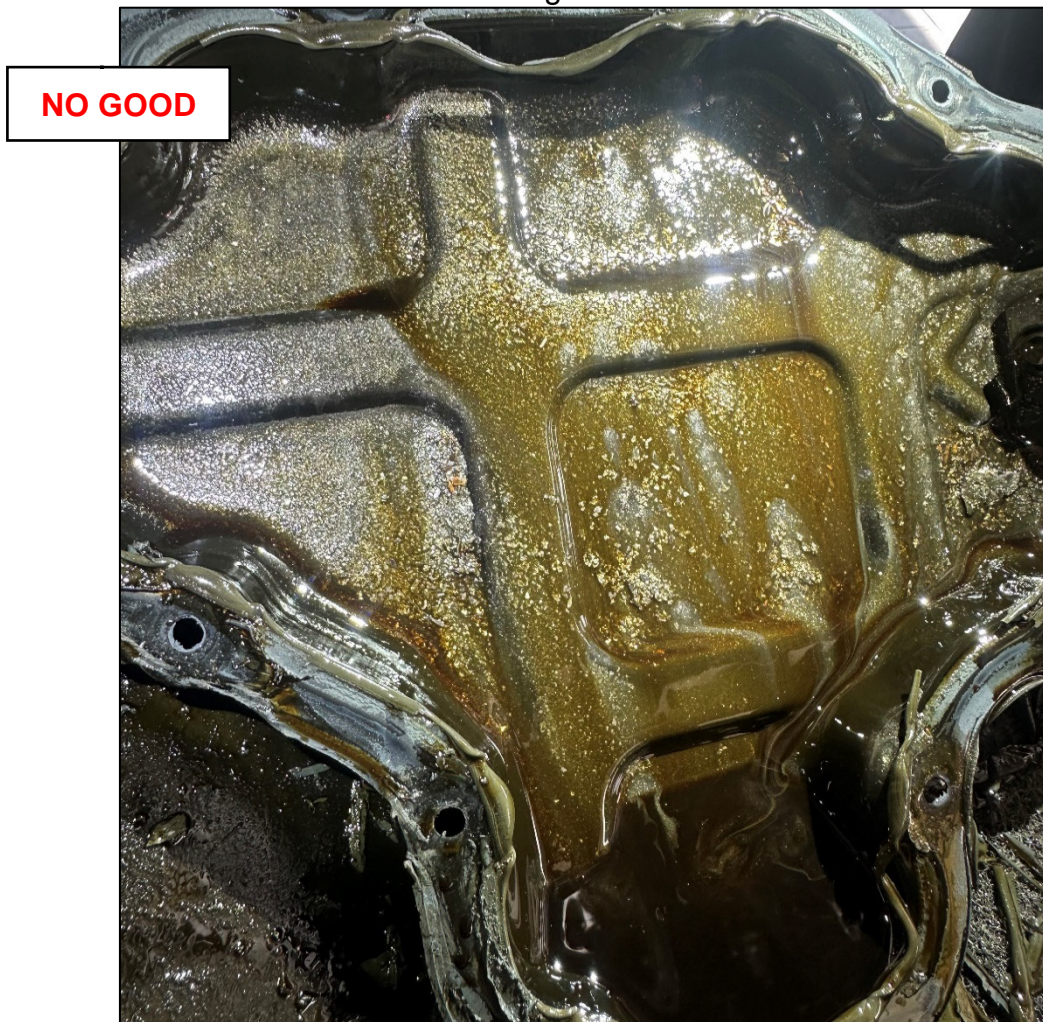
- Figure 12 and Figure 13 below, and Figure 14 on page 11 are examples of a **NO GOOD** condition.

NO GOOD

12. If the lower engine oil pan inspection was **NO GOOD condition**, similar to what is shown in Figure 12 through Figure 14 on pages 10 to 11, replace the long engine assembly (replace using normal campaign/warranty guidelines and preauthorization by Warranty Contact Center IS REQUIRED).
 - Refer to the ESM: **ENGINE > ENGINE MECHANICAL > KR20DDET > UNIT REMOVAL AND INSTALLATION > ENGINE ASSEMBLY > Removal & Installation**
 - Refer to **Campaign Related Information When Replacing Long Engine Assembly** for claim approval.

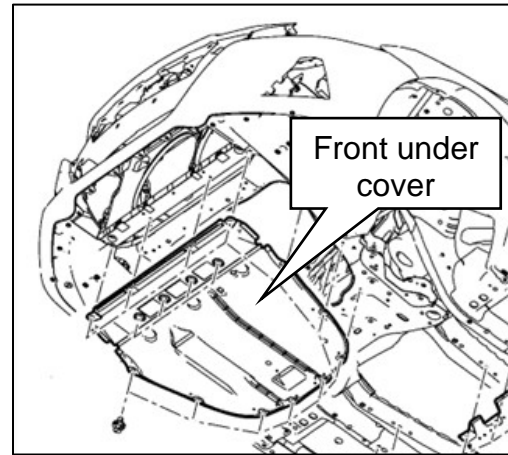
Figure 16

10. Install the front under cover.
