# VOLUNTARY RECALL CAMPAIGN

Classification: EM25-004C	Reference: NTB25-034C	Date: November 20, 2025
------------------------------	--------------------------	----------------------------

## VOLUNTARY SAFETY RECALL CAMPAIGN 2019-2020 ALTIMA; VCR ENGINE INSPECTION

**CAMPAIGN ID #:** R25B1  
**APPLIED VEHICLES:** 2019-2020 Altima (L34)  
**APPLIED ENGINES:** KR20DDET only

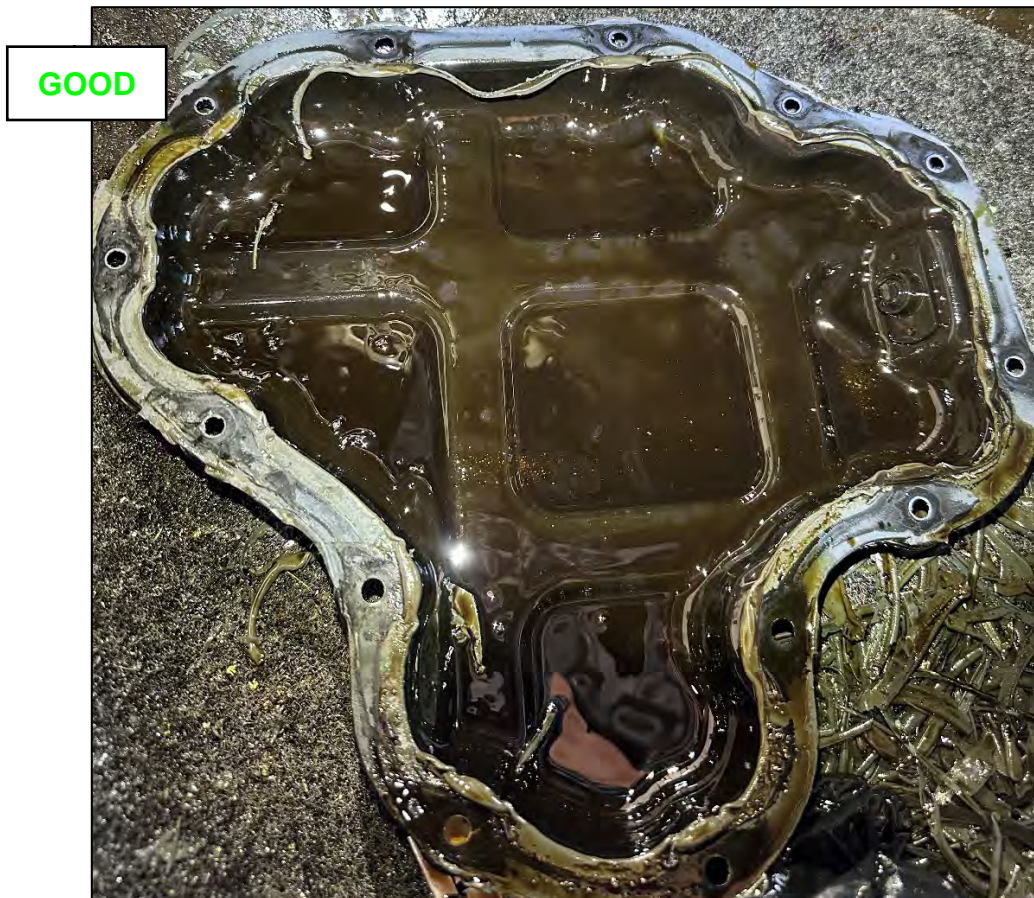
5. Inspect the lower engine oil pan for accumulated metallic copper-colored bearing debris and compare to the examples in Figure 6 through Figure 10 (pages 6 to 8). Bearing material will appear as sparkly fine copper-colored debris accumulated in recessed areas of the oil pan.
6. Is the lower engine oil pan clean with either no debris or only slight metallic debris, similar to what is shown in Figure 6 through Figure 10?

**YES:** The lower engine oil pan has no debris or only slight metallic debris (**GOOD**) similar to what is shown in Figure 6 through Figure 10 (pages 6 to 8). Continue to step 7 on page 11.

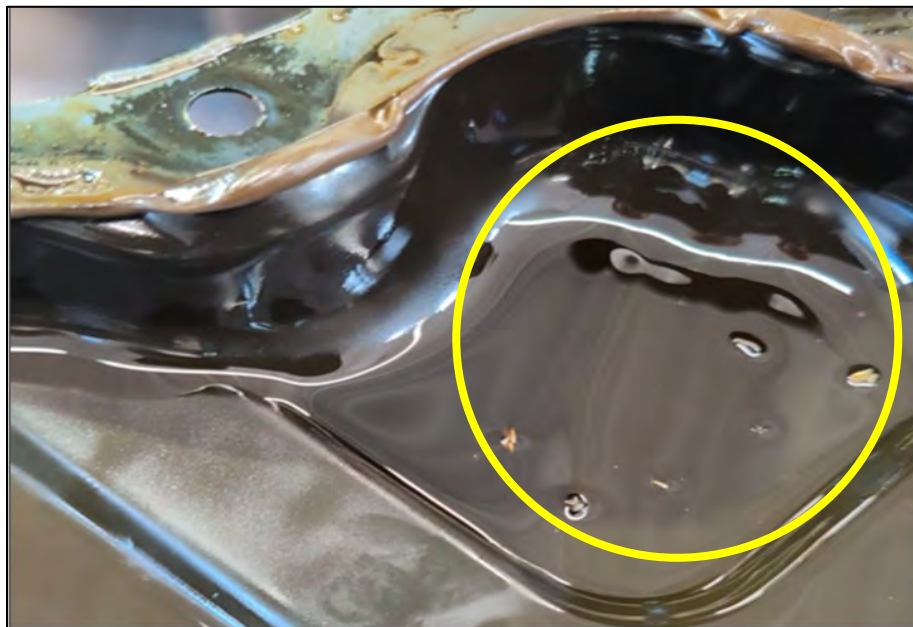
Figure 10

**HINT:** Gray RTV sealant debris migration is normal during oil pan removal (Figure 10). Do NOT replace the engine assembly for RTV debris. Remove the RTV sealant during normal oil pan cleaning.
