<b>NGDVTSB040 Visor Safety Labels</b>		<b>Revision</b>	-
<b>Release Date:</b>	July 2025	<b>Bulletin Type:</b>	Safety Recall
<b>Rework Time:</b>	.2 Hrs/Vehicle/Label (1 Person Hrs)	<b>PLRS Number:</b>	P108039.A0999
<b>Parts Returned:</b>	None Required	<b>Tread Component</b>	Electrical

Oshkosh Defense has decided that certain Next Generation Delivery Vehicles manufactured between June 1, 2024, and June 24, 2025, fail to meet the requirements of Federal Motor Vehicle Safety Standard 571.208 “Occupant Crash Protection”. The airbag warning label on the sun visor may detach.

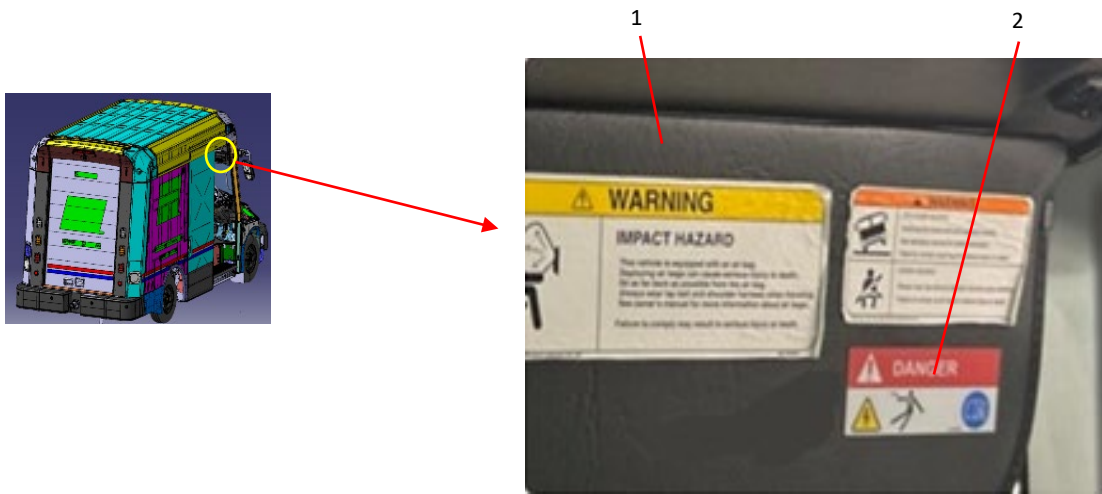
Figure 2. EV Danger Label Removal.

- 4) Locate and remove the “EV Danger” label (Figure 2, Item 2) from the driver side sun visor (Figure 2, Item 1).
- 5) Once the “EV Danger” label is removed, clean the area with isopropyl alcohol to remove any existing adhesive from the driver side sun visor (Figure 2, Item 1).

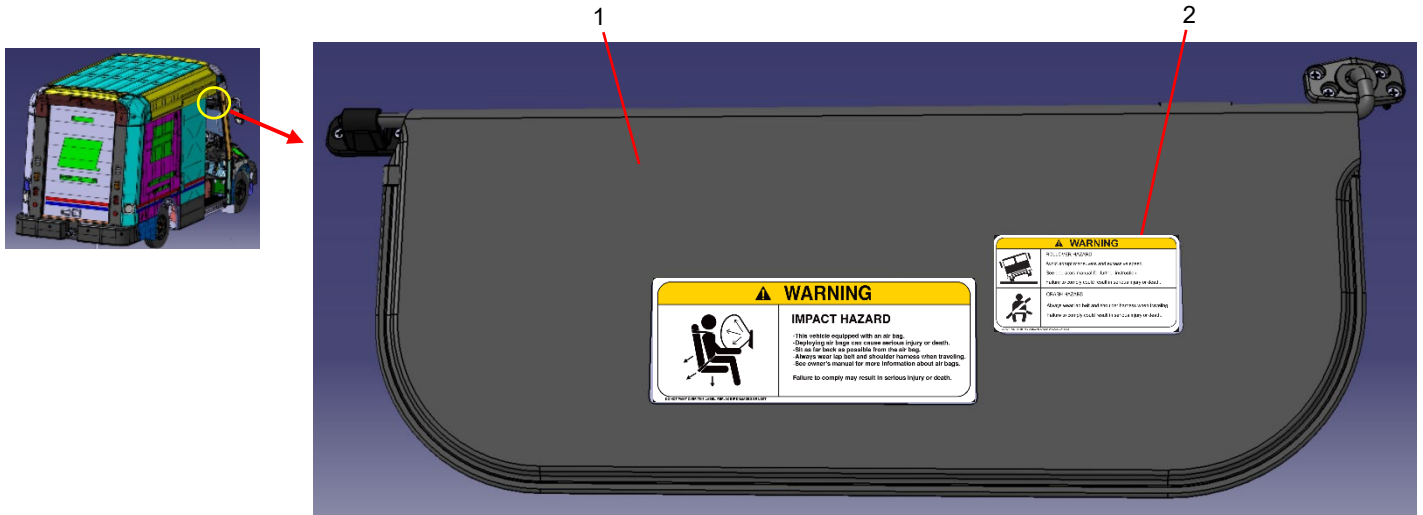
Figure 2. Rollover Warning Label Removal.

- 4) Locate the “Rollover” warning label (Figure 2, Item 2) on the driver side sun visor (Figure 2, Item 1) and remove it.

- 6) Once “Rollover” warning label (Figure 2, Item 2) is removed, clean the area with isopropyl alcohol to remove any existing adhesive from the driver side sun visor (Figure 2, Item 1).

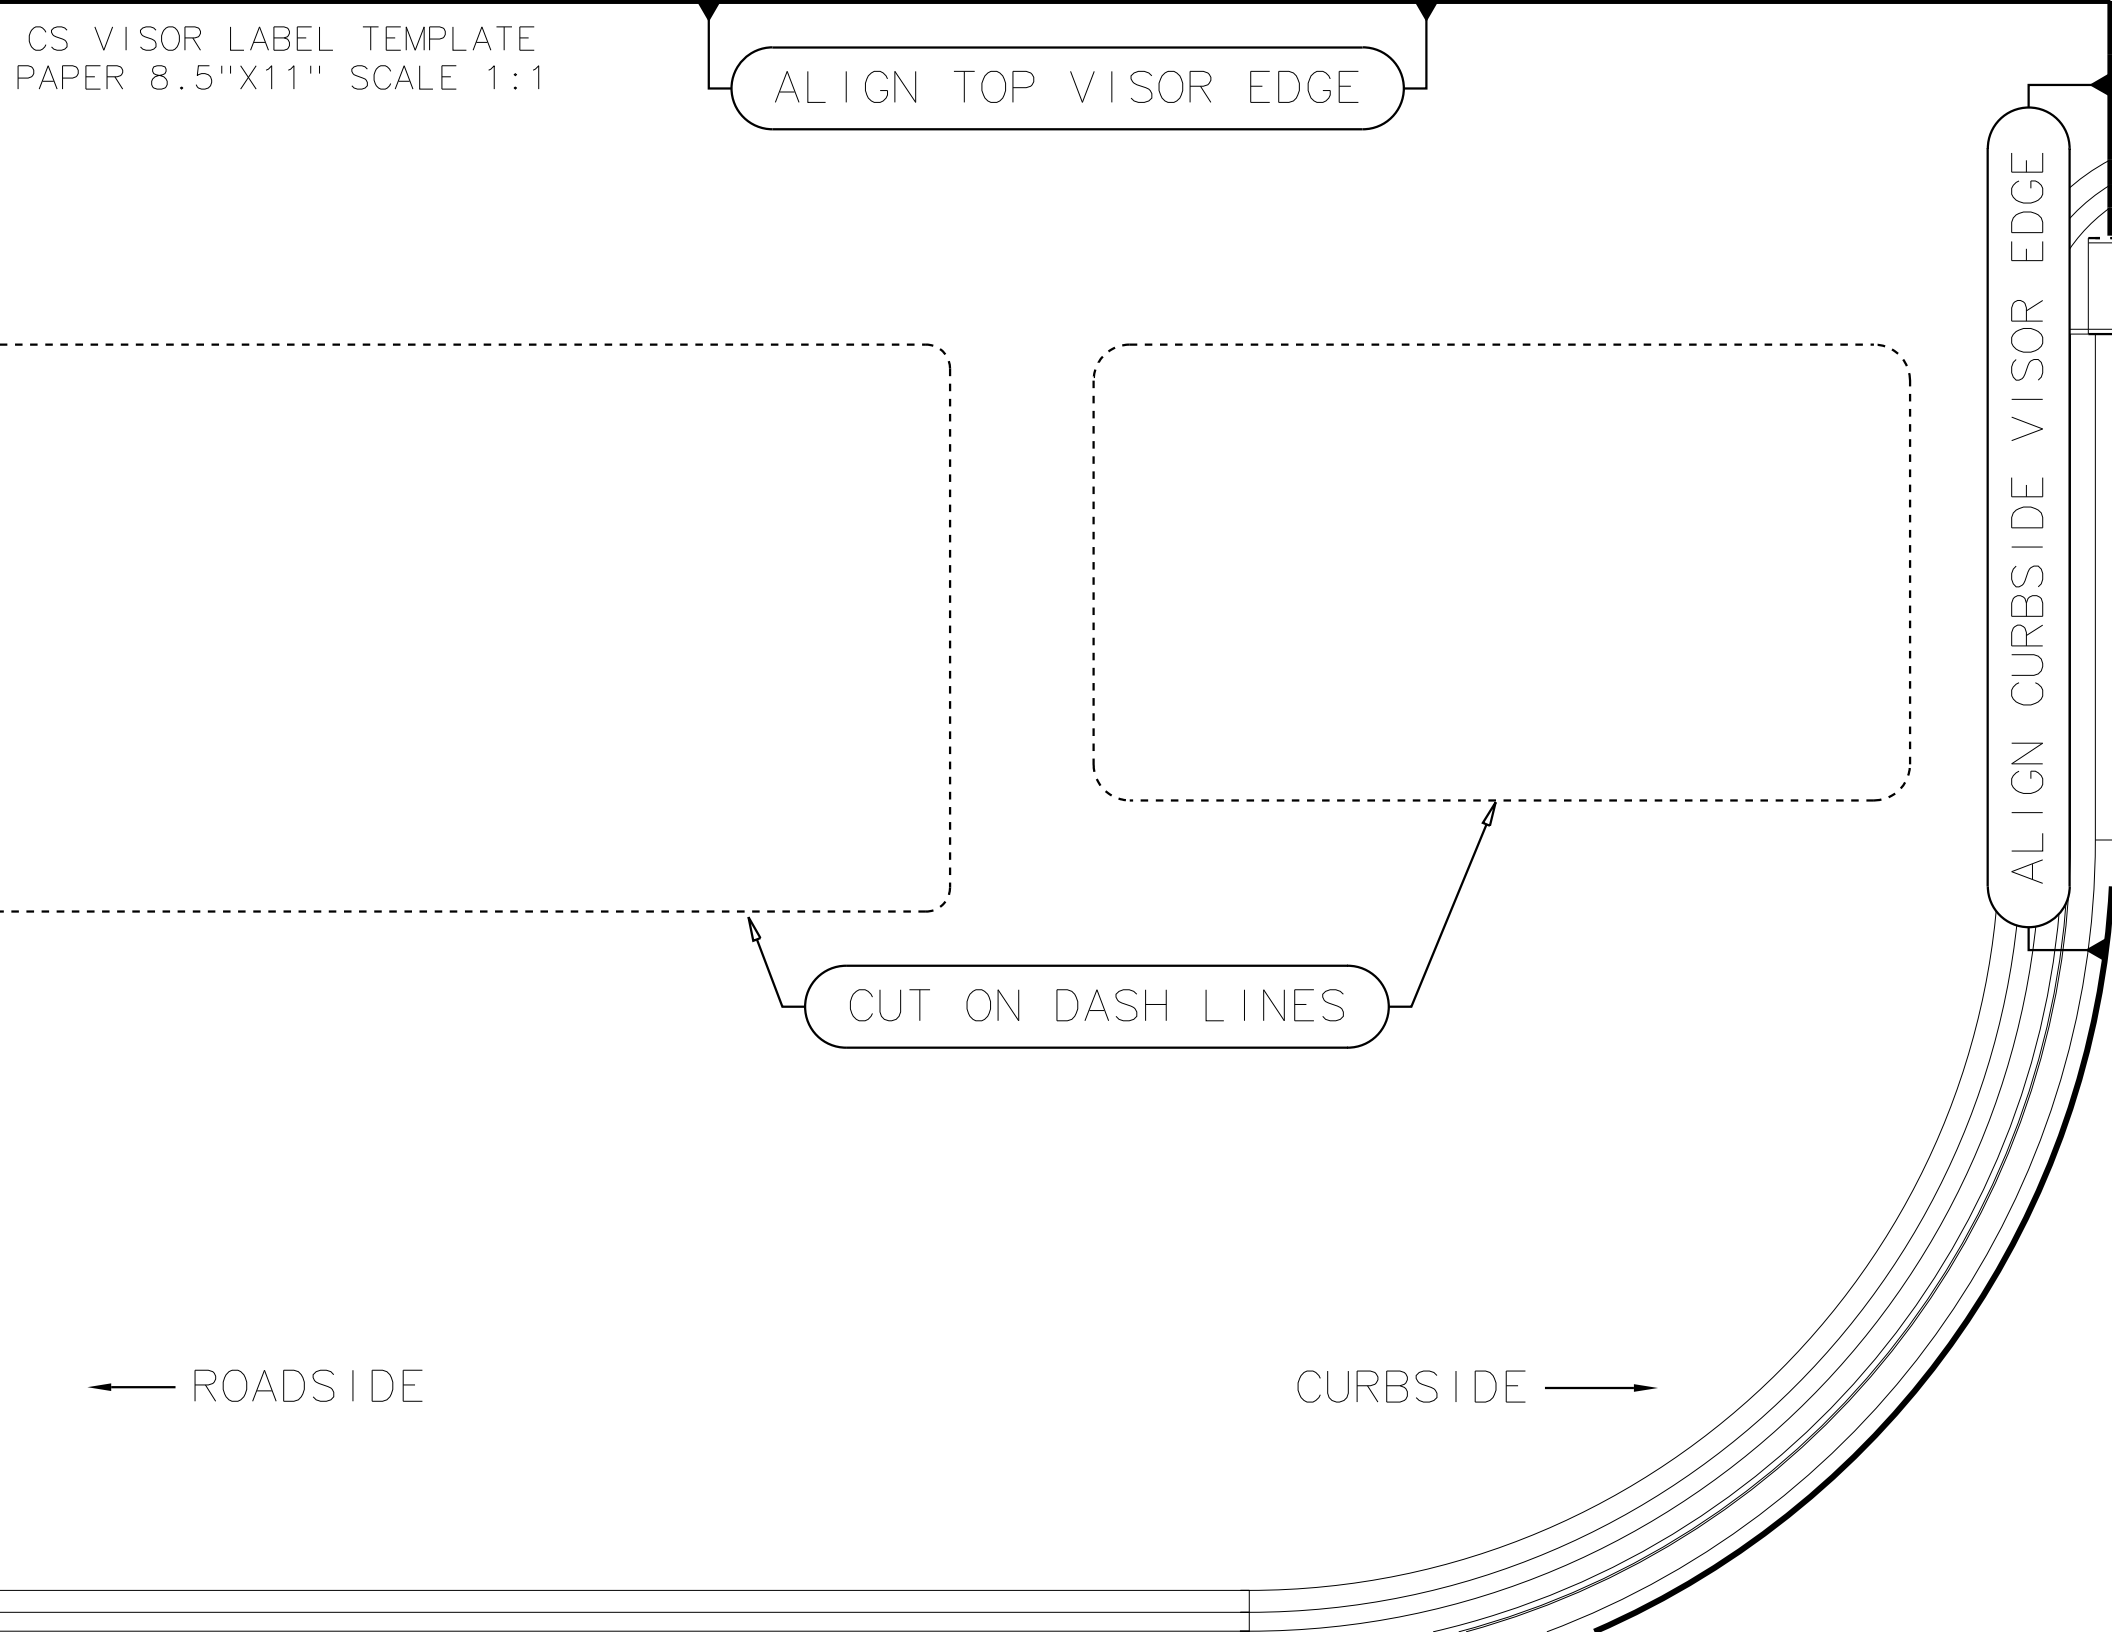
ALIGN TOP VISOR EDGE

ALIGN CURBSIDE VISOR EDGE

CUT ON DASH LINES
