IMPORTANT SAFETY RECALL
Airstream Interstate 19 & Interstate 24 Motorhome
NHTSA Recall 25V-450

PSM PIN CORRECTION PROCEDURE

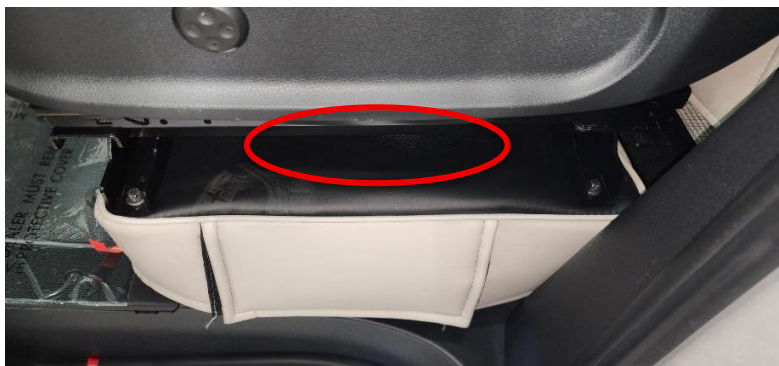
1. Locate the seat harness under the driver's seat by standing in the door area and looking between the seat and seat base; if it's visible and within reach, gently pull it out to begin the procedure.

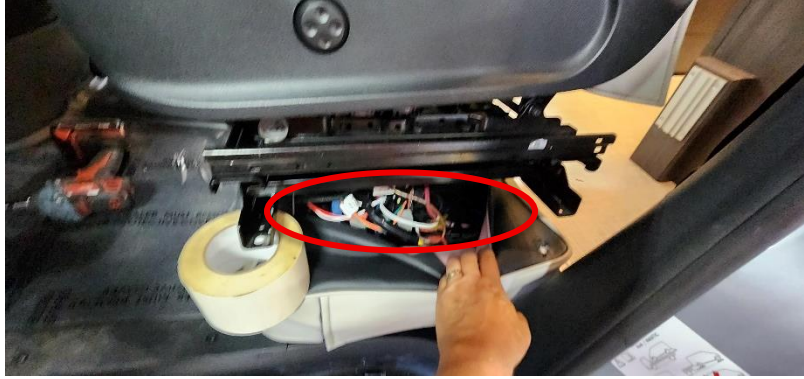
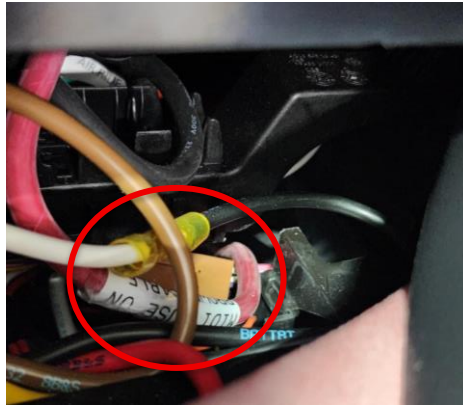
2. If the harness cannot be reached easily, use an impact gun with a T40 torque socket to remove the two outer seat bolts and loosen the two inner bolts by approximately $\frac{1}{2}$ inch, allowing the seat to tilt and provide safe access to the harness.

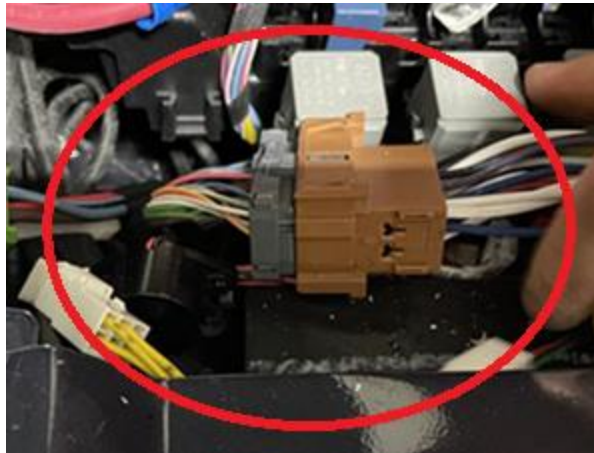
1. To start the correction process, separate the light brown connector from the grey harness.

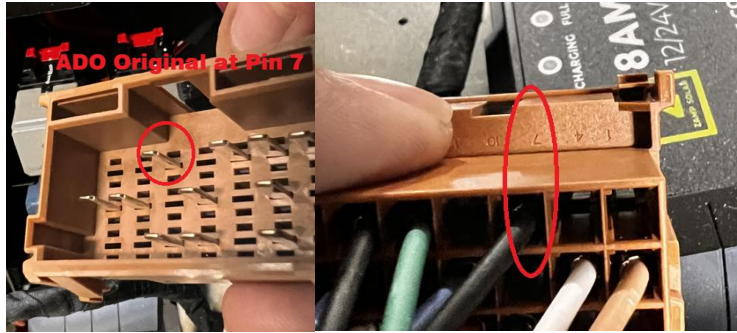
2. Locate Pin 7 on the connector, which is identified by the black wire carrying the ADO signal.

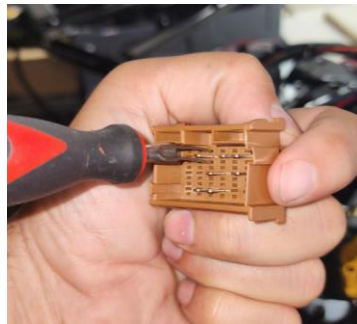
3. Use the pin removal tool to carefully extract the black wire from Pin 7 on the connector.

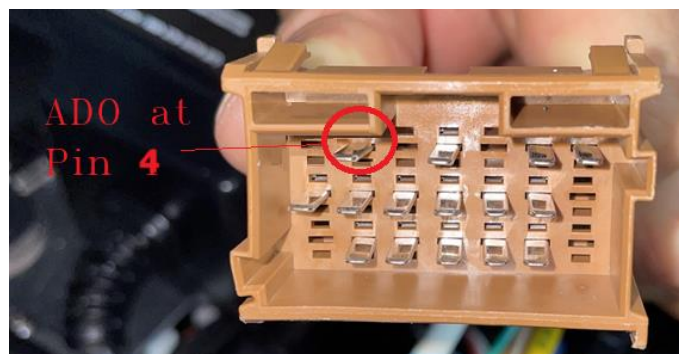
4. Relocate the black wire from Pin 7 to Pin 4 on the connector.

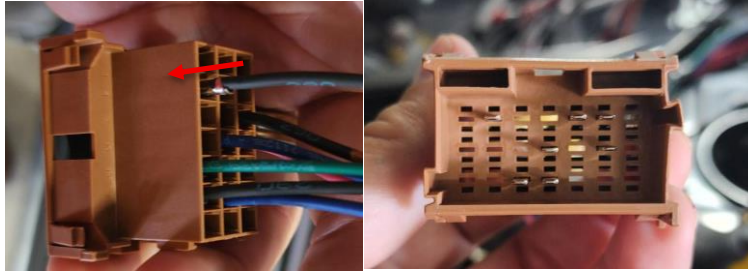
5. Verify that the ADO wire (black) is now securely seated in Pin 4 of the connector.
