## INSTRUCTION TO SERVICE

| ITS61407 | | DATE:07/23/2025 |
| SUBJECT: | Rework emergency exit window decals – J45 EN 56P | |
| ISSUE: | Emergency exits labelling are noncompliant to the requirements of FMVSS Standard No. 217; Bus emergency exits and window retention and release. | |

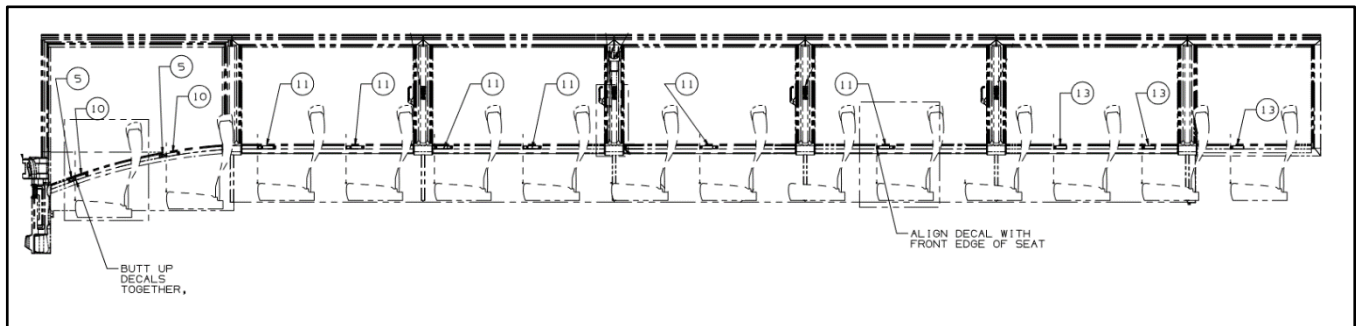
**Figure 1: RH Curbside Interior of the Coach**

3. On the interior of the coach, locate the new horizontal emergency nameplates. Install ref (PN: 1133853).
4. It is important to follow nameplates positioning as shown on Figure 1 and 2 for coach to be safety compliant.

**Note: If the decals exist in the below locations, confirm whether the PNs match. If decals don't match, remove by drilling the rivet and install new decals as per below.**

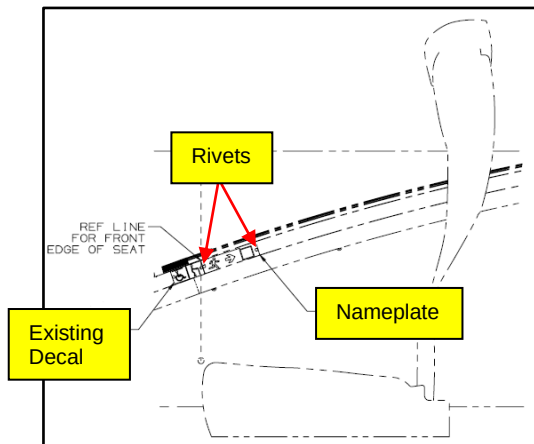
Figure 3: Nameplate and Existing Decal

5. As shown on Figure 3, butt up nameplate together with existing decal (NF PN: 03-15-7278 ref). If coach has existing decal (NF PN: 03-15-7278) at last few passenger rows, butt up name plate together (See Figure 5).
6. Position nameplates, items 10 to 13, as close as possible to the front edge of the seat cushion (See Figure 4).
7. As required, match-drill a 0.12" dia x 0.37" deep hole using the nameplate being mounted as a template. Repair/patch up existing unused holes as necessary.
8. Use rivets (NF PN: 19-13-24) to mount new nameplates at the specified locations.
