**PREVOST**

# SAFETY RECALL

**SR25-23A**

DATE :	September 2025	SECTION :	18 BODY
SUBJECT:	<b>INSPECTION AMAYA SEATS</b>

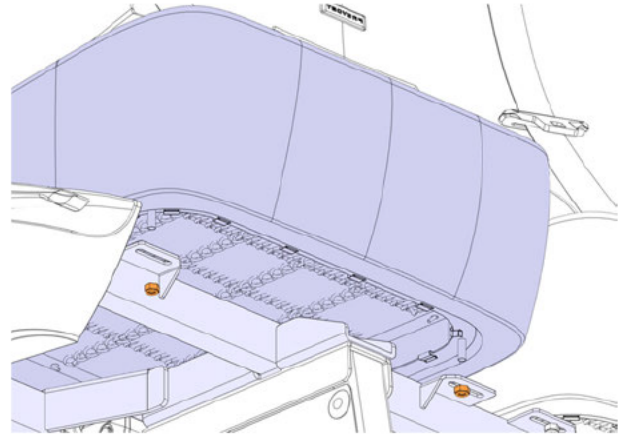
1. Remove the nuts (2x) and remove the aisle side seat cushion.

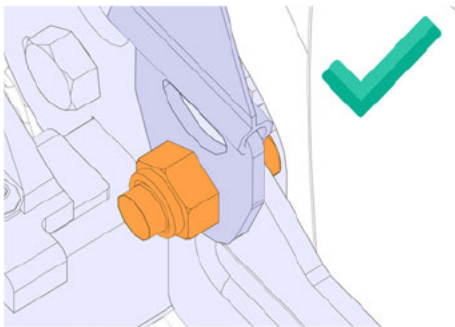
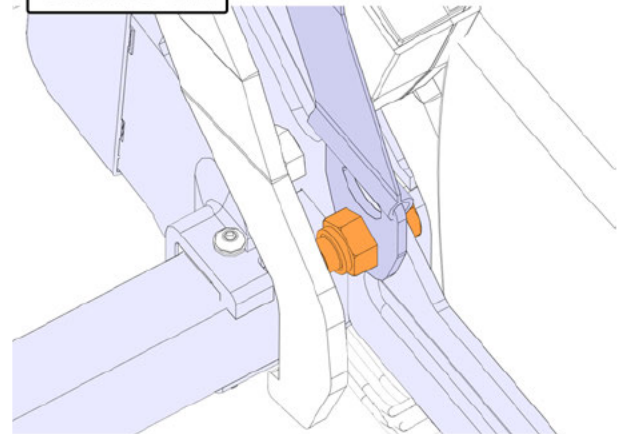
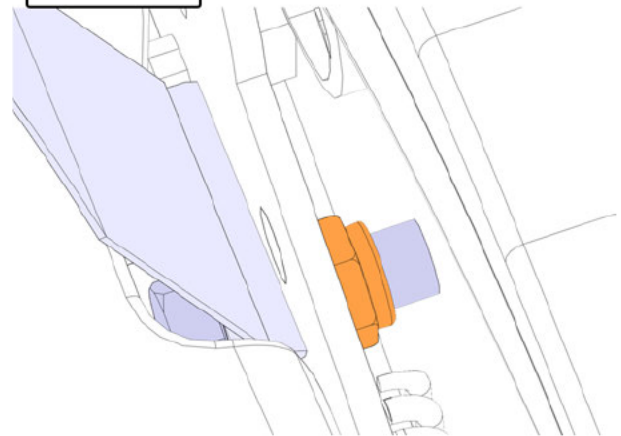
2. Verify that belt nuts (2x) are firmly seated and that at least 2 threads are protruding.

**Note:** for the window-side belt, you must push the plastic cover to inspect.

- If OK, go to the next step.
- If not, go to the **retighten nuts** section.

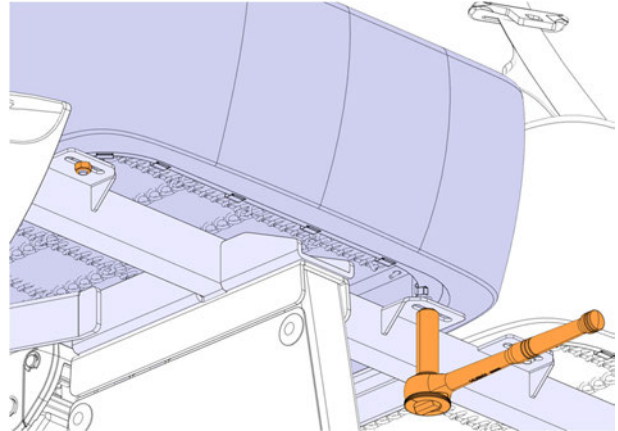
6. Reinstall the cushion on the aisle side, ensuring that the nuts (2x) are firmly in place and that at least two threads protrude.

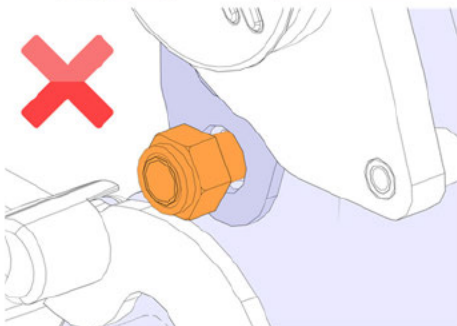
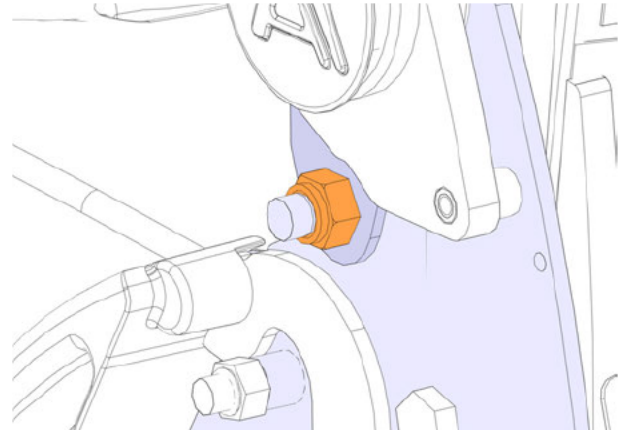
2. Pull the top of the cover to inspect
3. Verify that the belt nut is firmly seated and that at least 2 threads are protruding.

- If OK, go to the next step.
- If not, go to the **retighten nuts** section.

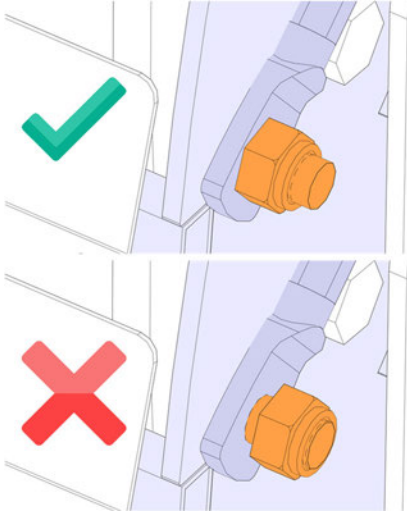
6. Pull the top of the cover to inspect
7. Verify that the buckle nut is firmly seated and that at least 2 threads are protruding.

- If OK, go to the next step.
- If not, go to the **retighten nuts** section.

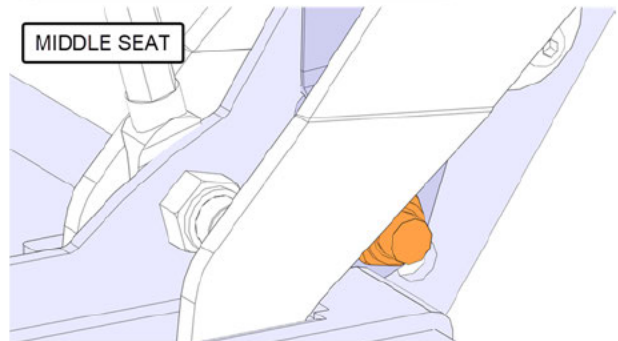
2. Verify that belt nuts (3x) are firmly seated and that at least 2 threads are protruding.

**Note:** for the window-side belt, you must push the plastic cover to inspect.

- If OK, go to the next step.
- If not, go to the **retighten nuts** section.

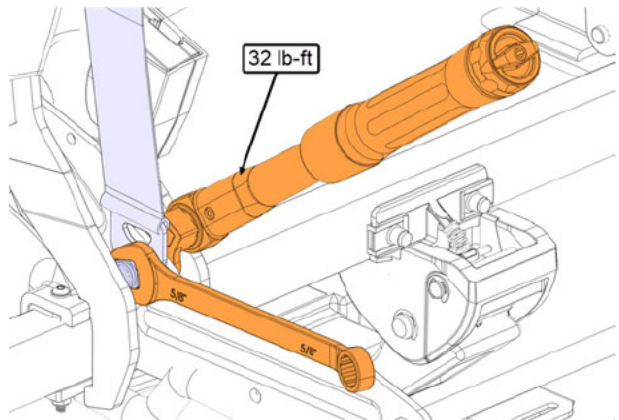
4. Retighten the nut (1x) of the center belt and apply a torque of **32 lb-ft ± 3 lb-ft**.

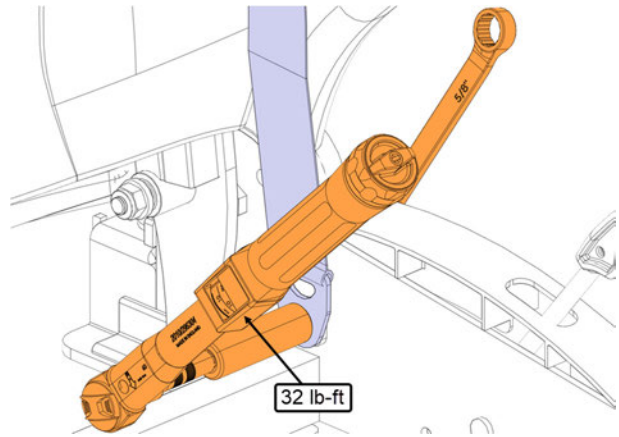
5. Retighten the nut (1x) of the window side belt and apply a torque of **32 lb-ft  $\pm$  3 lb-ft**.

**Note: To access the nut, you must pull the plastic finish.**

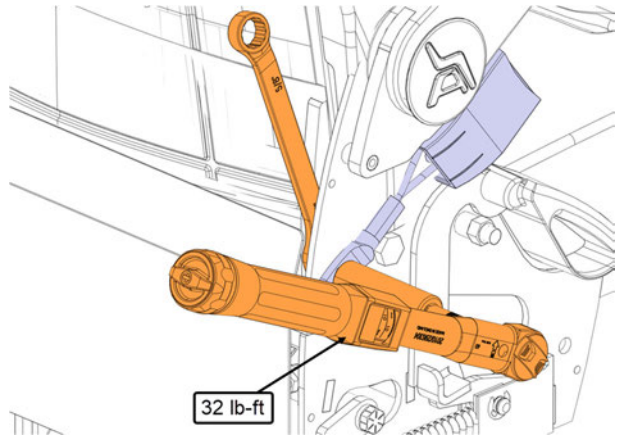
6. Retighten the nut (1x) on the aisle side buckle and apply a torque of **32 lb-ft ± 3 lb-ft**.
