**PREVOST**

**SAFETY  
RECALL**

**SR25-22**

DATE :	October 2025	SECTION :	18 BODY
SUBJECT:	ENTRANCE DOOR LOWER WINDOWS REPLACEMENT

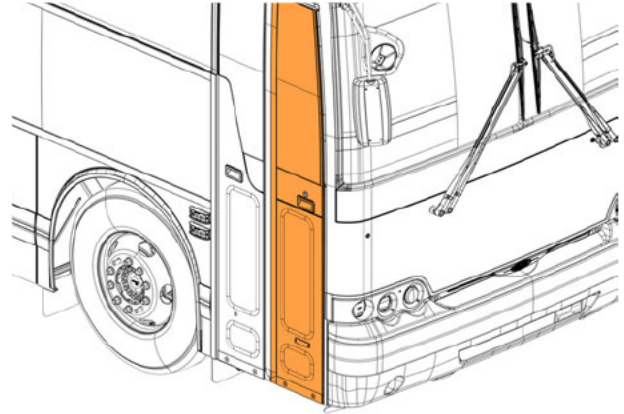
1. Locate the front section of the entrance door.

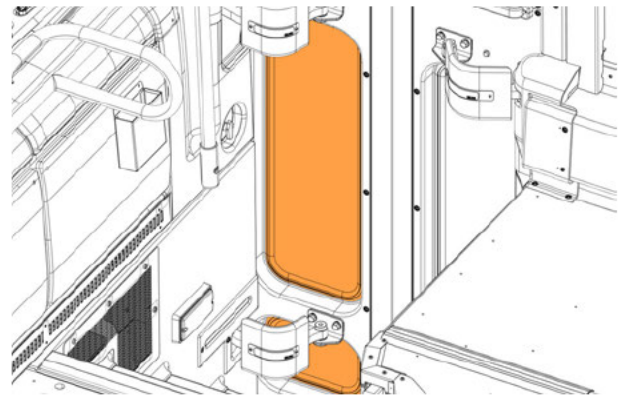
2. Locate the central and lower windows to replace.

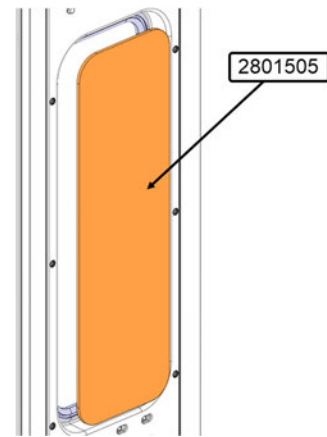
5. Install the new central window 2801505.

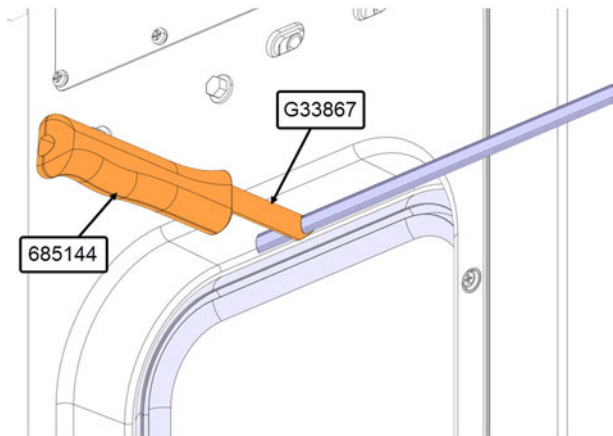
6. Reinstall the locking strip with lubricant for rubber 680879, starting at the top center.

**Note: To facilitate installation, use the special tool G33867 with the handle 685144.**

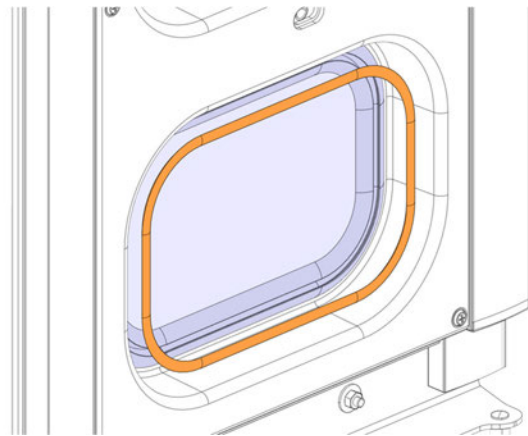
7. Remove the locking strip of the lower window. Keep the locking strip to reuse it.

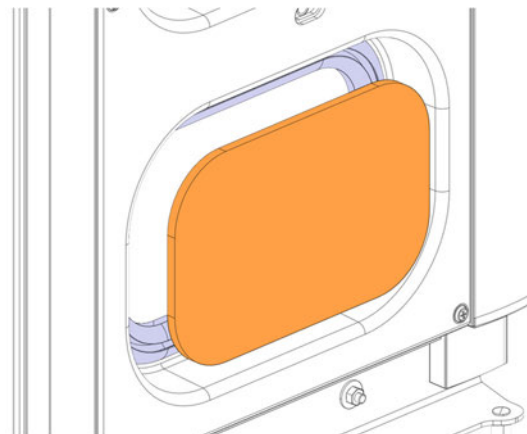
8. Remove the lower window and discard.

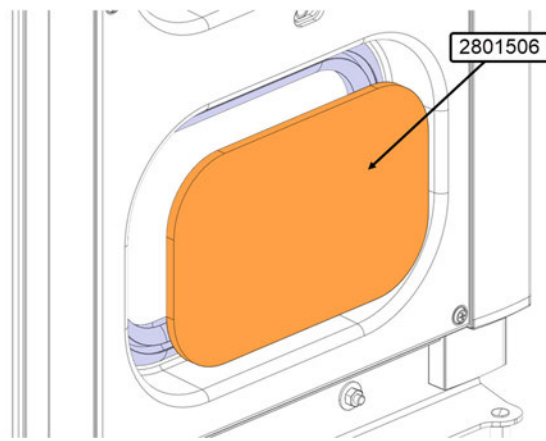
9. Install the new lower window 2801506.

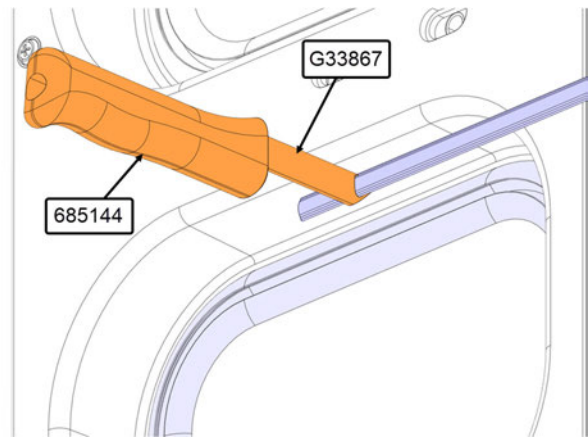
10. Reinstall the locking strip with lubricant for rubber 680879, starting at the top center.

**Note: To facilitate installation, use the special tool G33867 with the handle 685144.**

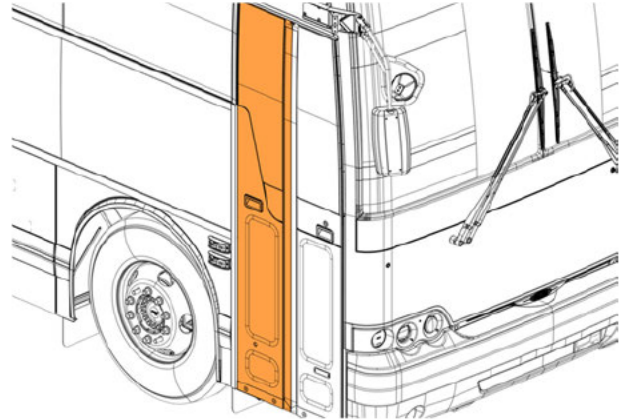
1. Locate the rear section of the entrance door.

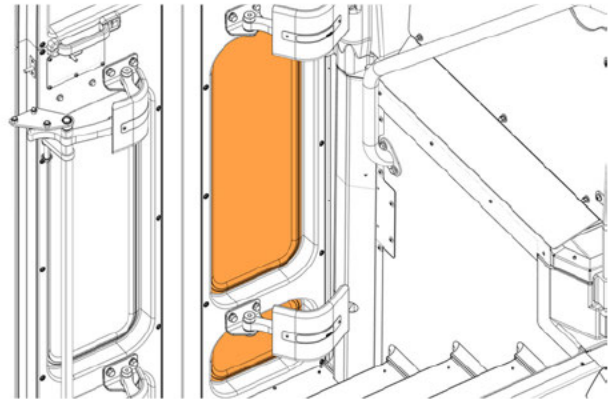
2. Locate the central and lower windows to replace.

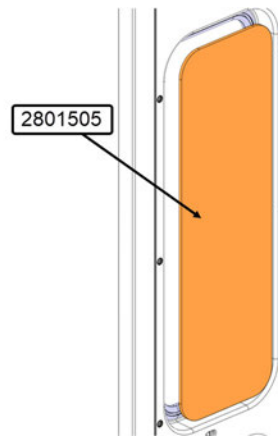
5. Install the new central window 2801505.

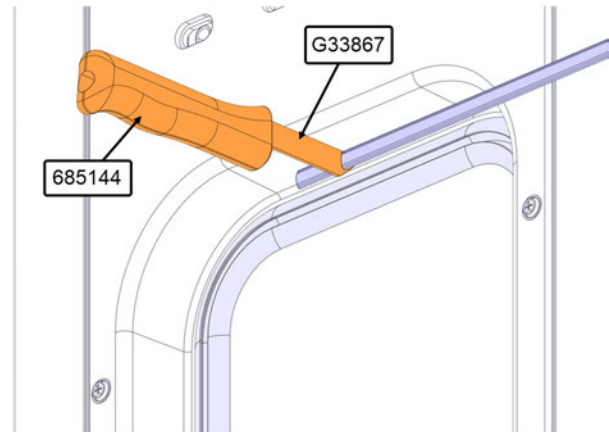
6. Reinstall the locking strip with lubricant for rubber 680879, starting at the top center.

**Note: To facilitate installation, use the special tool G33867 with the handle 685144.**

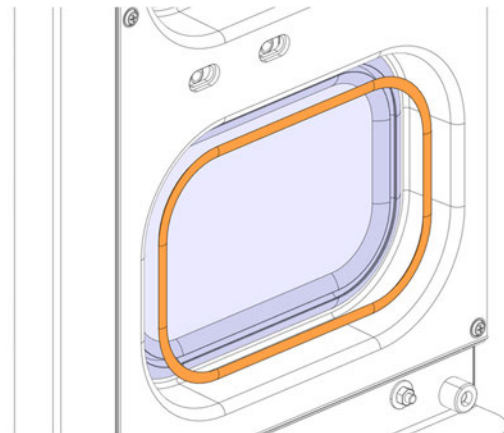
7. Remove the locking strip of the lower window. Keep the locking strip to reuse it.

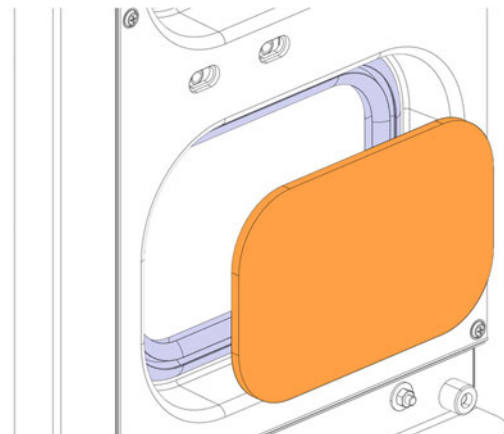
8. Remove the lower window and discard.

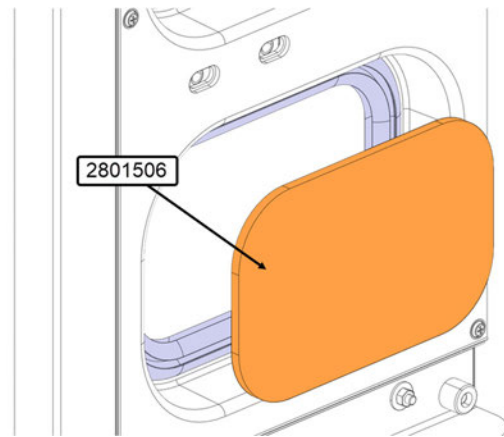
9. Install the new lower window 2801506.

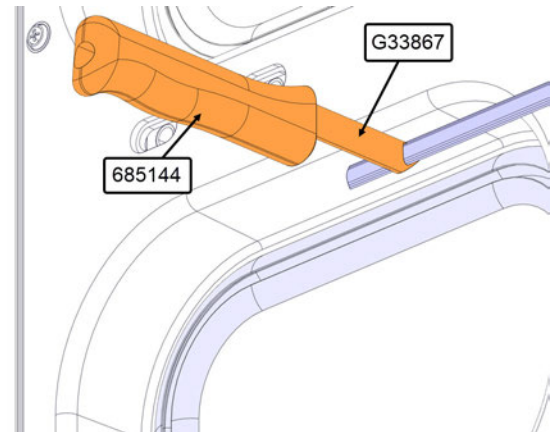
10. Reinstall the locking strip with lubricant for rubber 680879, starting at the top center.

**Note: To facilitate installation, use the special tool G33867 with the handle 685144.**
