# SAFETY RECALL

## 2nd Row Headrest

Reference: 20C / NHTSA 25V-472

2023-2024 (WL) Jeep Grand Cherokee/Grand Cherokee L

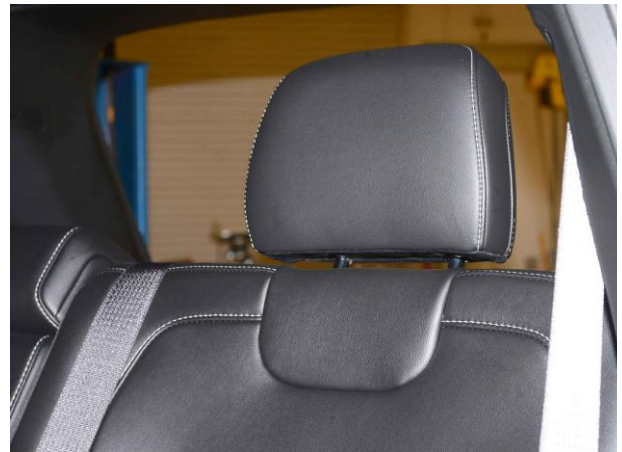
**Figure 1 – Headrest In Locked Position**

1. Move the front seats forward.
2. Make sure that the headrest is in the locked position (Figure 1).

4. Return the second row seat to the fully upright position (Figure 3).
5. Return the headrest to the locked position (Figure 1).

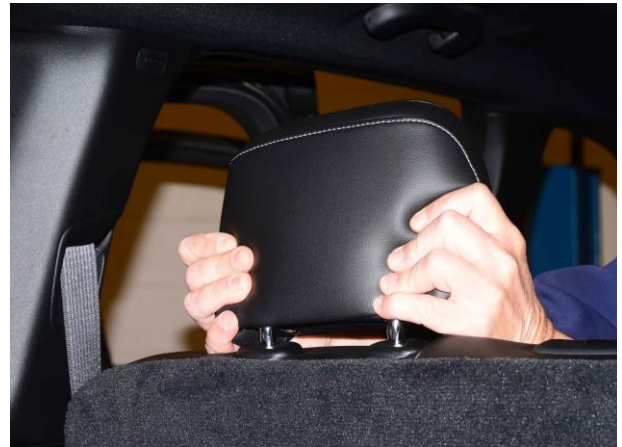
**Figure 4 – Testing Headrest – Side to Side Motion**

6. Kneeling in the seat, facing the headrest, with moderate effort, rock the headrest from side to side using both hands (Figure 4).

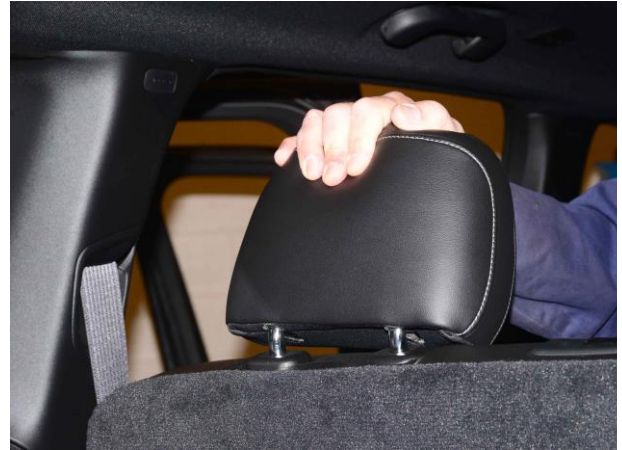
**Figure 5 – Testing Headrest – Fore / Aft Motion**

7. Pull the headrest toward you with moderate effort (Figure 5).

8. Did the headrest release from the locked position?

- **Yes:** replace the headrest. Proceed to **B. Headrest Replacement.**
- **No:** Repeat Steps 2-7 nine more times. If the headrest remains locked each time, it has passed inspection.

**NOTE:** If the headrest fails to remain locked in the upright position during any of the ten tests, it must be replaced.

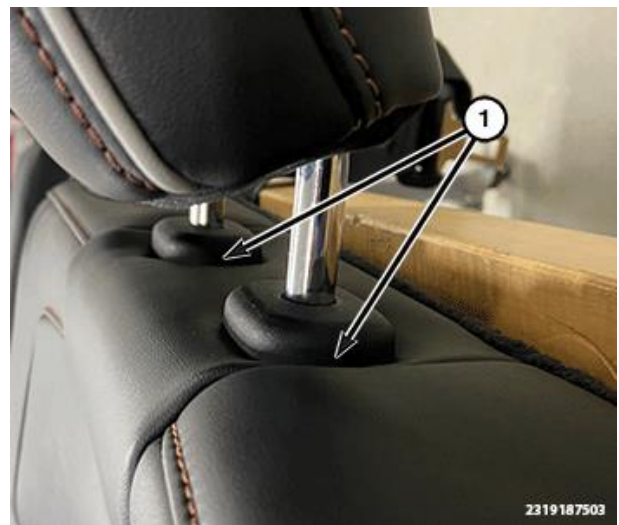
**Figure 6 – Early Design Outer Headrest Retainers**

4. For early model vehicles, use a small allen wrench to depress the headrest retainers (1) and lift the headrest and cable out of the seat back (Figure 6).

- Transfer the old headrest retainer to the new headrest.
- Test cycle the seat for proper head rest function before installing the cover.

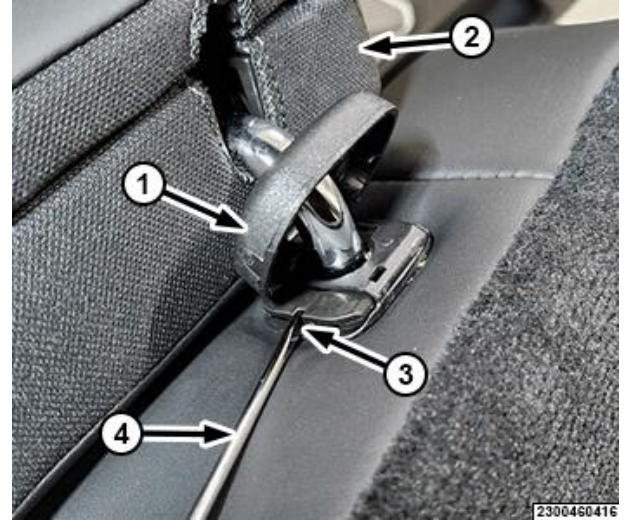
**Figure 7 – Late Design Outer Headrest Retainers**

5. For late model vehicles, use a trim stick or equivalent to release the headrest retainer cap (1) (Figure 7).
6. Using a small flat headed screwdriver (4), push in on the headrest retainer slot (3) to release the headrest. Repeat for the opposite side and lift to remove the headrest and cable from the seat back (2) (Figure 7).
