ASA7 - Check Screw Connection of Airbag in Front Seats and Rework if Necessary (Stop Delivery/ Recall Campaign)

Model Line: **Macan Electric (XAB)**

Concerns: **Front side airbag**

Cause: **On the affected vehicles, it is possible that during the production process the airbags in front seats have not been secured to the seat backrest in accordance with the specifications.**

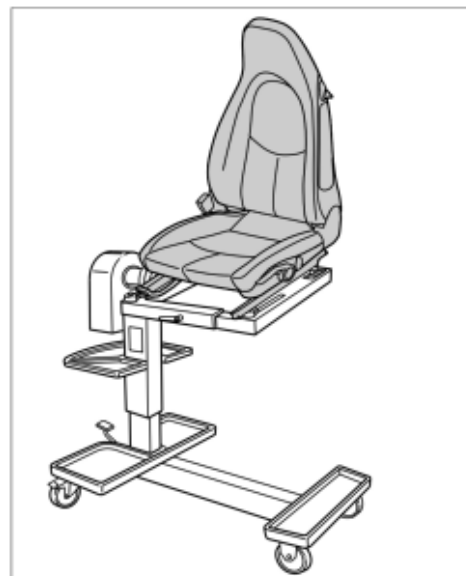
Front seat on assembly device

2 Install front seat to seat assembly device **VAS 6136 - holder for seat repair** ⇒ *Front seat on assembly device* and put it into position to work on the seat backrest.
 If there is no seat assembly device, carefully place the front seat on a suitable work surface to work on the seat backrest.

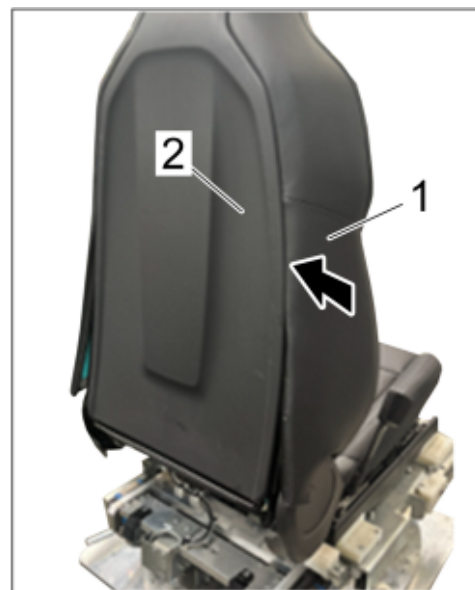
Backrest cover for comfort seat

3.1 Open backrest cover ⇒ *Backrest cover for comfort seat -1-* on the corresponding side up to half of the backrest cover ⇒ *Backrest cover for comfort seat -2-*.

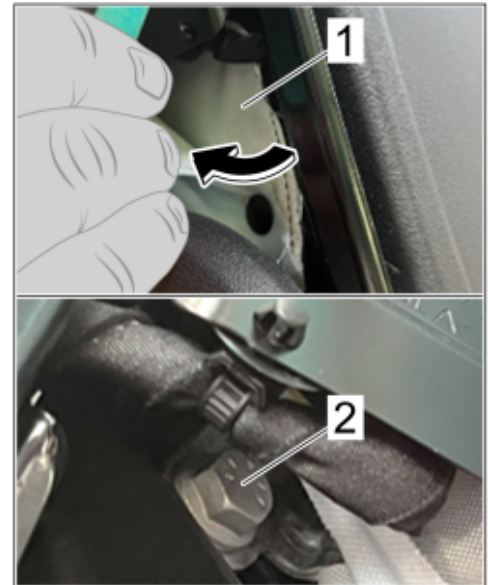
3.2 Carefully slide from behind airbag pocket ⇒
Screw connection behind airbag pocket -1-
in ⇒ Screw connection behind airbag pocket
-Arrow direction- to the side until the screw is
⇒ Screw connection behind airbag pocket -2-
visible.

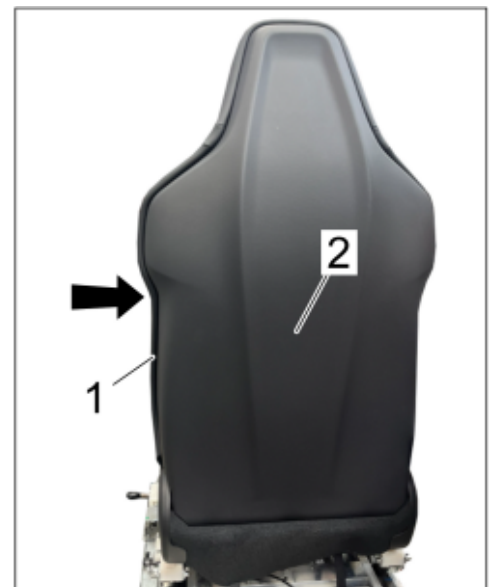
4.1 Open backrest cover ⇒ Backrest cover for
sports seat -1- on the corresponding side up
to the shoulder side wall of the backrest cover
⇒ Backrest cover for sports seat -2-.

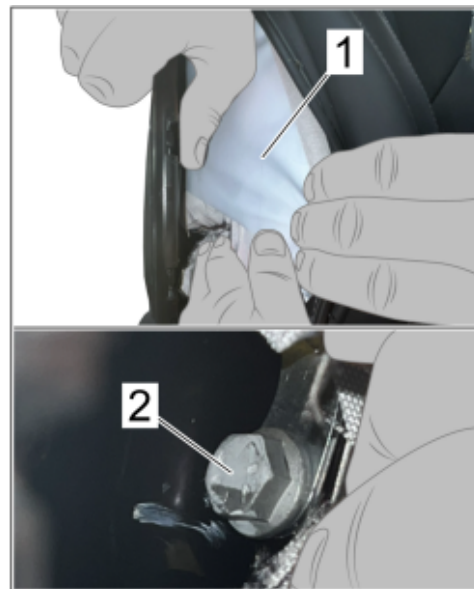
Screw connection behind airbag pocket

- 4.2 Carefully push the backrest cover inwards from the front and slide the airbag pocket ⇒ *Screw connection behind airbag pocket -1-* in the rear area to the side until the screw is ⇒ *Screw connection behind airbag pocket -2-* visible.
- 5 Check screw connection securing airbag to seat backrest.

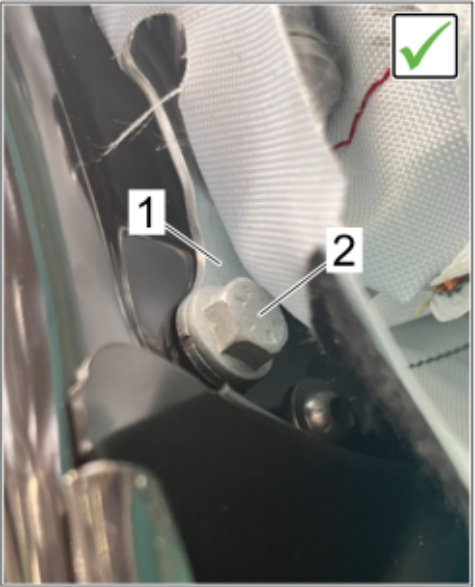
Assessment	Action
<p>(✓) The airbag holder ⇒ <i>Airbag holder on seat backrest -1-</i> is attached to the seat backrest using the screw ⇒ <i>Airbag holder on seat backrest -2-</i>.</p>

<p style="text-align: center;"><i>Airbag holder on seat backrest</i></p>	<p>The screw connection is OK.</p> <p>Close backrest cover and install front seat.</p> <p>⇒ <i>Workshop Manual '720119 Removing and installing front seat'</i></p> <p>Then enter the campaign in the Warranty and Maintenance Logbook.</p> <p>End of action.</p> <p>Invoicing for the corresponding scope, scope 1 - 7.</p>
<p>(x) The airbag holder ⇒ <i>Airbag holder loose -1-</i> is not under the screw ⇒ <i>Airbag holder loose -2-</i> and is loose.</p>

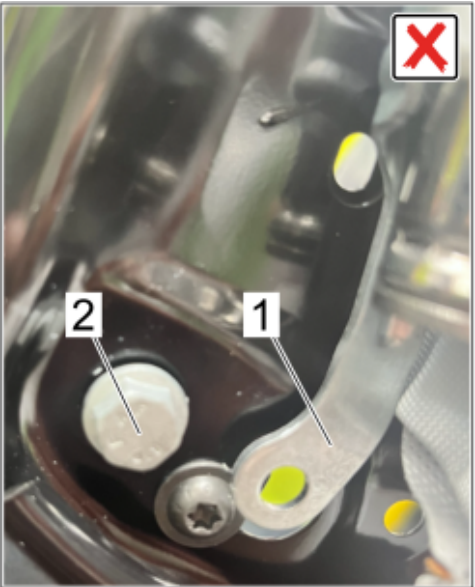
<p style="text-align: center;"><i>Airbag holder loose</i></p>	<p>The screw connection is not OK.</p> <p>Continue with:</p> <p>⇒ <i>Technical Information '720119 Rework screw connection for front side airbag'</i></p> <p>Invoicing for the corresponding scope, scope 8 - 14.</p>

- Work Procedure:
- 1 Remove backrest cover.
⇒ *Workshop Manual '72261900 Removing and installing backrest cover (basic and comfort seat)'*
⇒ *Technical Information '72261905 Removing and installing backrest cover (sports seat)'*
 - 2 Unscrew screw ⇒ *Airbag holder loose -2-*.
 - 3 Install side airbag correctly.

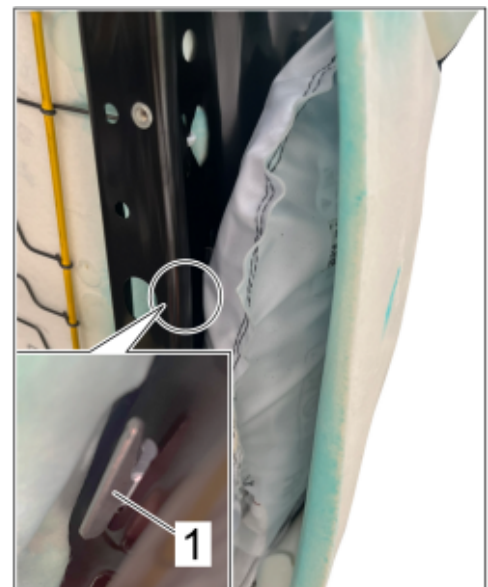
Airbag hook in seat frame

- 3.1 Make sure that the hook ⇒ *Airbag hook in seat frame -1-* is correctly attached to the seat frame.

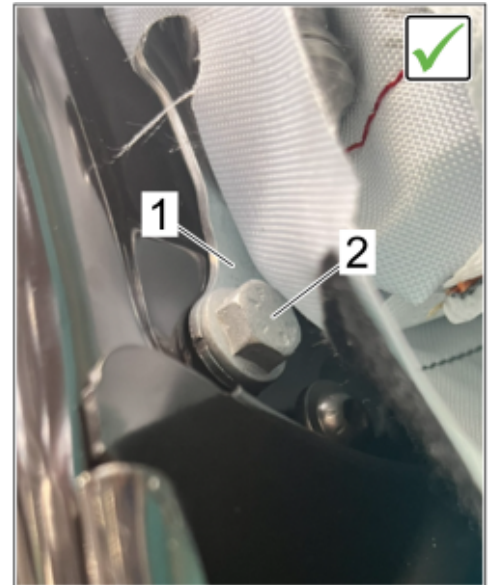
Airbag holder on seat backrest

- 3.2 Screw ⇒ *Airbag holder on seat backrest -2-* in screw and tighten with **Tightening torque 9.7 Nm (7.2 ftlb.)**.
- 4 Install backrest cover.
⇒ *Workshop Manual '72261900 Removing and installing backrest cover (basic and comfort seat)'*
⇒ *Technical Information '72261905 Removing and installing backrest cover (sports seat)'*
- 5 Install the front seat.
⇒ *Workshop Manual '720119 Removing and installing front seat'*
- 6 Enter the campaign in the Warranty and Maintenance Logbook.
