GROUP	MODEL
Safety Recall Campaign	2023-2025MY K5 (DL3, DL3a)
NUMBER	DATE
SC346 (Rev 1, 12/23/2025)	November 2025

SUBJECT: **C-PILLAR GARNISH MOLDING REPLACEMENT (SC346)**

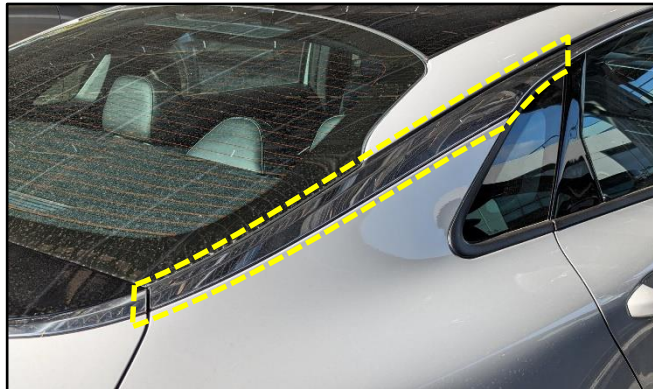
This bulletin provides information to replace the C-Pillar molding(s) on certain 2023-2025MY K5 (DL3, DL3a) vehicles produced from October 3, 2022 through July 24, 2024. Due to a supplier quality issue, the C-pillar garnish face plate(s) on the subject vehicles may progressively delaminate and become loose from the base of the molding. If the vehicle continues to be driven in this condition, the face plate may eventually fall off. A face plate that detaches from the vehicle while in motion may create a road hazard for other road users, increasing the risk of a crash. Follow the procedure outlined in this publication to replace the applicable C-Pillar (Left and/or Right side) molding(s) for the applicable vehicle. Before conducting the procedure, verify that the vehicle is included in the list of affected VINs.

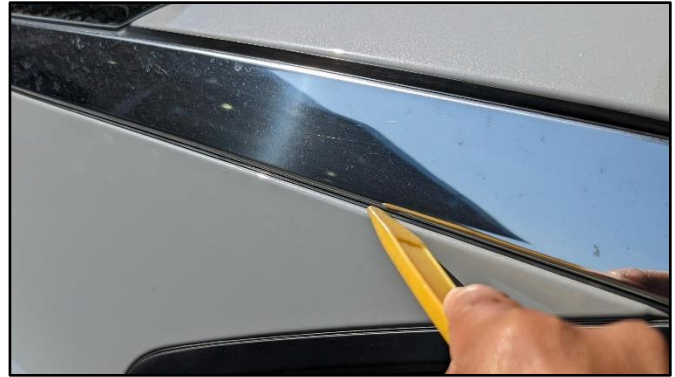
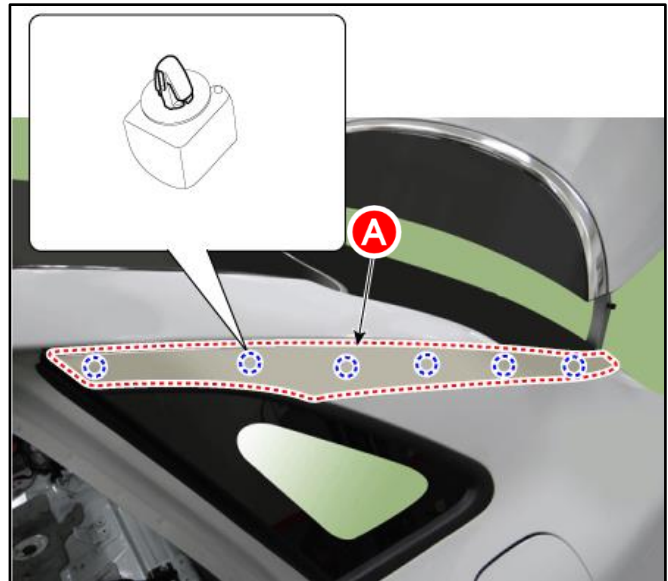
- Using a non-marring plastic trim tool, carefully pry with 'light' upward pressure in between the rear C-Pillar chrome garnish rubber and the body to detach the C-Pillar Garnish Molding (refer to the table above for the applicable VIN for the vehicle you are working on).
- Replace the affected (Left and/or Right side) rear C-Pillar garnish (B) by referring to "Body (Interior and Exterior) → Quarter Fixed Glass → Repair Procedures (C-Pillar Garnish, step 2)" in the applicable Shop Manual in KGIS.

Note: The new C-Pillar garnish includes new clips.

Use extreme caution when removing the door belt outside weatherstrip(s). The faceplate can become sharp when detached and can cause serious injury.
