GROUP	MODEL
Safety Recall Campaign	2023-2025MY K5 (DL3, DL3a)
NUMBER	DATE
SC346	November 2025

SAFETY RECALL CAMPAIGN

SUBJECT: **C-PILLAR GARNISH MOLDING REPLACEMENT (SC346)**

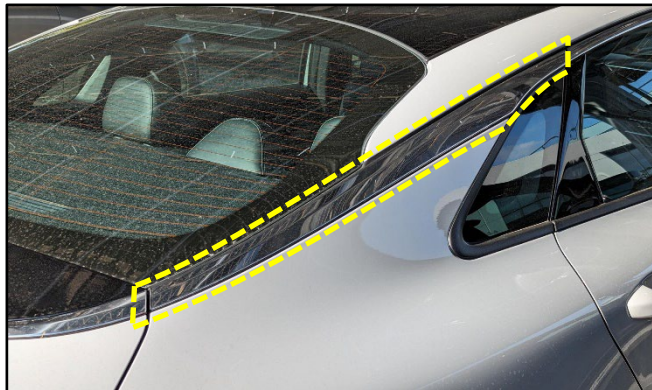
This bulletin provides information to replace the C-Pillar molding(s) on certain 2023-2025MY K5 (DL3, DL3a) vehicles produced from October 3, 2022 through July 24, 2024. Due to a supplier quality issue, the C-pillar garnish face plate(s) on the subject vehicles may progressively delaminate and become loose from the base of the molding. If the vehicle continues to be driven in this condition, the face plate may eventually fall off. A face plate that detaches from the vehicle while in motion may create a road hazard for other road users, increasing the risk of a crash. Follow the procedure outlined in this publication to replace the applicable C-Pillar (Left and/or Right side) molding(s) for the applicable vehicle. Before conducting the procedure, verify that the vehicle is included in the list of affected VINs.

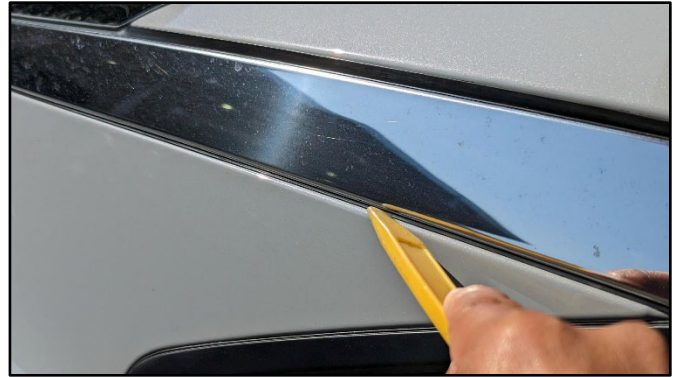
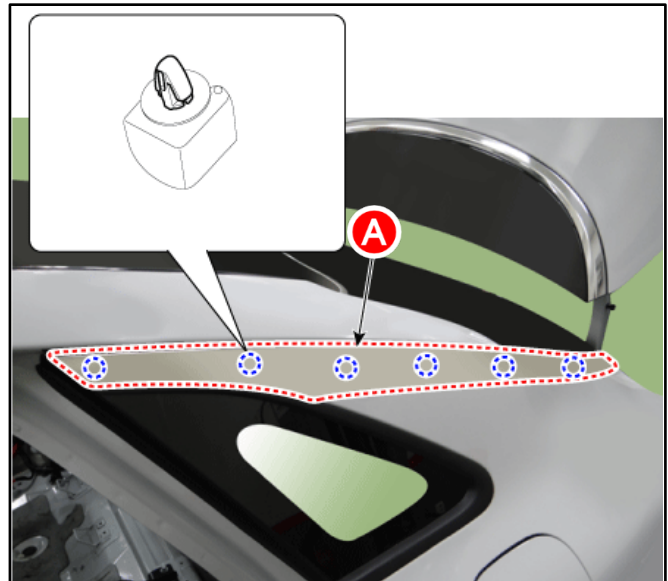
Use extreme caution when removing the door belt outside weatherstrip(s). The faceplate can become sharp when detached and can cause serious injury.

- Using a non-marring plastic trim tool, carefully pry with 'light' upward pressure in between the rear C-Pillar chrome garnish rubber and the body to detach the C-Pillar Garnish Molding (refer to the table above for the applicable VIN for the vehicle you are workin on).
- Replace the affected (Left and/or Right side) rear C-Pillar garnish (B) by referring to "Body (Interior and Exterior) → Quarter Fixed Glass → Repair Procedures (C-Pillar Garnish, step 2)" in the applicable Shop Manual in KGIS.

Note: The new C-Pillar garnish includes new clips.
