# WORK INSTRUCTIONS

## MODEL Z UNDER FLOOR WIRING

### INSPECTION AND SECUREMENT

<b>RECALL:</b>	900009 Model Z Under Floor Wiring		
<b>PRODUCT:</b>	Model Z3100 5th Wheel	<b>REVISION:</b>	REV-A
<b>DATE:</b>	August 4, 2025	<b>LABOR RATE:</b>	4.0 Inspection only / 5.0 Inspect and repair

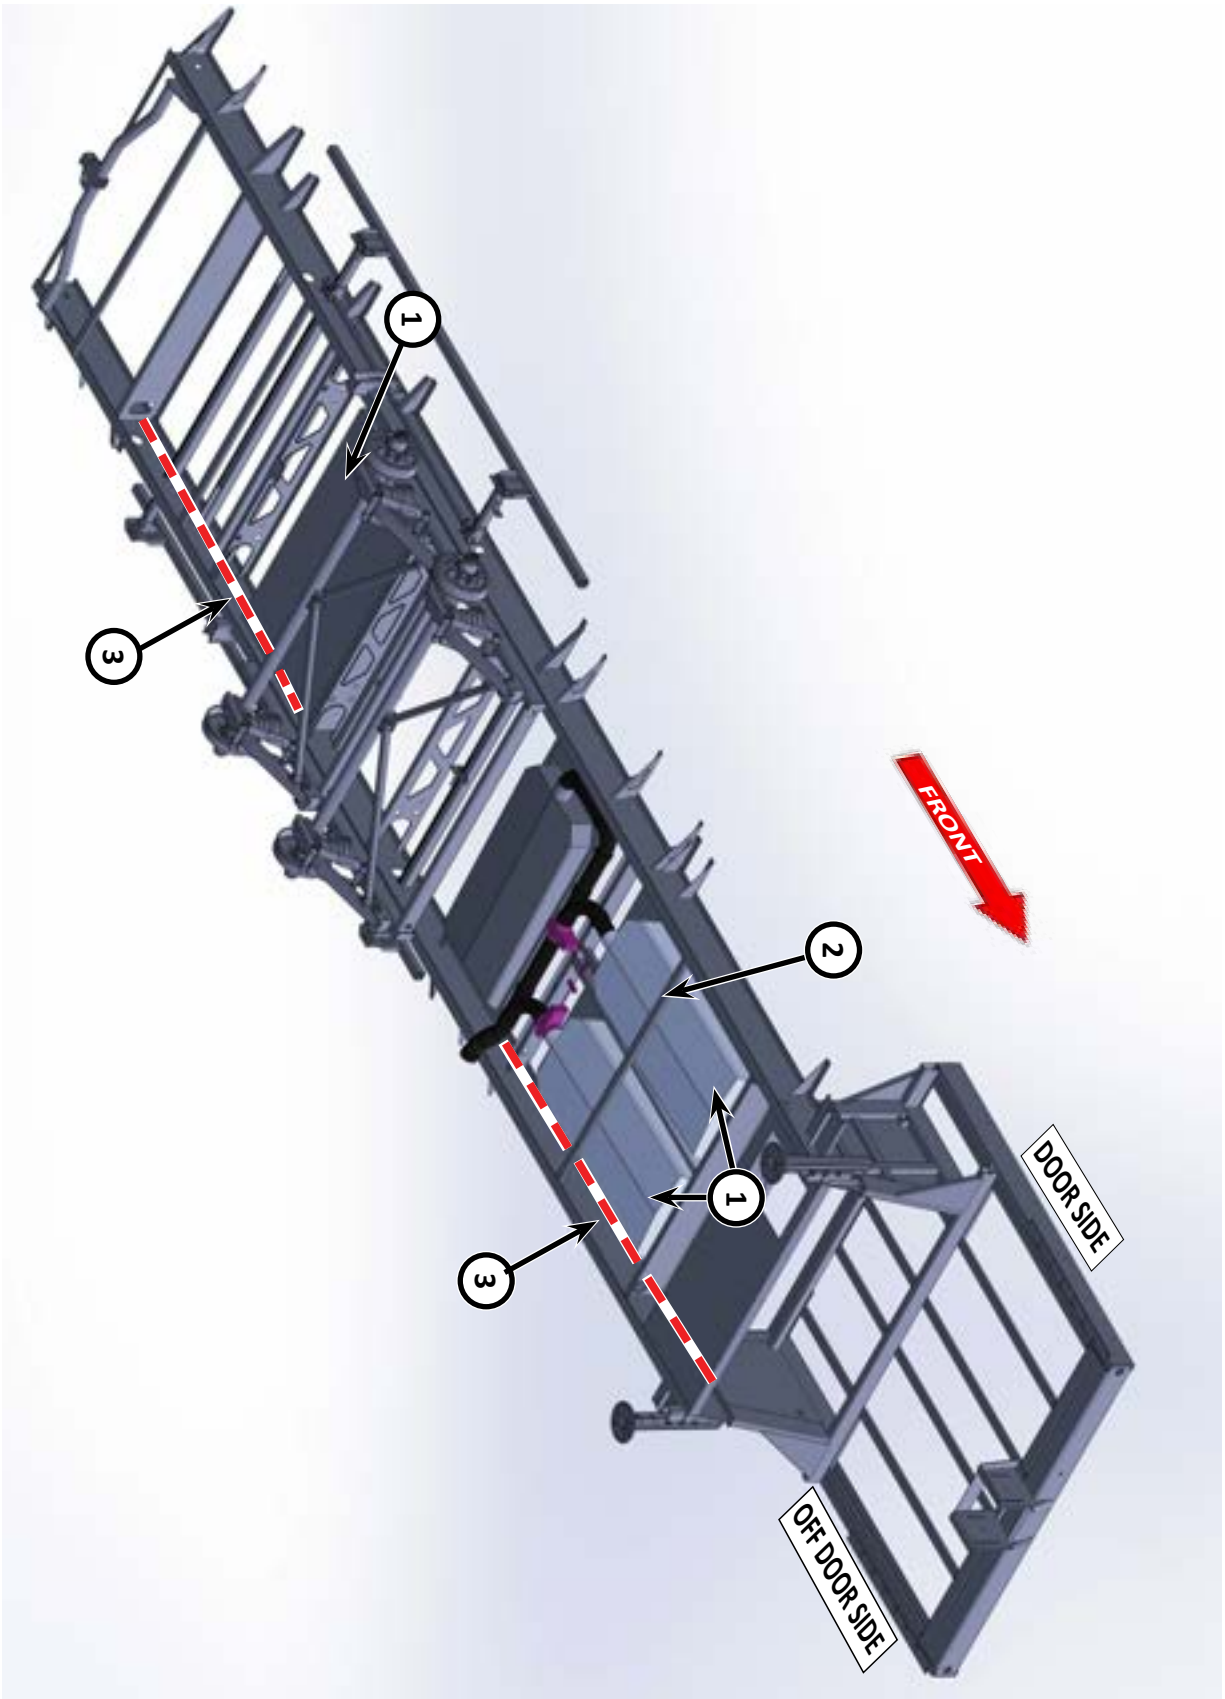
# WIRING LOCATION

1 Holding Tanks

2 Tank Support Bracket

3 Subject Wiring

VIEW FROM BELOW  
(UNDERBELLY REMOVED)

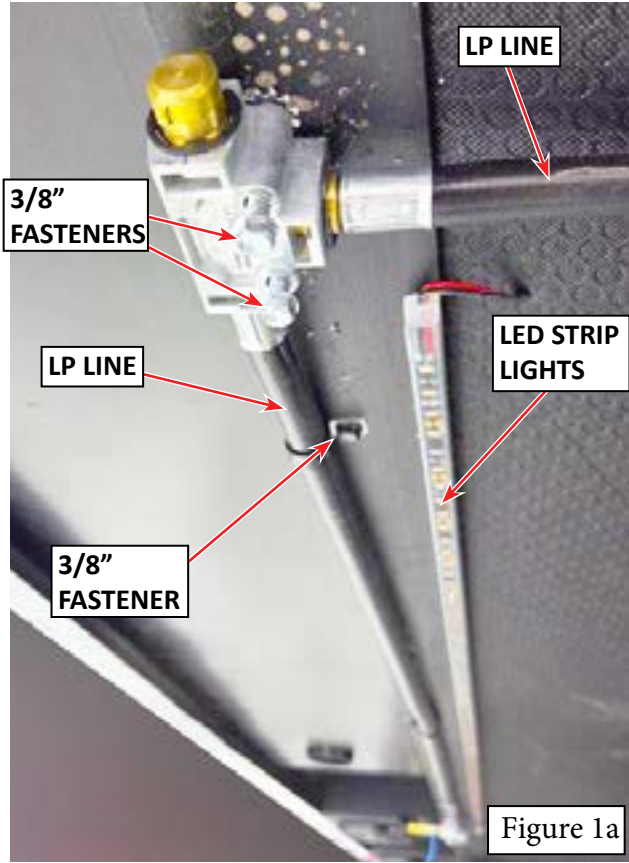
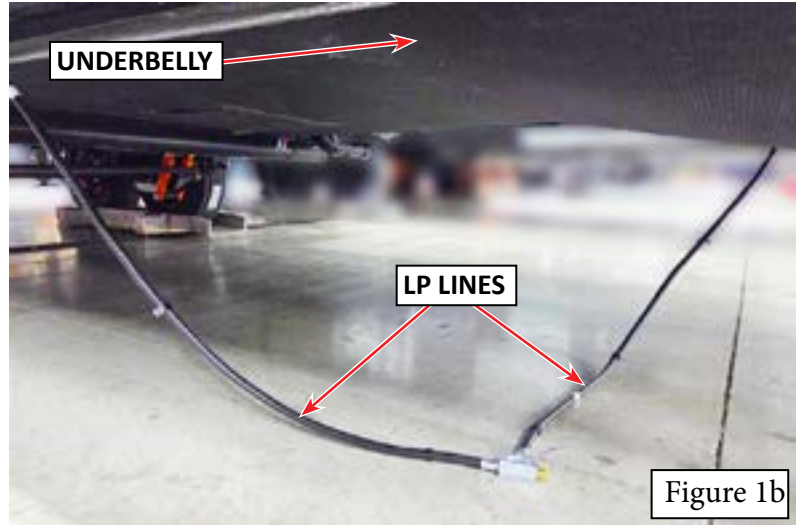
1. READ AND UNDERSTAND ALL INSTRUCTIONS PRIOR TO BEGINNING WORK.
2. Working with the underbelly FORWARD of the axles, use a screw gun (or ratchet socket driver) with a 3/8" socket to remove the fasteners holding the LP gas line beneath the unit (Figure 1a). Lower the LP gas line from the bottom of the RV (Figure 1b).

18. Use the original 3/8" fasteners to secure the LP lines to the frame rail (Page 5, Figures 1a and 1b).
19. Reinstall underbelly support brackets (Page 8, Figures 8a and 8b). Tighten to snug (as directed above) until the washers are flattened.

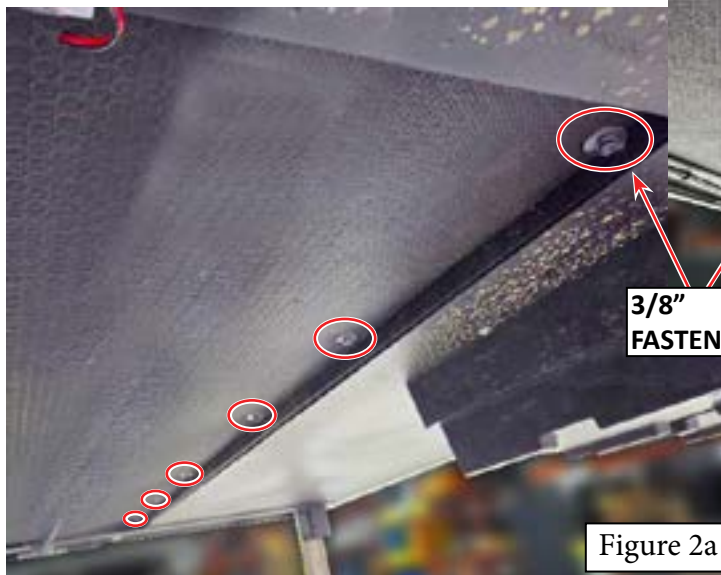
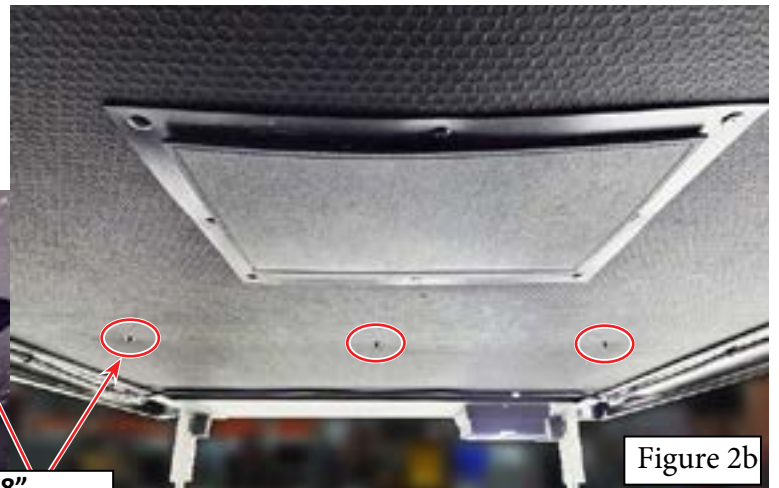
3. Remove the 3/8" fasteners holding the underbelly in place (Figure 2a and 2b).

17. Use an impact screw gun and a 3/8" socket to install the original 3/8" fasteners (refer to Page 5, Figures 2a and 2b) to secure the underbelly in place. **NOTE: These 3/8" self-tapping fasteners should be tightened to snug until the washers are flattened; not left loose, or overtightened to avoid stripping or damage to the underbelly material. There is NO torque spec for these fasteners.**

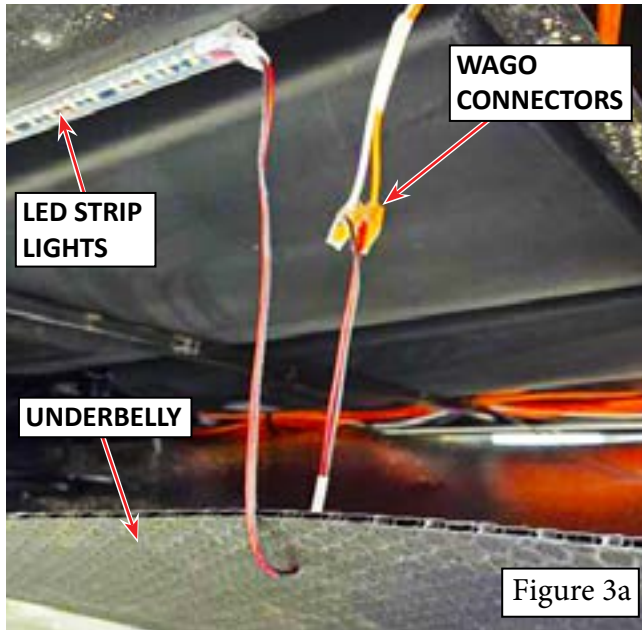
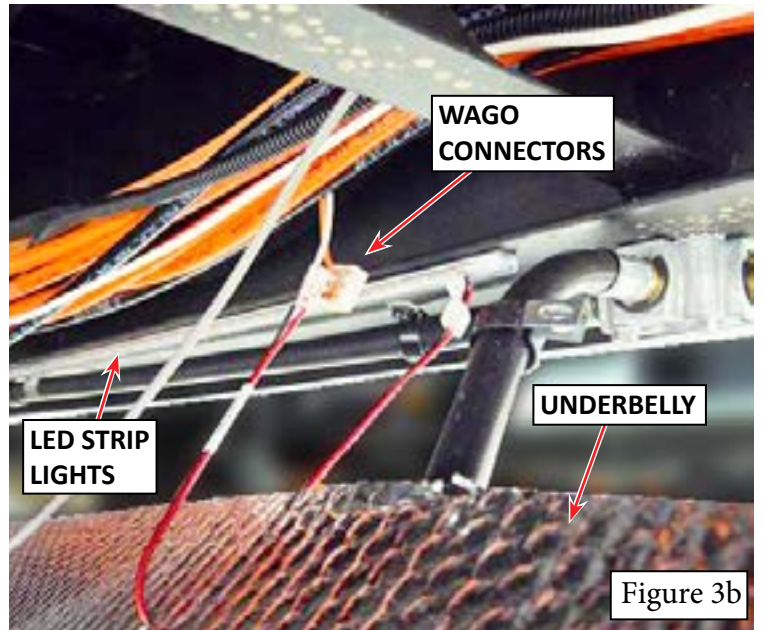
4. Lower the front 2' - 3' of the underbelly to gain access to the wiring connections for the LED light strips (Figure 3a and 3b). Disconnect the power wires to the light strips on both the DS and ODS at the Wago connectors located in the underbelly.

16. Install underbelly material to its original position. Lift it carefully and route the wires for the LED light strips through the original holes. Use the original Wago connectors to connect the LED strip wiring to the power wires in the underbelly (refer to Page 6, Figures 3a and 3b and Page 9, Figure 10). Test the lights **BEFORE** proceeding to step 17.

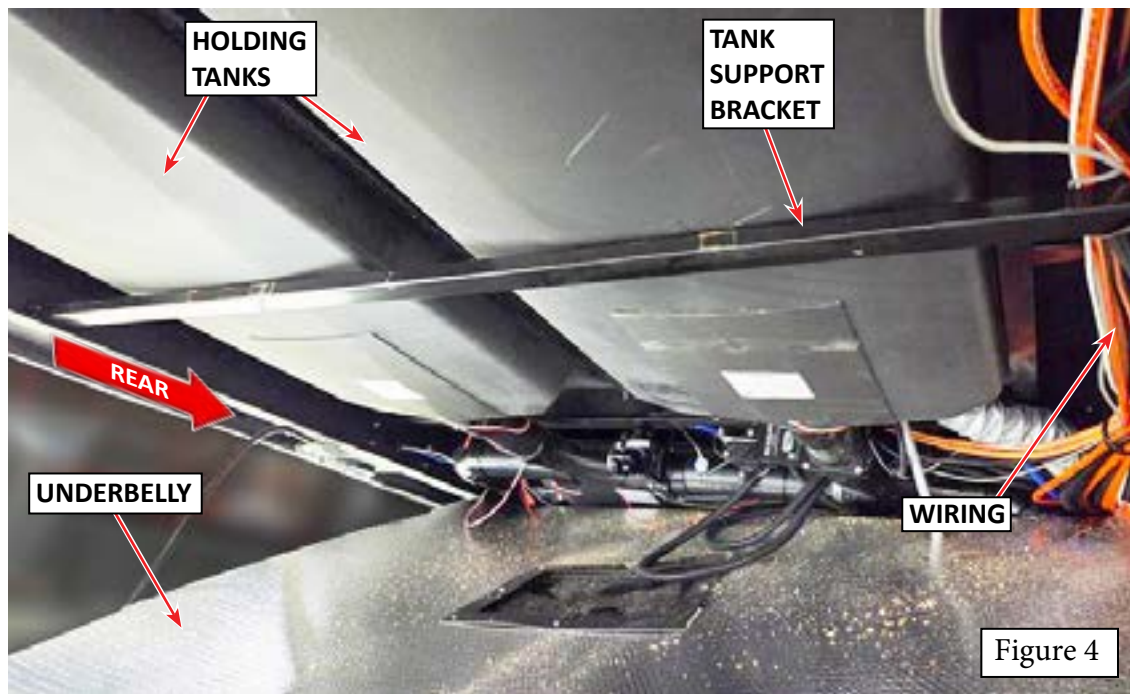
5. When the wiring for the LED strips is disconnected and clear of the underbelly, continue carefully lowering the underbelly down from the front of the RV, working it down until just before the holding tank drain connections (just behind the holding tanks - Figure 4).

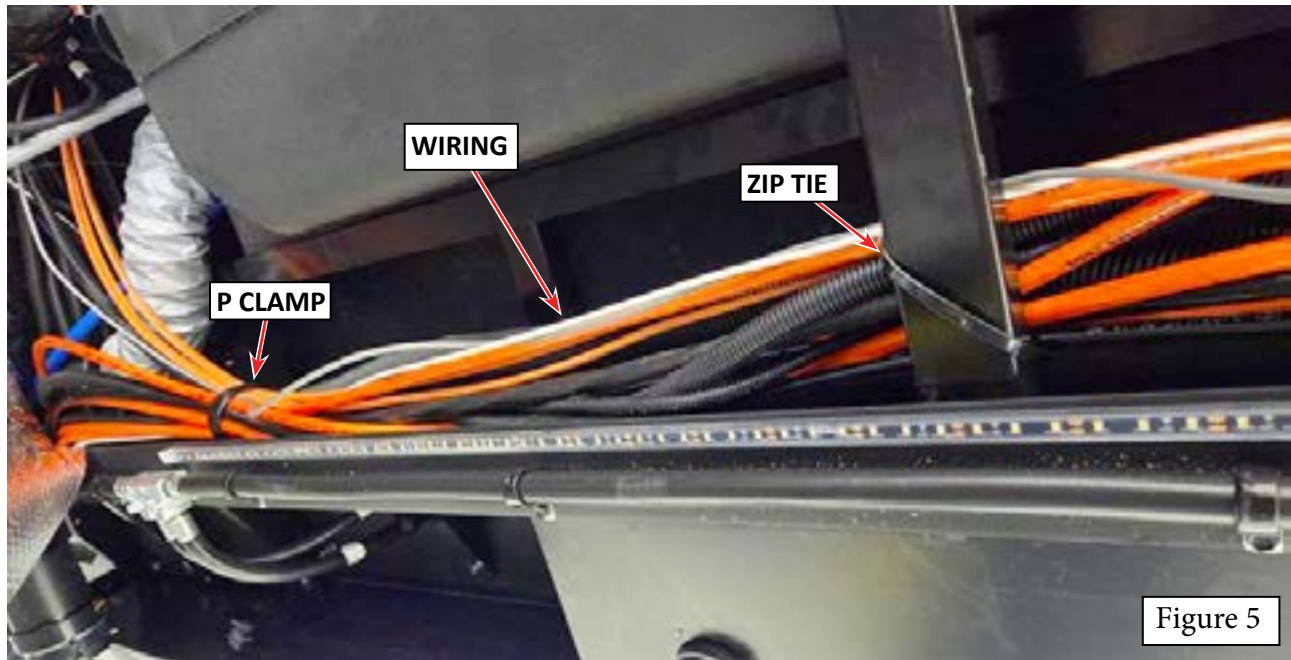
6. Follow all wiring along the off-door side frame rail to see if all wires are securely attached to the structure to eliminate or minimize movement in transit (Figure 5). Note any wires that have come loose or are not properly secured.

15. Upon completion of inspection and any necessary wiring work, use zip ties and wiring loom as necessary to secure the wire and other wiring to the frame structure of the RV to prevent or minimize movement in transit (refer to Page 7, Figure 5 and Page 9, Figure 11).

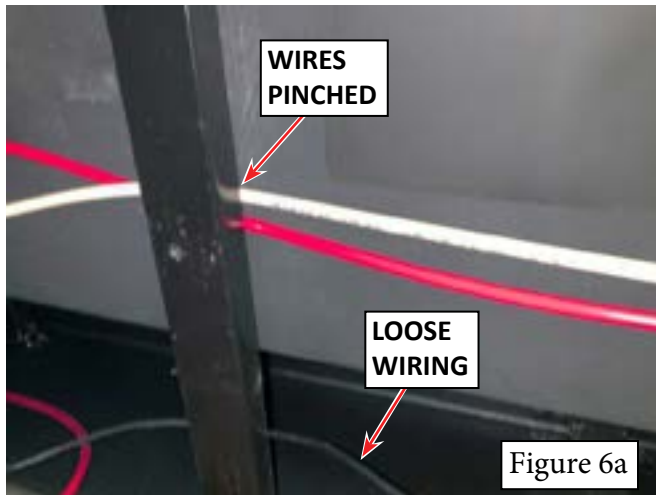
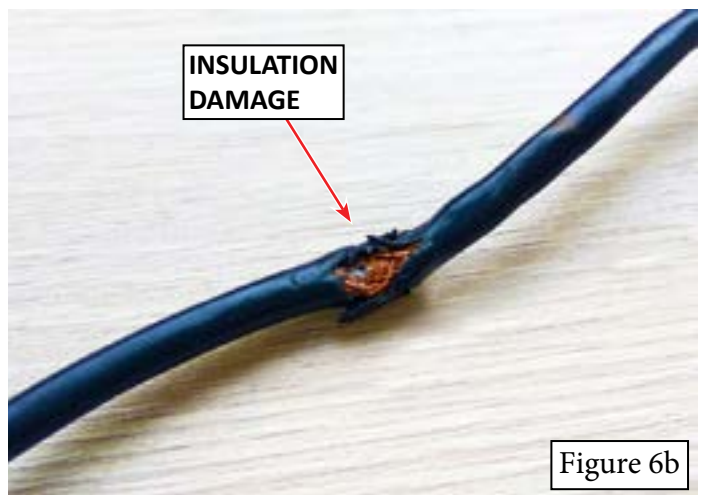
7. If wires have come loose, use zip ties and P-clamps to secure them to the chassis structure. If wires have migrated to a position under the holding tanks at the cross member support (Figure 6a), reposition the wire to the wire bundle, and inspect for wear, chafing or any other damage to the insulation that would expose the internal wires (Figure 6b). If the insulation is damaged and wire elements are exposed, the wire must be repaired or replaced.

14. Wiring repairs will differ depending on whether the damaged wires are 120 VAC or 12 VDC. The National Electrical Code (NEC) and NFPA 1192 provide guidelines for safe electrical installations, including wiring repairs. Key aspects for wiring repairs include proper splicing techniques, grounding requirements, and the use of appropriate wiring methods (not shown).

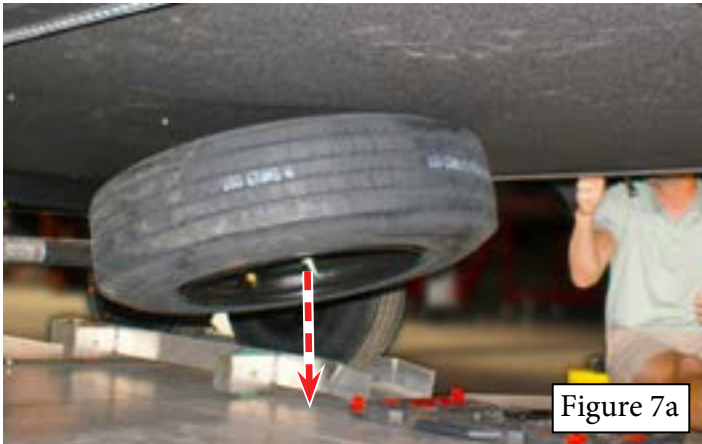
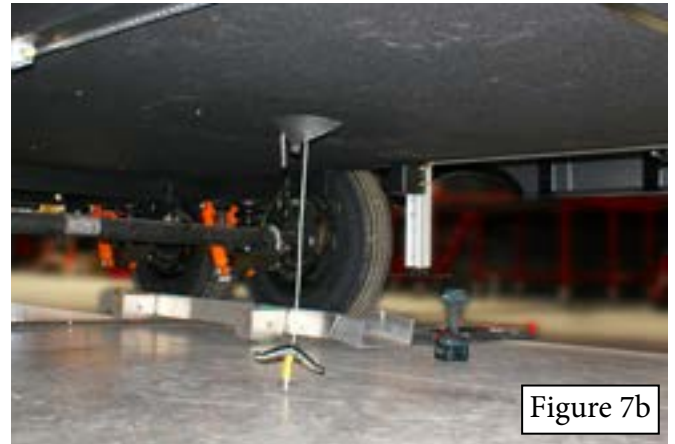
8. **Inspect wiring AFT of the axles.** Use the hand crank provided with the RV, or a 3/4" socket to lower the spare tire from its stored position under the RV (Figure 7a). Remove the tire from under the RV (Figure 7b).

20. Use the hand crank provided with the RV, or a 3/4" socket and ratchet driver to return the spare tire to the stored position under the RV (Page 8, Figure 7a).

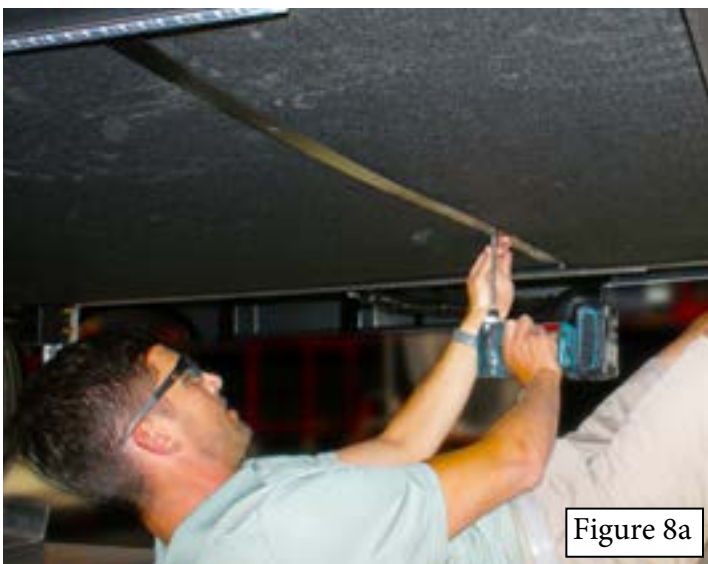
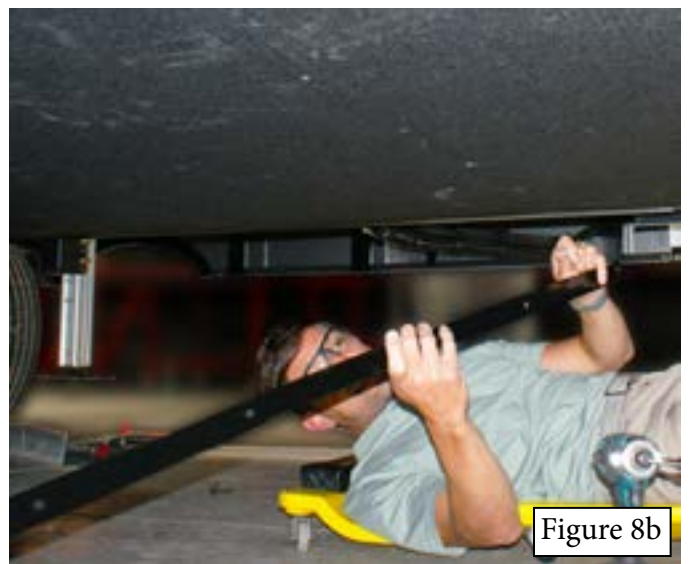
9. Use an impact driver with a 3/8" socket to remove the 3/8" fasteners holding the support bracket in place (Figure 8a). Remove the bracket from under the RV (Figure 8b).

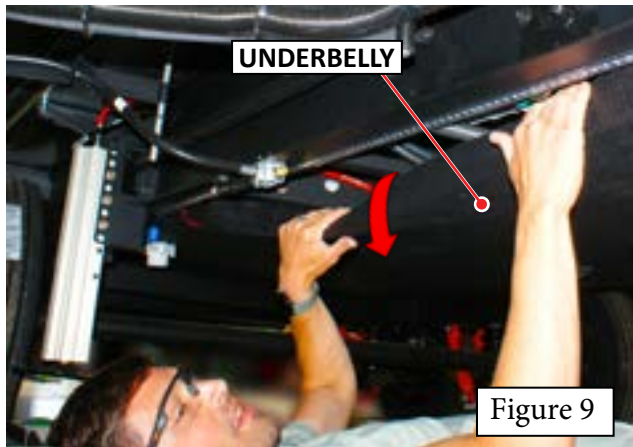
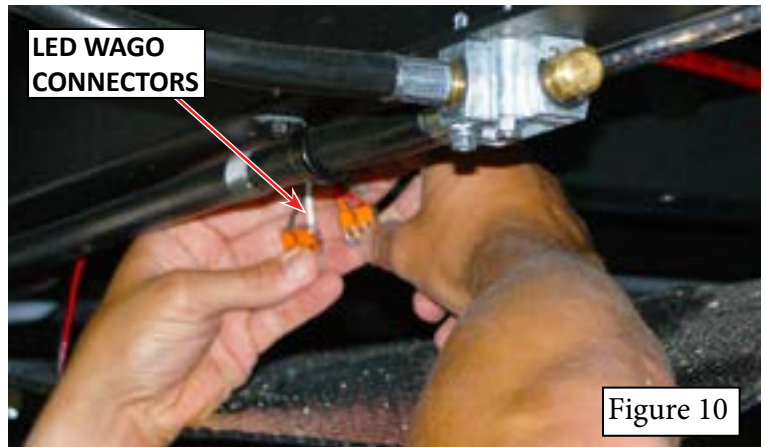
10. Remove the remaining 3/8" fasteners holding the underbelly in place along the off-door side of the frame rail behind the axles. Open the underbelly starting just behind the axles (Figure 9).
11. Locate the wiring for the ODS rear LED strip. Access the Wago connectors for the LED lights. Disconnect the wiring for the LED strip lights (Figure 10).

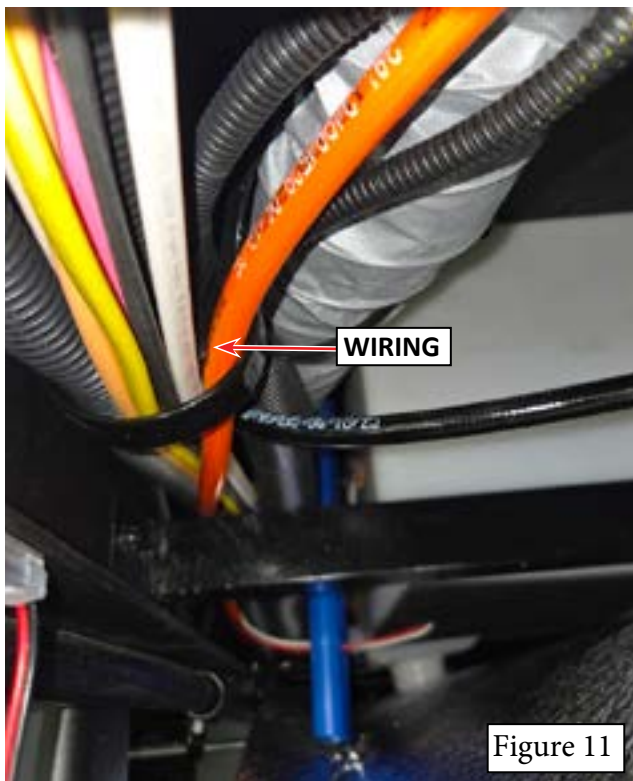
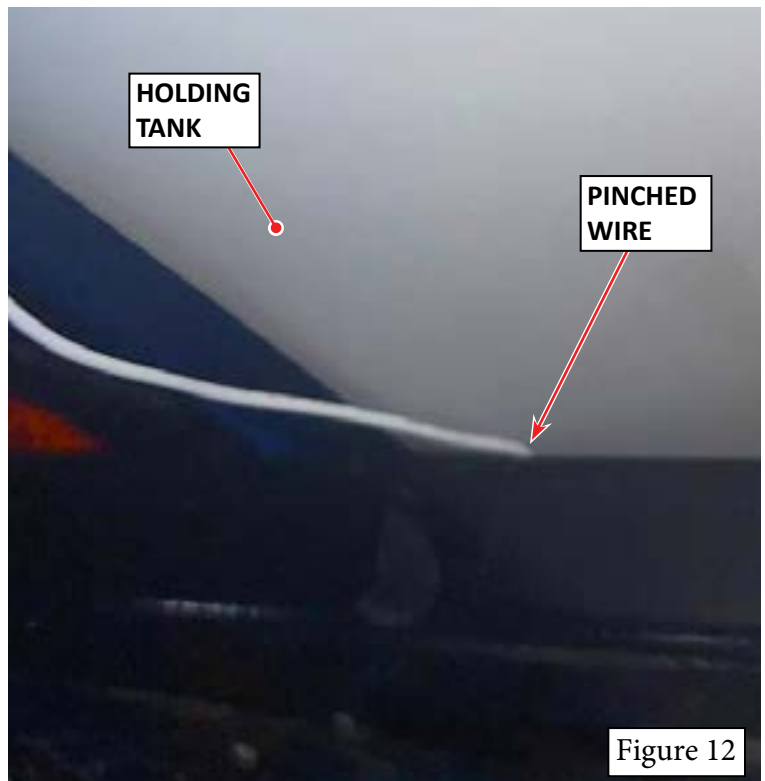
12. Inspect the wiring along the rear ODS frame rail (Figure 11). Look for loose, unsecured wires. If any loose wires are found, secure to the wiring bundle or frame structure via zip-tie and/or P-clamp.
13. Look for wires that may have become pinched between bracket and holding tanks (Figure 12). Inspect, repair or replace as in Step 7.
