# ***SERVICE PROCEDURE***

**25510**  
**December 2025**

## **SUBJECT: SAFETY RECALL**

**Brake systems on certain 2016 thru 2023 IC Bus™ CE Series school buses built 6/4/2015 thru 12/14/2023, manufactured without a silicone block harness, with feature codes 0004198, 0004240 (Brake system, hydraulic with Hydro-Max brake booster).**

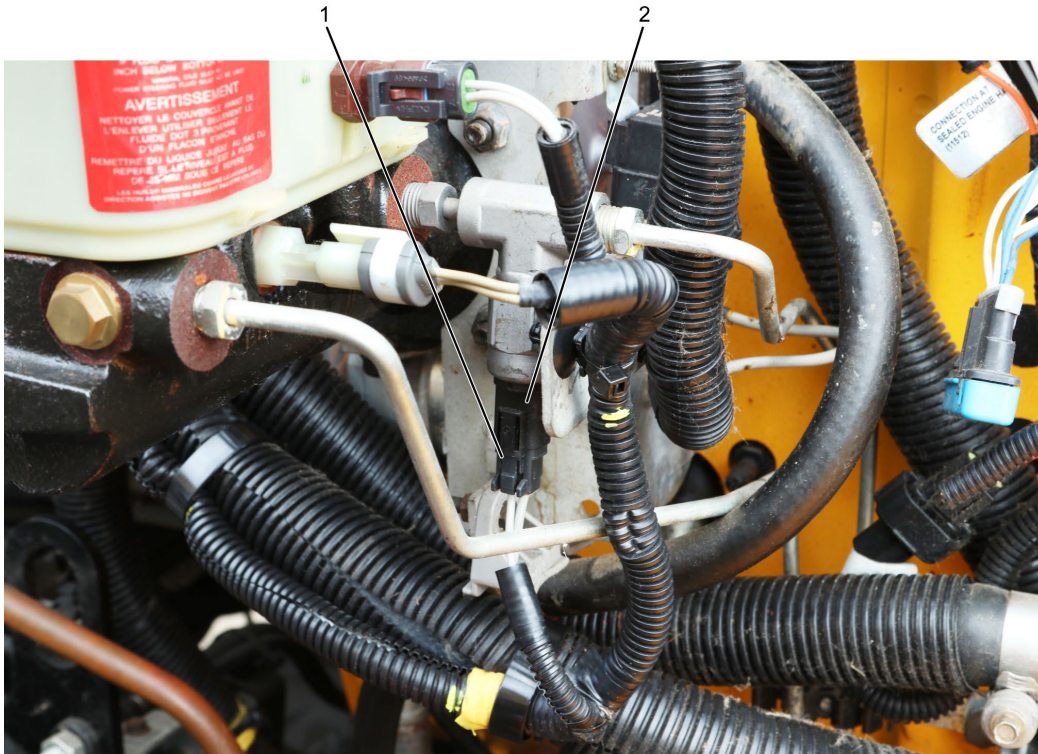
### Figure 1. Brake Pressure Switch Connector Location

1. Brake pressure switch connector
  2. Brake pressure switch
6. Locate and disconnect brake pressure switch connector (Figure 1, Item 1) from brake pressure switch (Figure 1, Item 2) located near vehicle master cylinder.

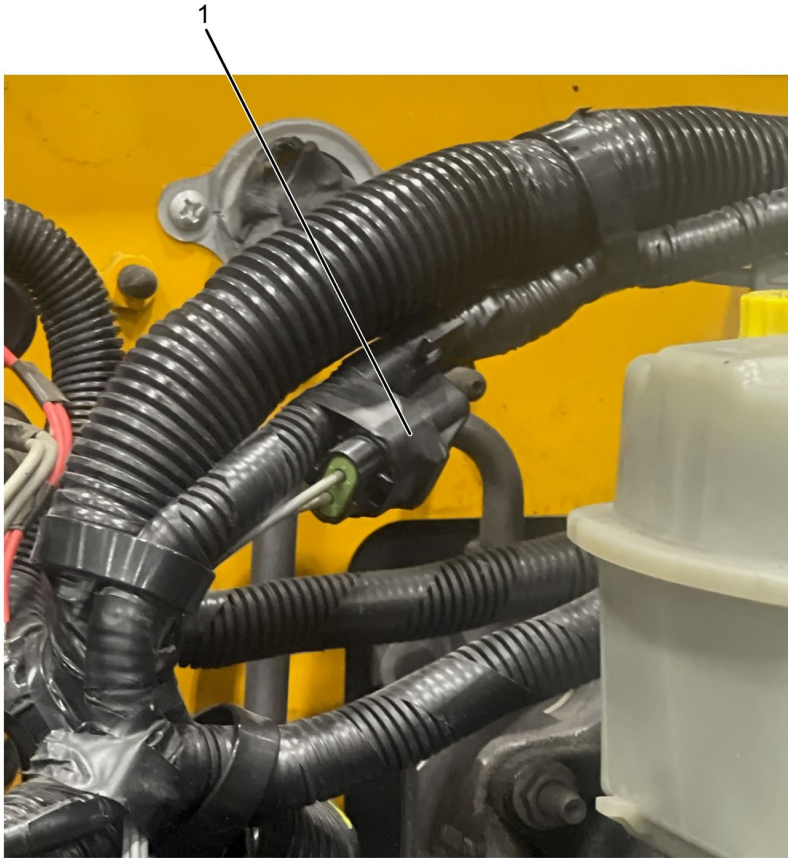
**Figure 3. 5 Amp Hydro-Max Pressure Fuse Location**

1. 5 amp Hydro-Max pressure fuse

8. Locate 5 amp Hydro-Max pressure fuse (Figure 3, Item 1) on the left-side of master cylinder.

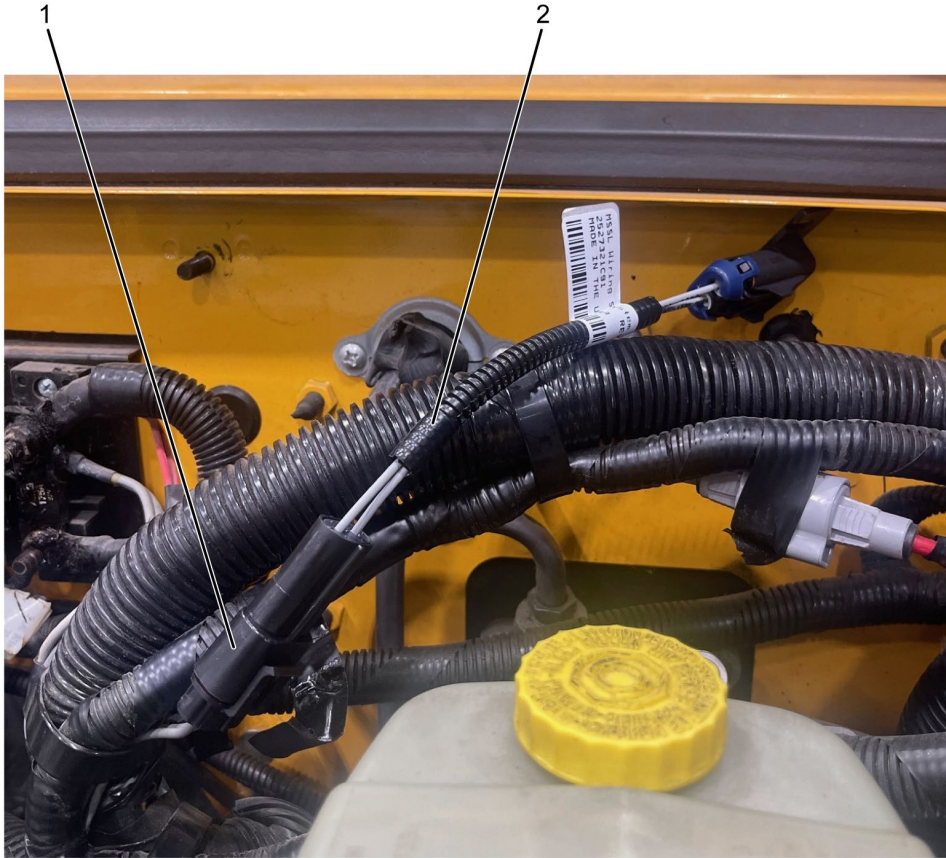
**Figure 4. 5 Amp Hydro-Max Pressure Fuse Harness Extension**

1. 5 amp Hydro-Max pressure fuse connector
2. Extension harness

11. Install extension harness (Figure 4, Item 2) to 5 amp Hydro-Max pressure fuse connector (Figure 4, Item 1). Using cable tie strap, secure extension harness to main harness.
12. Close and latch hood.
13. Remove wheel chocks.
