## SAFETY RELATED RECALL

Global Recall Action  
Number: N759v6

Subject: <b>Range Rover (L405) Front Suspension Knuckle Crack</b>	Publication No.: N759v6
	Model: Range Rover (LG)
	Model Year: 2014 - 2016
	Date of Issue: 19 November 2025

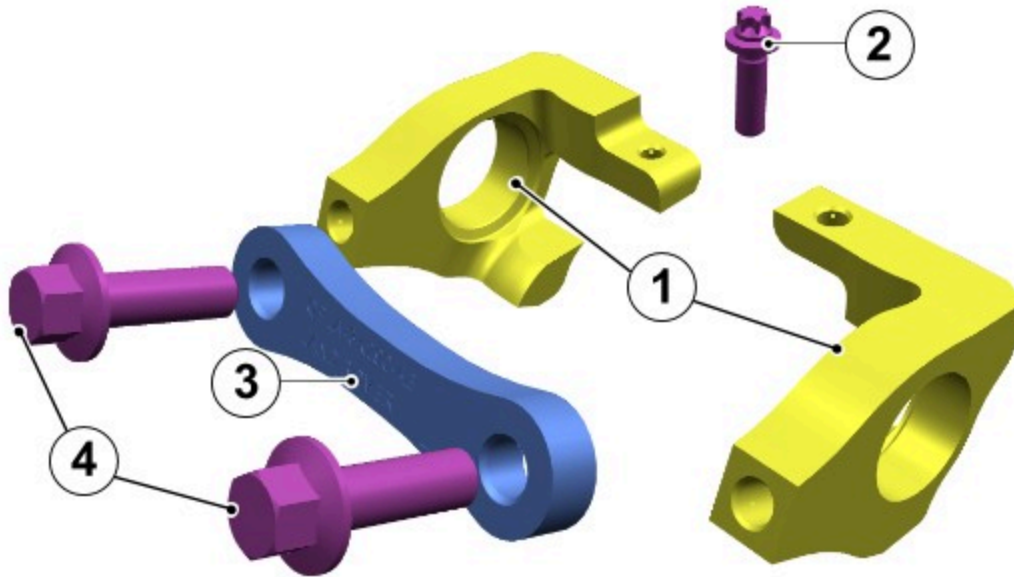
E377524

1. The illustration shows the front knuckle bracket components.

1. Front knuckle bracket side hooks.
2. Front knuckle bracket side hooks bolt.
3. Front knuckle bracket rear plate.
4. Front knuckle bracket rear plate bolts.

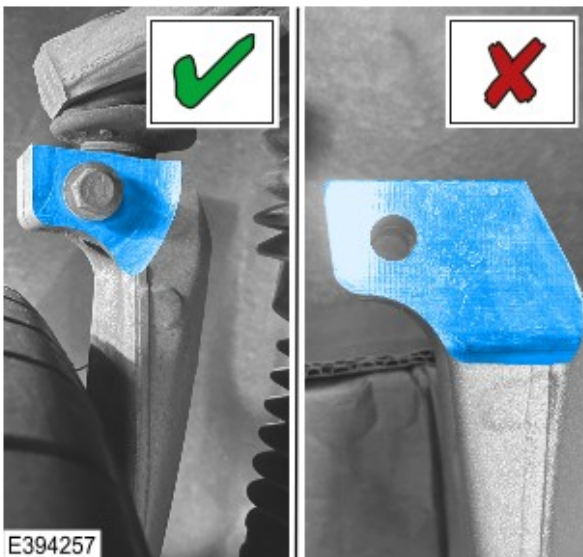
Inspect the front right wheel knuckle.

- If the front right wheel knuckle is the type shown in the illustration with the **GREEN ✓**, it has **PASSED** service inspection 1. No further action is required for the front right wheel knuckle, **continue to the next step**.
- If the front right wheel knuckle is the type shown in the illustration with the **RED X**, it has **FAILED** service inspection 1. **Continue to the next step**.

- The vehicle may have either type of front wheel knuckle installed, both types of front wheel knuckles could be installed on the vehicle.
- Both front wheel knuckles must be inspected. The vehicle may have a different type of front wheel knuckle installed on the left side to the right side.

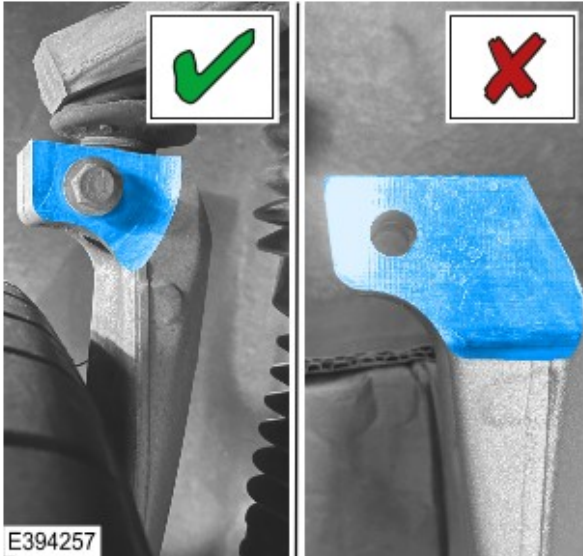
2.

Inspect the front left wheel knuckle.

- If the front left wheel knuckle is the type shown in the illustration with the **GREEN ✓**, it has **PASSED** service inspection 1. No further action is required for the front left wheel knuckle, **continue to the next step**.
- If the front left wheel knuckle is the type shown in the illustration with the **RED X**, it has **FAILED** service inspection 1. **Continue to the next step**.

- The vehicle may have either type of front wheel knuckle installed, both types of front wheel knuckles could be installed on the vehicle.
- Both front wheel knuckles must be inspected. The vehicle may have a different type of front wheel knuckle installed on the left side to the right side.

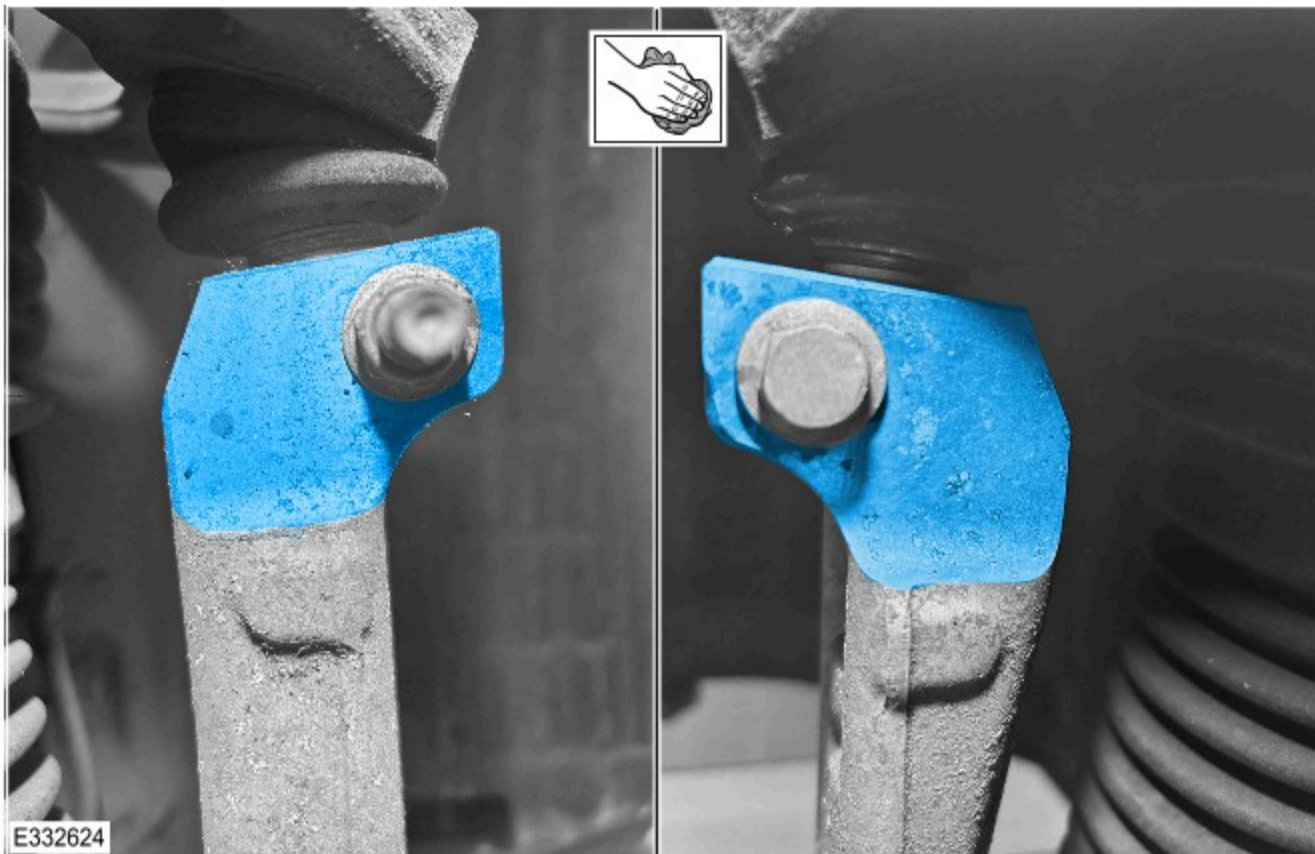
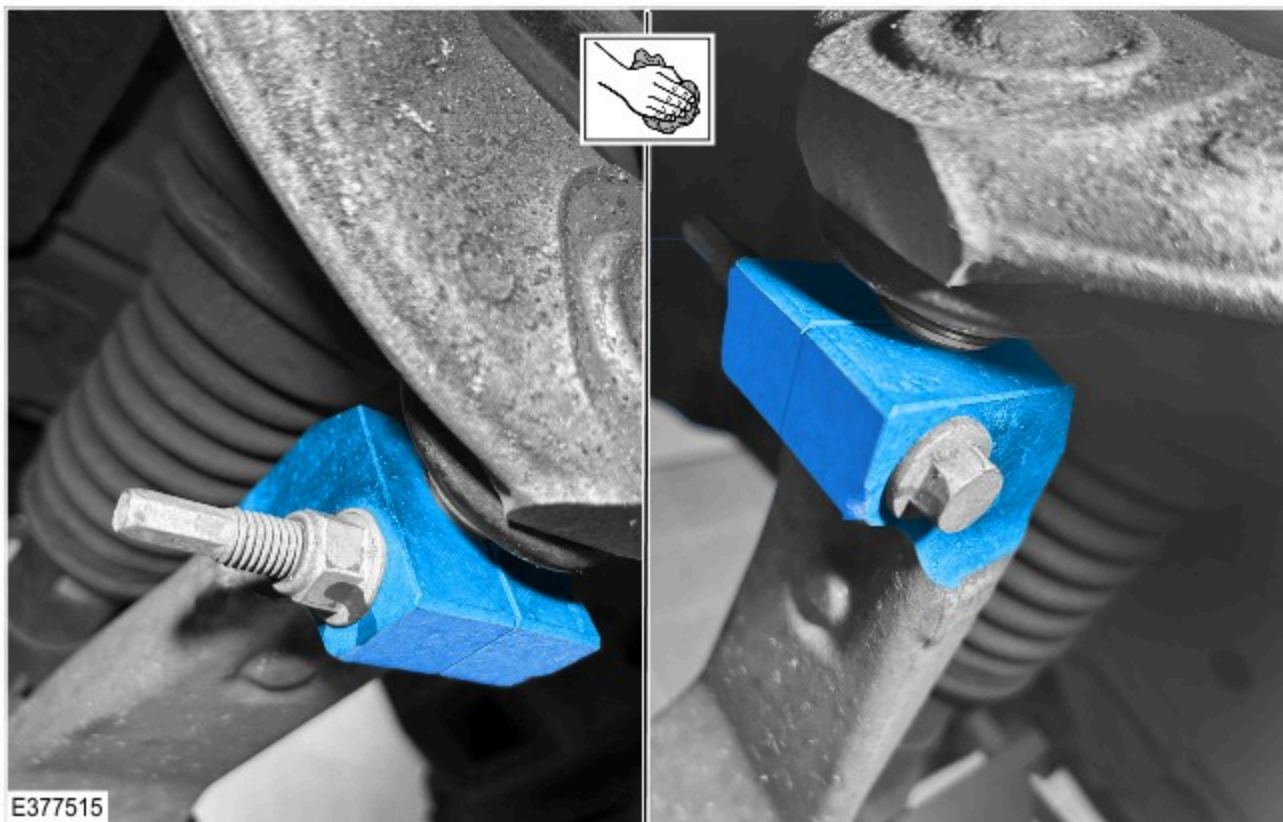
- 
2. Use a non abrasive cloth and suitable cleaning fluid to clean the area of the front knuckle shown highlighted in the illustrations.

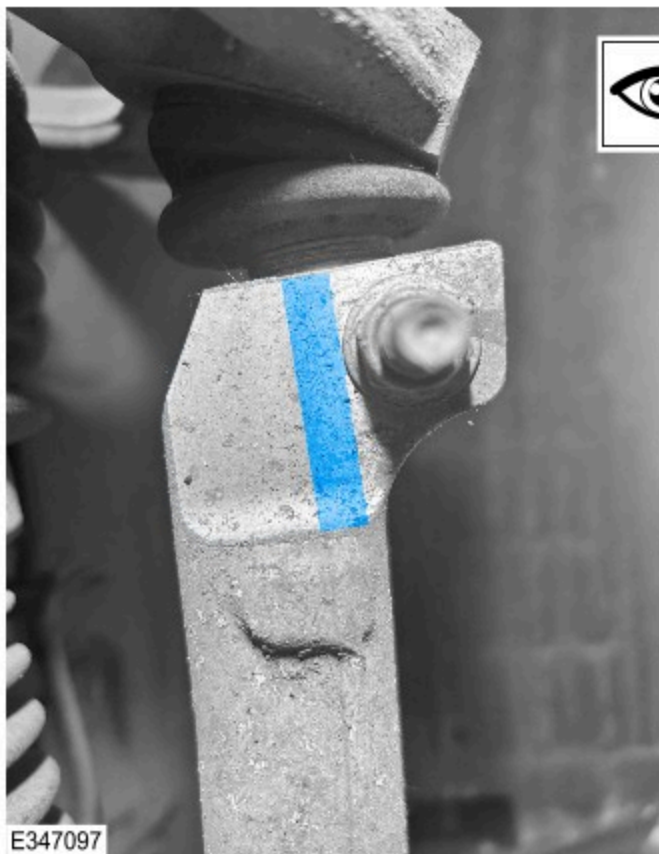
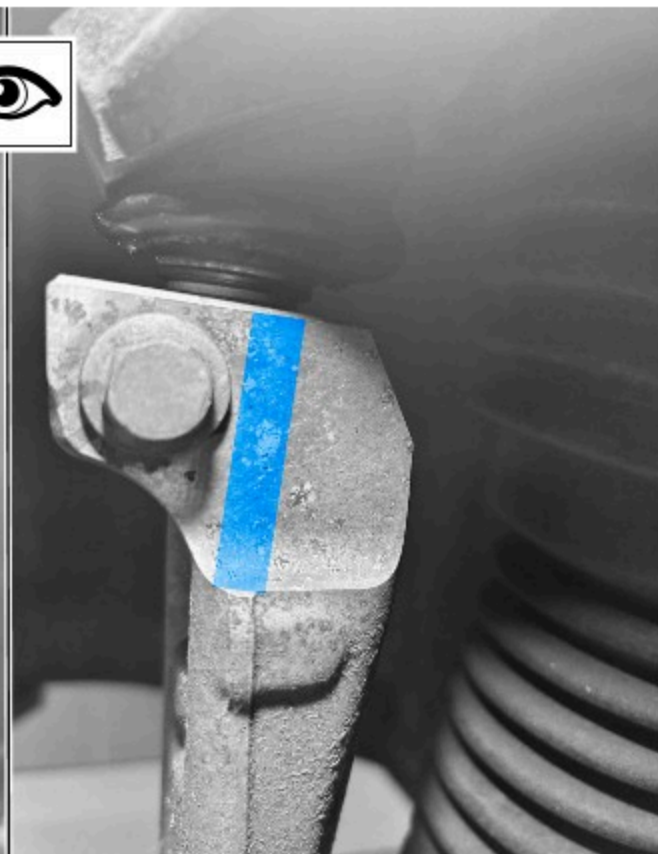
E347097

3. Carefully inspect the front knuckle for visible cracks. Examples of cracks are shown in the next step.

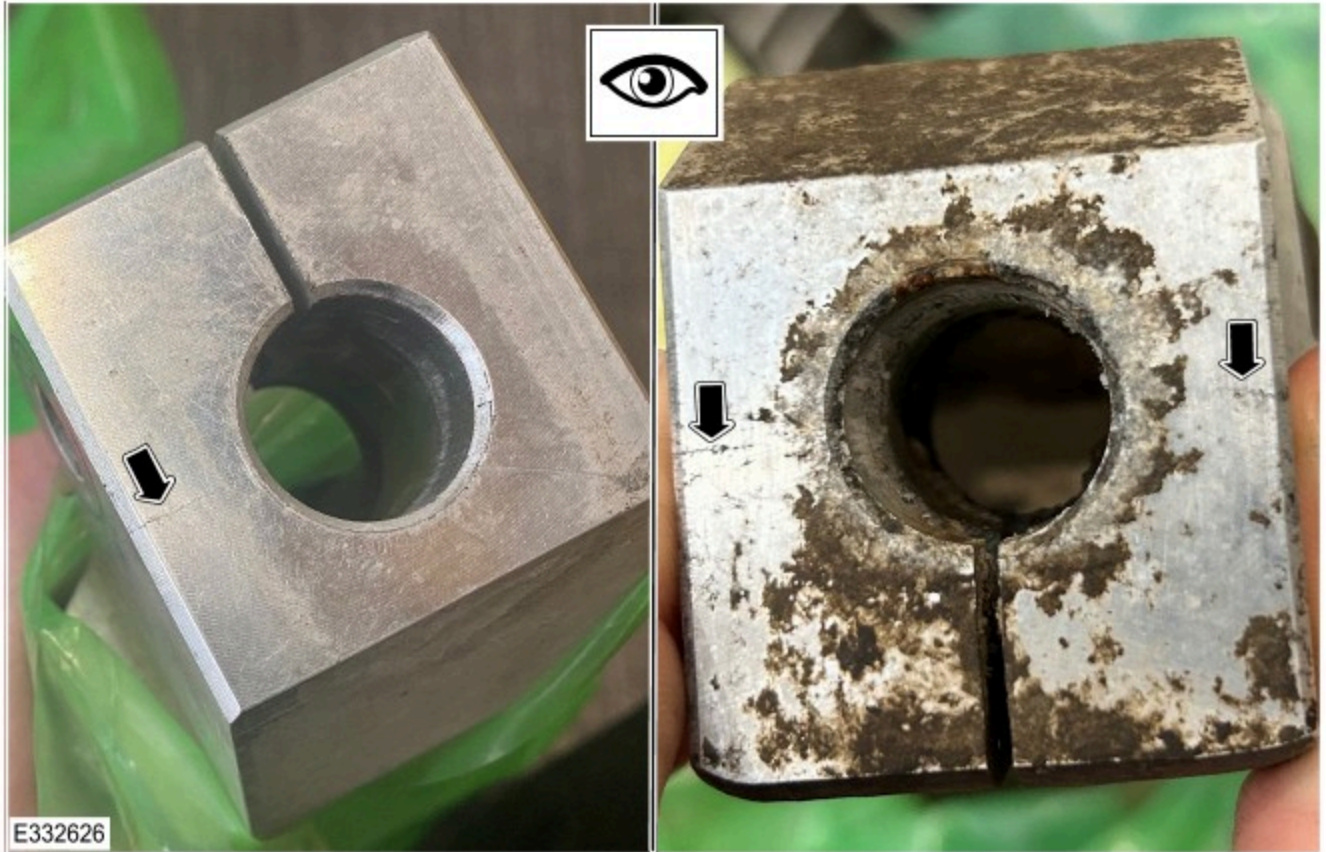
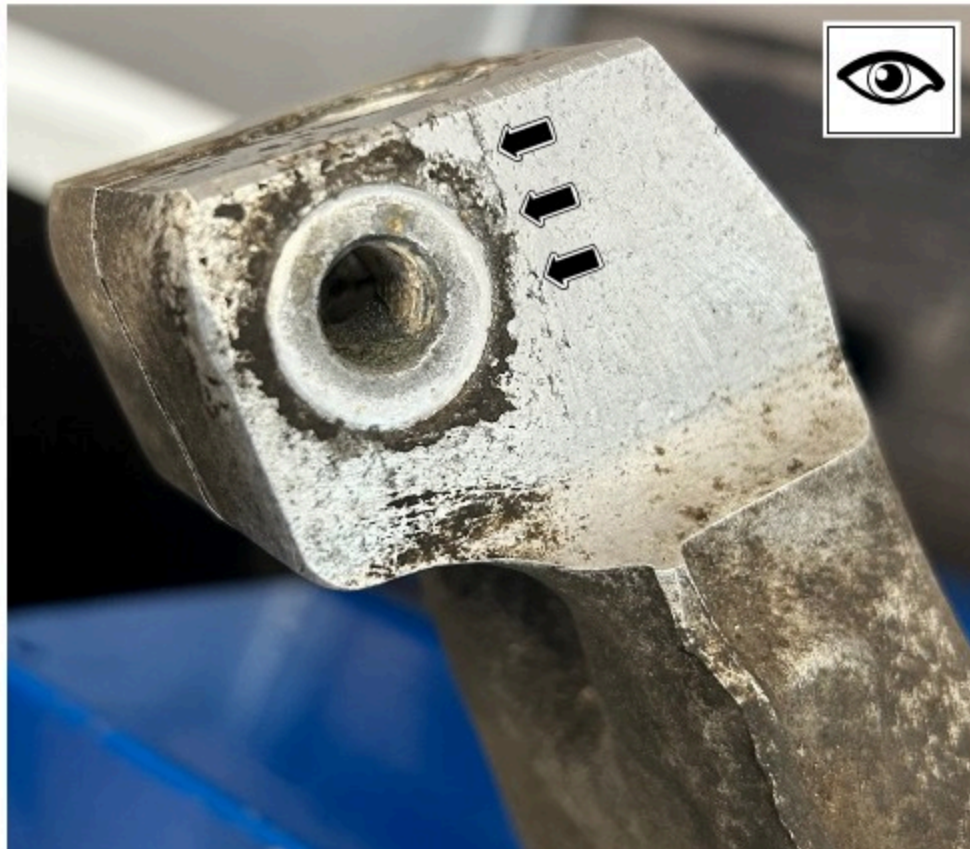
Examples of front knuckle cracks are shown in the illustrations.

- If cracks **ARE** visible on the front knuckle, the front knuckle has **FAILED** service inspection 2. Replace the front knuckle that has **FAILED** service inspection 2 (see TOPIx Workshop Manual section 204-01: Front Suspension - Removal and Installation - Wheel Knuckle).
- If cracks **ARE NOT** visible on the front knuckle, the knuckle has **PASSED** service inspection 2. **Continue to the FRONT KNUCKLE BRACKET INSTALLATION PROCEDURE.**

- The example illustrations are applicable to both left and right front knuckles.
- Use a suitable flashlight and / or a mirror to assist with the visual inspection.

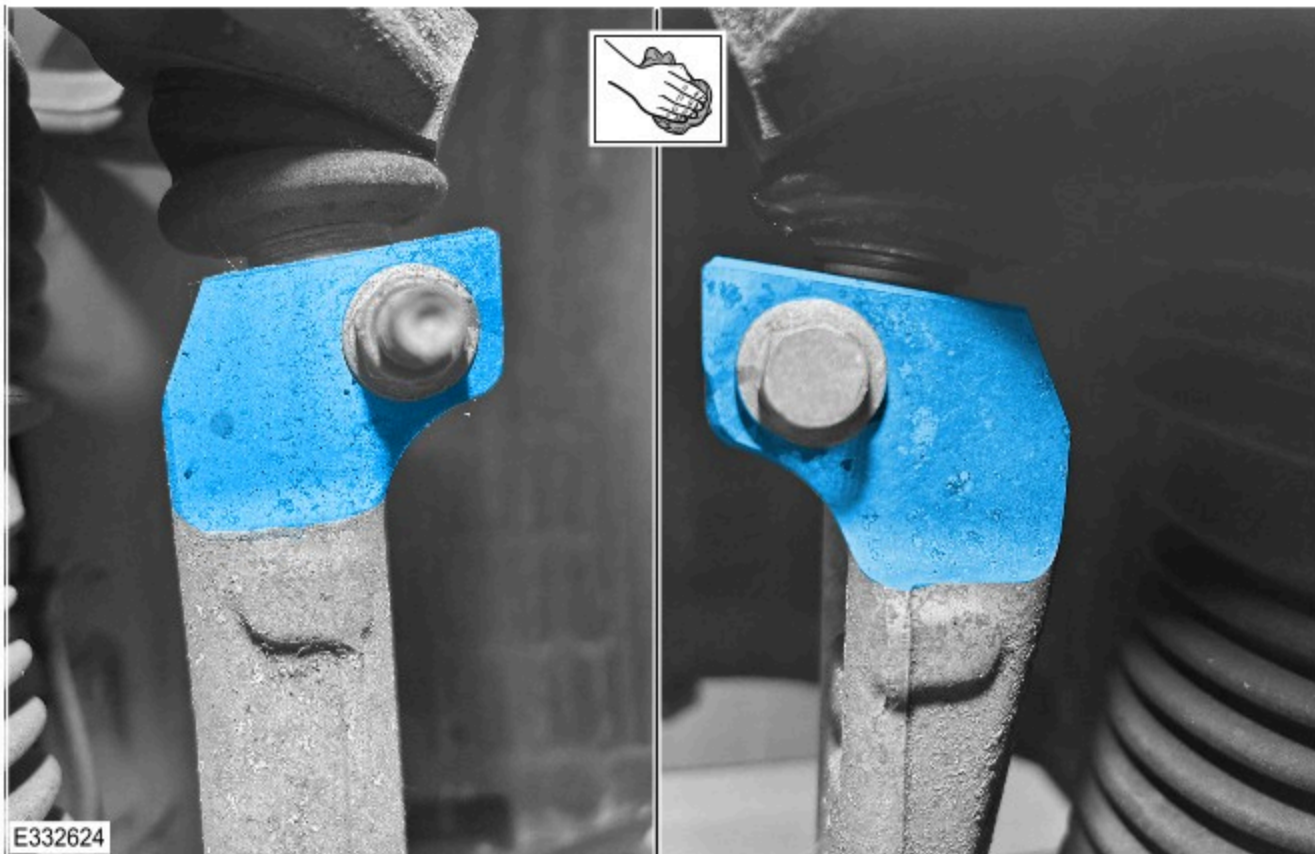
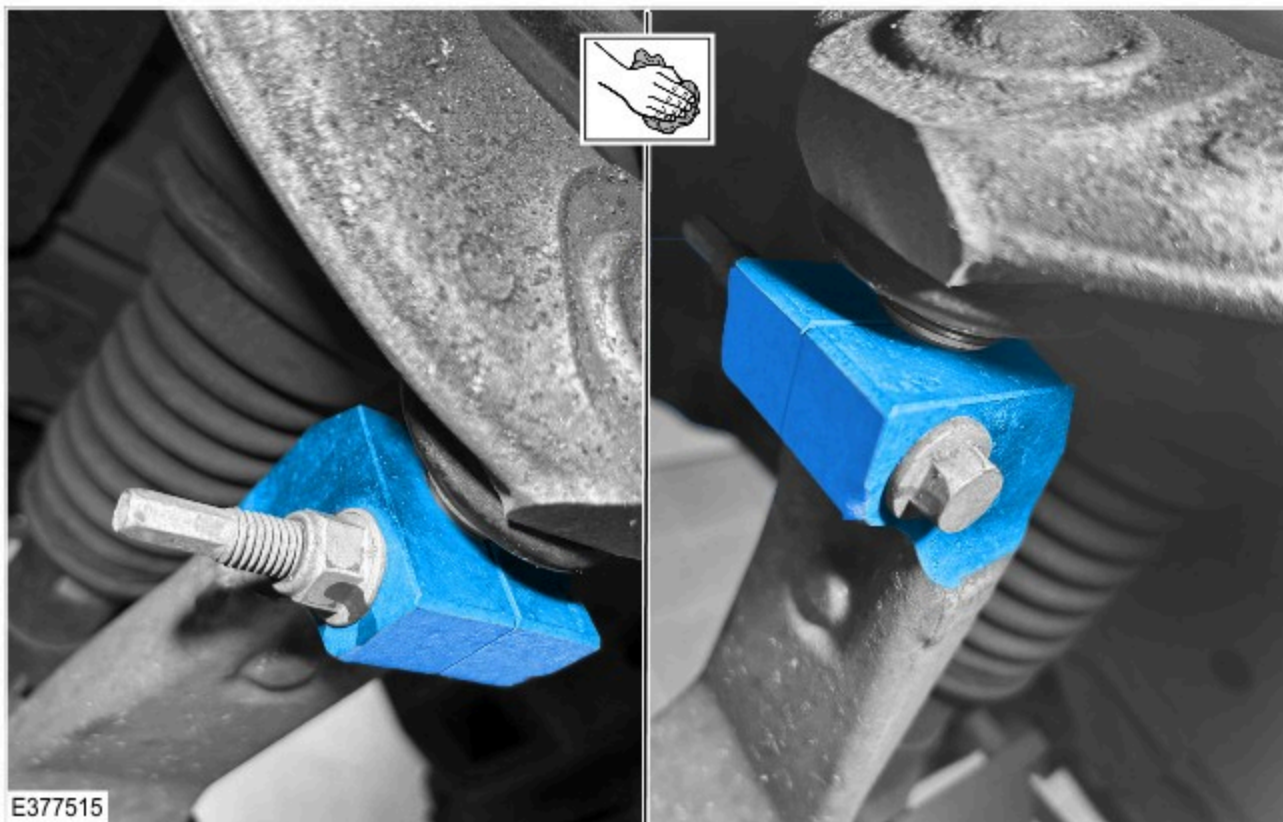
1. The area of the front knuckle shown highlighted in the illustrations must be clean and free from contamination.

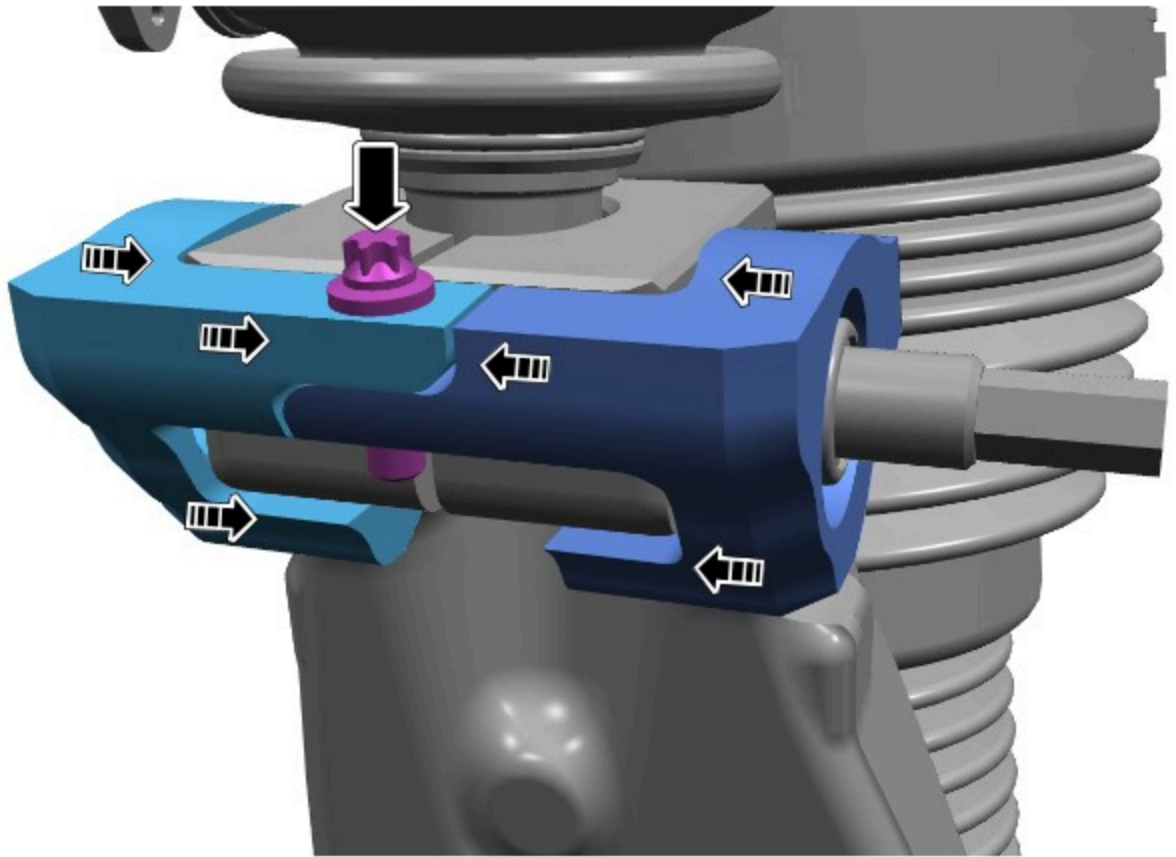
E373427

2. Install the 2 front knuckle bracket side hooks.

- Apply Loctite® 243 to the bolt.
- Install the bolt, finger tight only at this stage.

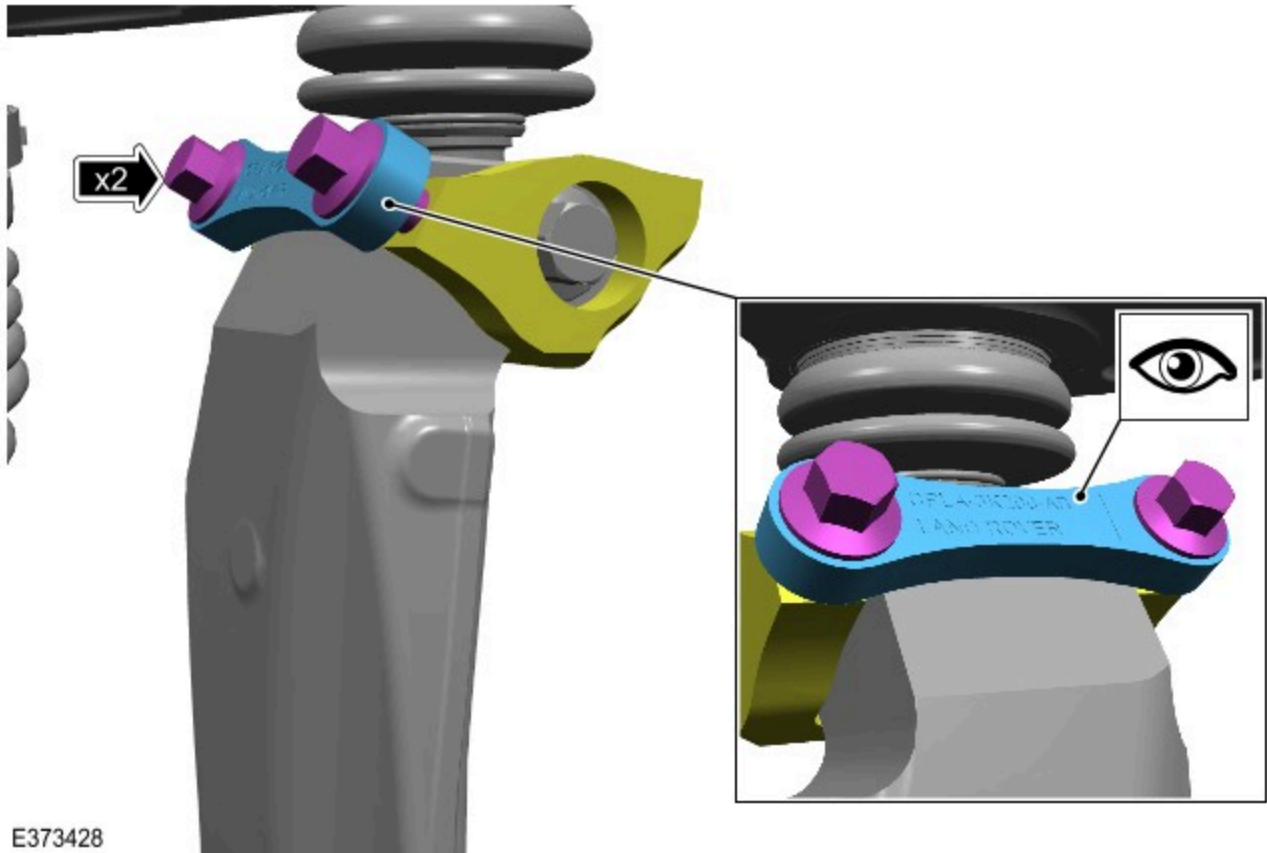
E373428

The front knuckle bracket rear plate must be installed with the part number facing outward from the front wheel knuckle.

Install the front knuckle bracket rear plate.

- Apply Loctite® 243 to the 2 bolts.
- Install the 2 bolts, finger tight only at this stage.

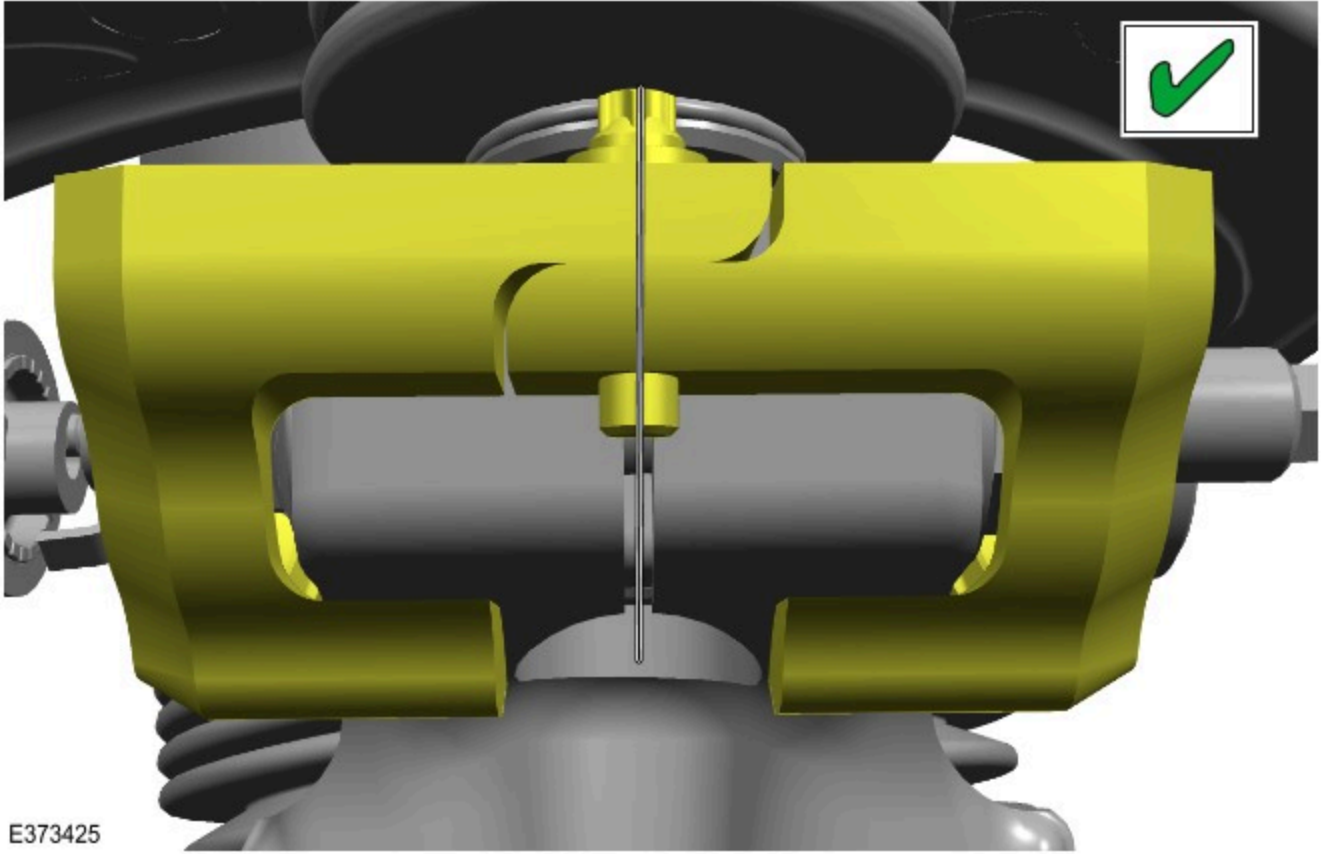
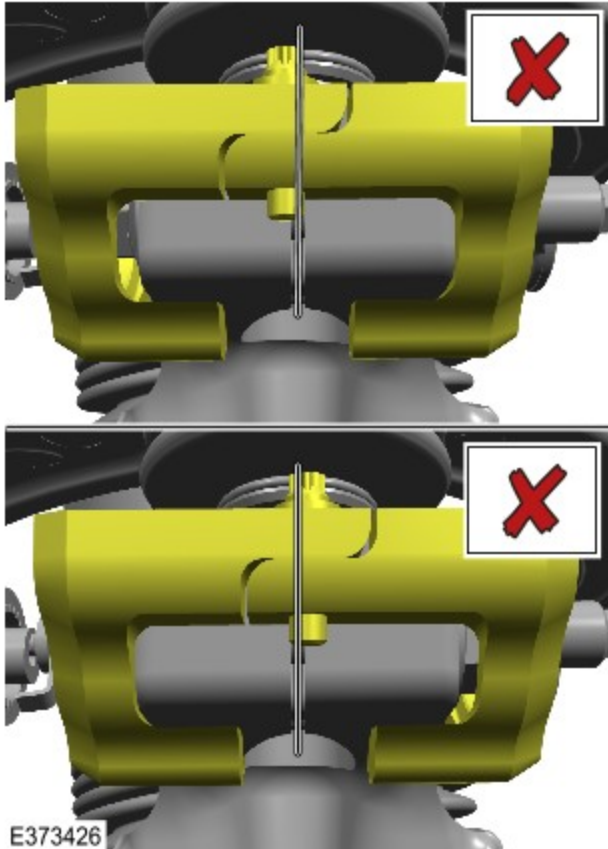
E373425

4. Align the front knuckle bracket to be central to the front knuckle.

- The front knuckle bracket must be centrally aligned to the front wheel knuckle as shown in the illustration with the **GREEN** ✓.
- The front knuckle bracket must not be aligned to the front wheel knuckle as shown in the illustrations with the **RED X**.

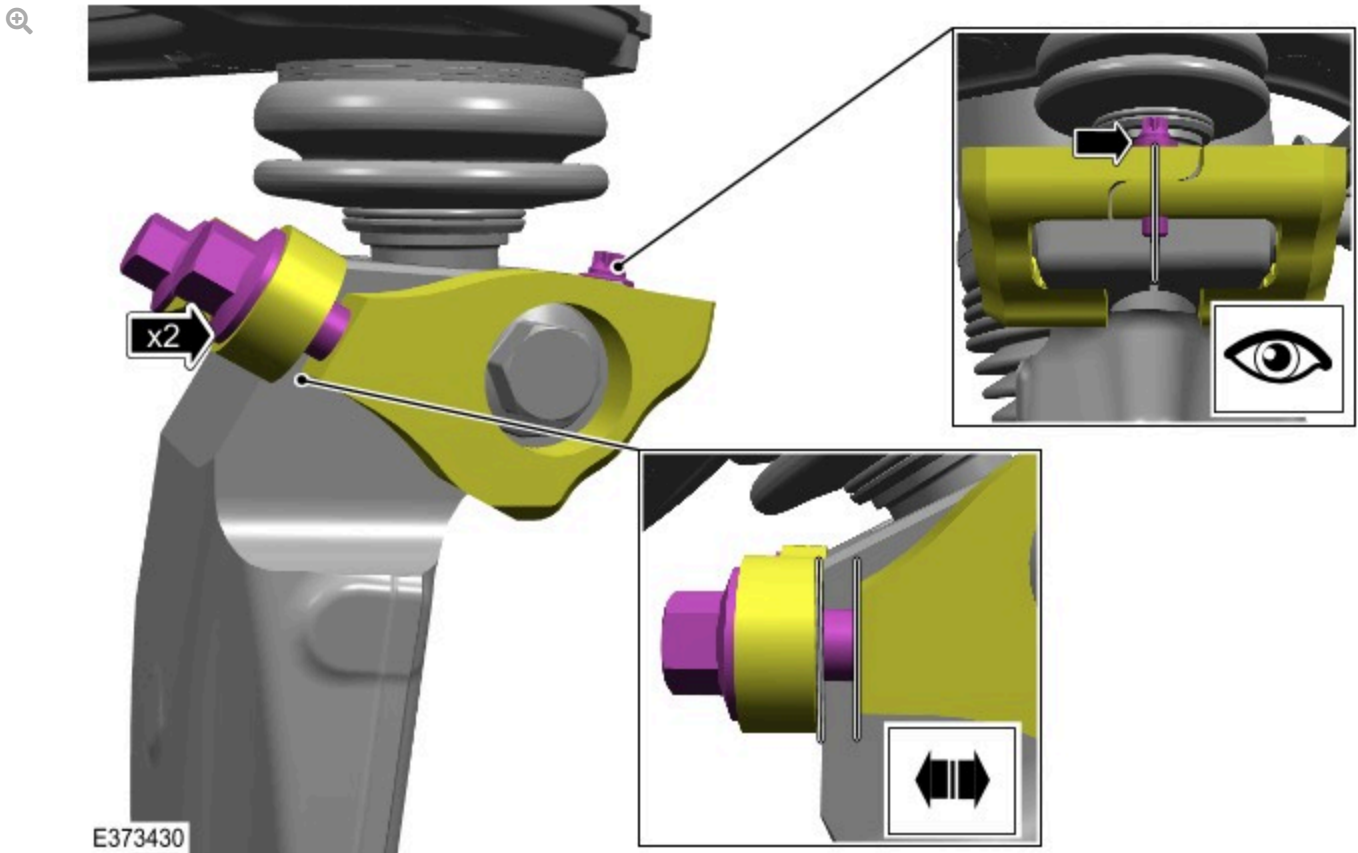
- There must be a gap between the front knuckle bracket rear plate and the 2 front knuckle bracket side hooks.
- The gap between the front knuckle bracket rear plate and the 2 front knuckle bracket side hooks must be maintained both sides of the front knuckle bracket rear plate.
- The front knuckle bracket must remain central to the front knuckle during tightening, as shown in the illustration.

Fully tighten the 3 front knuckle bracket bolts.

1. M5 Bolt: **6 Nm**
2. M8 Bolts:
  - Stage 1: **10 Nm**
  - Stage 2: **24 Nm**
