## SAFETY RELATED RECALL

Global Recall Action  
Number: D027v3

<b>Subject:</b>  <b>Range Rover (L405) Front Suspension Knuckle Crack</b>	Publication No.: D027v3
	Model: Range Rover (LG)
	Model Year: 2015 - 2017
	Date of Issue: 22 May 2026

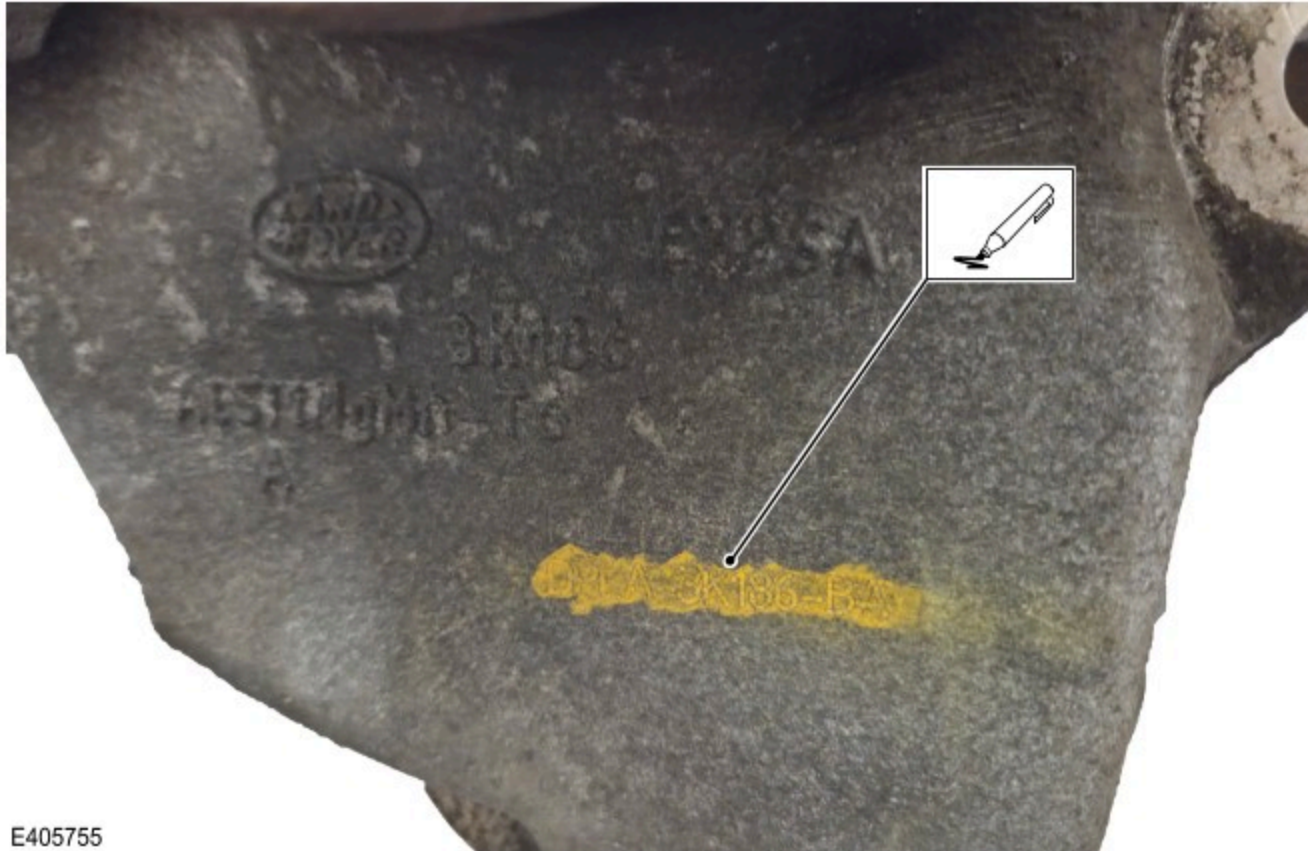
E405755

4. Using a paint pen, apply paint to the front wheel knuckle part number. The part number will be in the location shown in the illustration, on every front wheel knuckle.
  - Using a suitable cloth, remove excess paint from the part number.

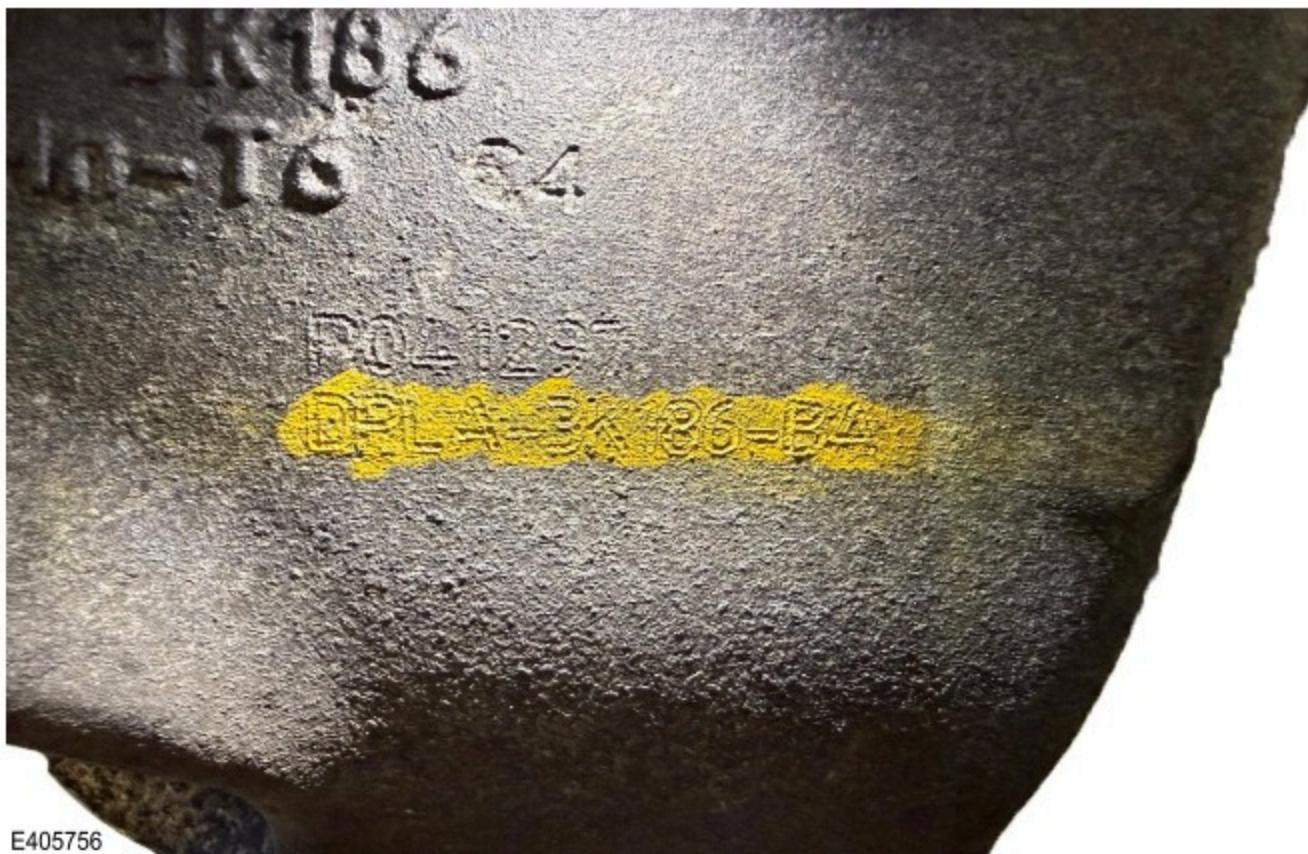
Inspect the front wheel knuckle part number.

- If the front wheel knuckle part number **IS** any of the following part numbers, the front wheel knuckle **has FAILED** Service Inspection 2, **continue to step 7**.
  - **CPLA-3K185-BA, CPLA-3K186-BA, DPLA-3K185-BA or DPLA-3K186-BA.**
- All other front wheel knuckle part numbers are considered to **have PASSED** Service Inspection 2, **continue to step 6**.

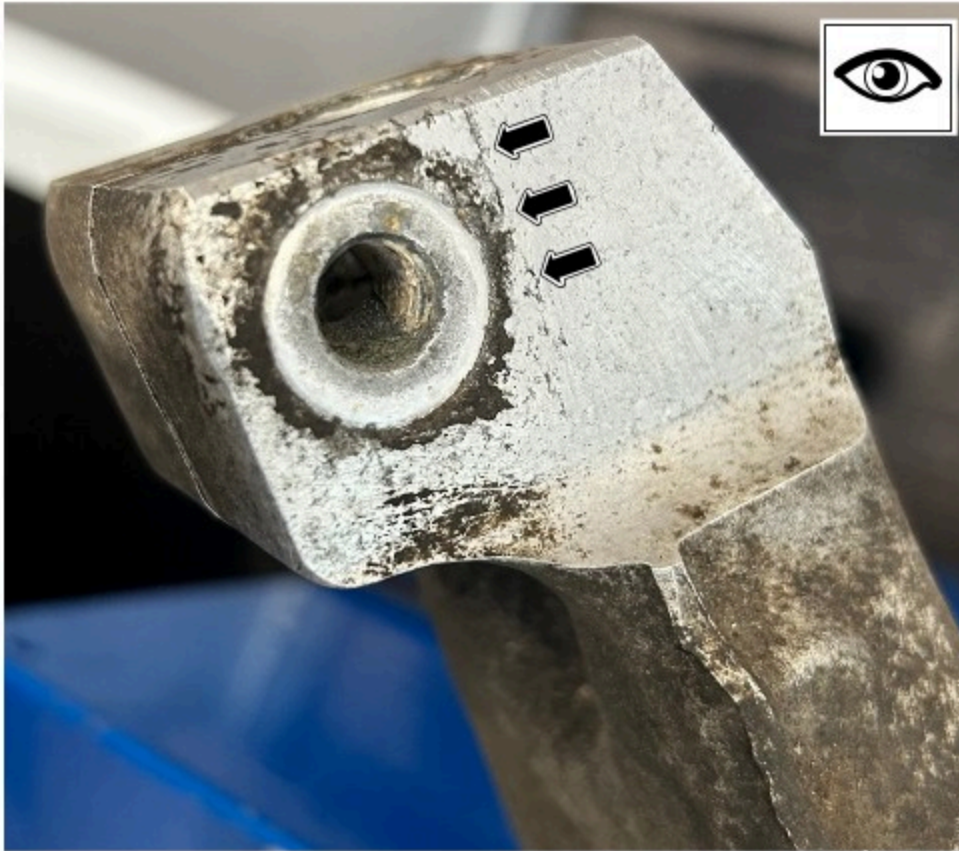
E332627

Examples of front wheel knuckle cracks are shown in the illustrations.

- If cracks **ARE** visible on the front wheel knuckle, the front wheel knuckle has **FAILED** service inspection 3. Replace the front wheel knuckle that has **FAILED** service inspection 3, continue to **FRONT WHEEL KNUCKLE REPLACEMENT**.
- If cracks **ARE NOT** visible on the front knuckle, the knuckle has **PASSED** service inspection 3. **Continue to the FRONT WHEEL KNUCKLE BRACKET INSTALLATION PROCEDURE.**
  - For **CPLA Prefix** front wheel knuckles, continue to the **CPLA PREFIX FRONT WHEEL KNUCKLE BRACKET INSTALLATION PROCEDURE**.
  - For **DPLA Prefix** front wheel knuckles, continue to the **DPLA PREFIX FRONT WHEEL KNUCKLE BRACKET INSTALLATION PROCEDURE**.

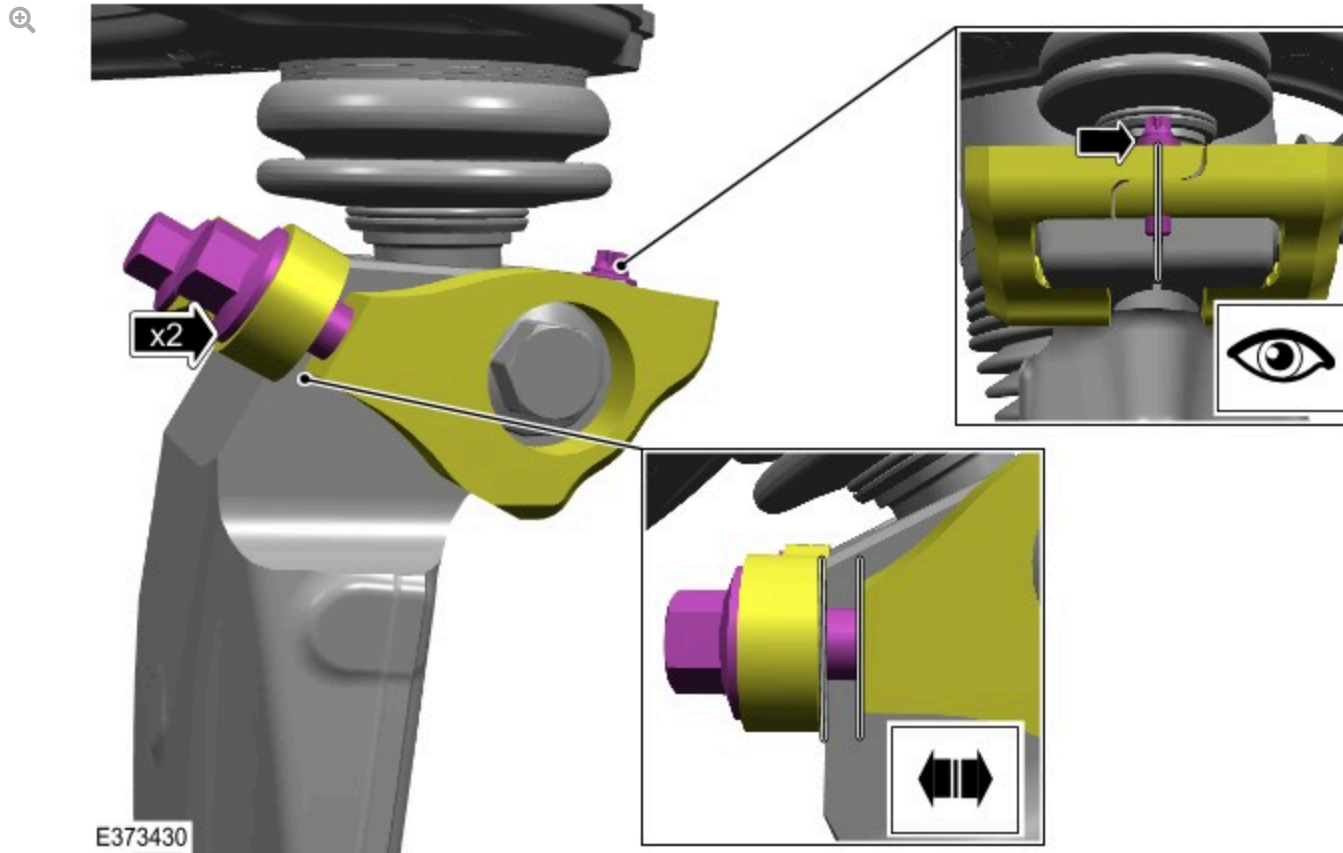
Fully tighten the 3 front knuckle bracket bolts.

1. M5 Bolt: **6 Nm**
2. M8 Bolts:
  - Stage 1: **10 Nm**
  - Stage 2: **24 Nm**
3. Re-torque the M5 Bolt: **6 Nm**

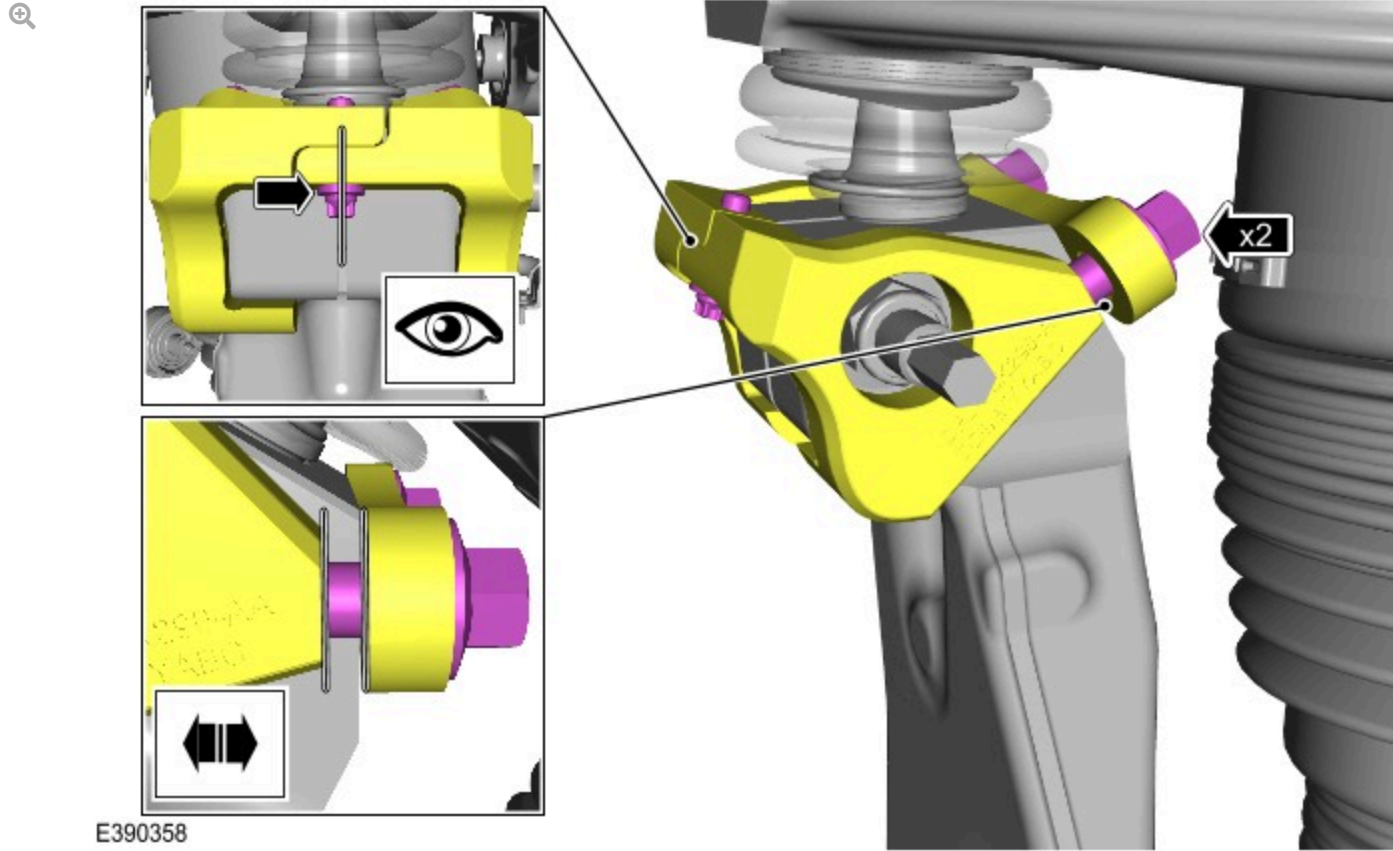
Fully tighten the 3 front knuckle bracket bolts.

1. M5 Bolt: **6 Nm**
2. M8 Bolts:
  - Stage 1: **10 Nm**
  - Stage 2: **24 Nm**
3. Re-torque the M5 Bolt: **6 Nm**
