## SAFETY RELATED RECALL

Global Recall Action  
Number: D041v2

<b>Subject:</b> <b>Range Rover (L405) Front Suspension Knuckle Crack</b>	Publication No.: D041v2
	Model: Range Rover (LG)
	Model Year: 2016
	Date of Issue: 19 November 2025

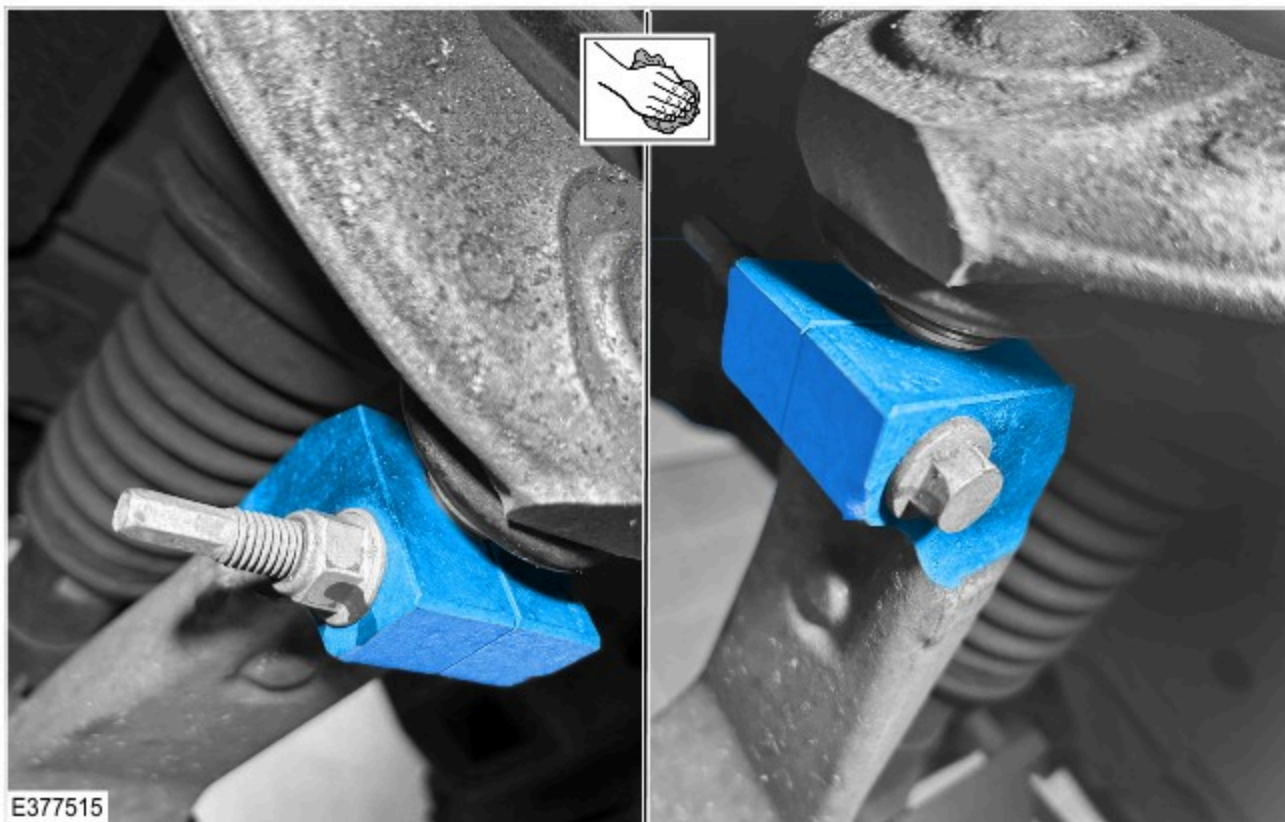
- 
2. Use a non abrasive cloth and suitable cleaning fluid to clean the area of the front knuckle shown highlighted in the illustrations.

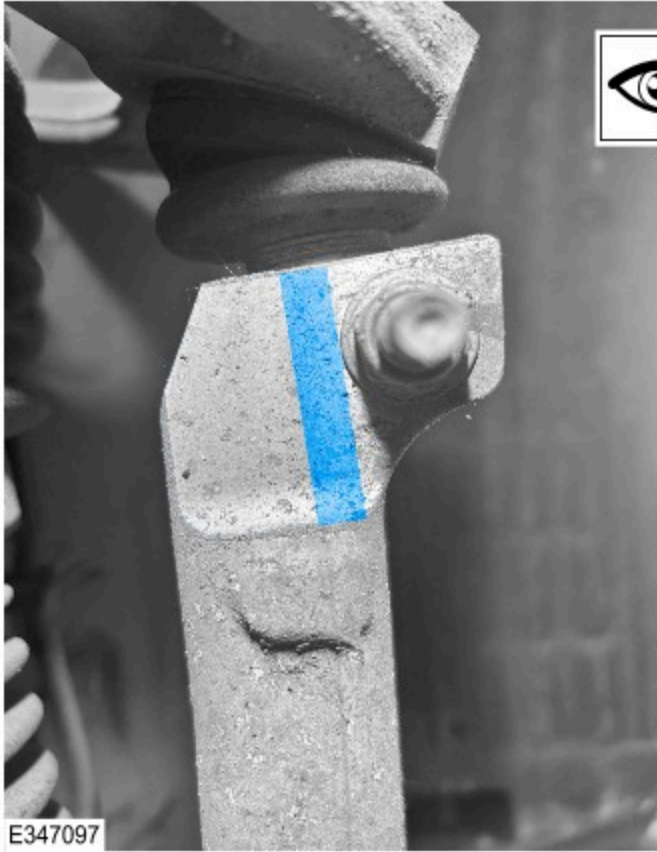
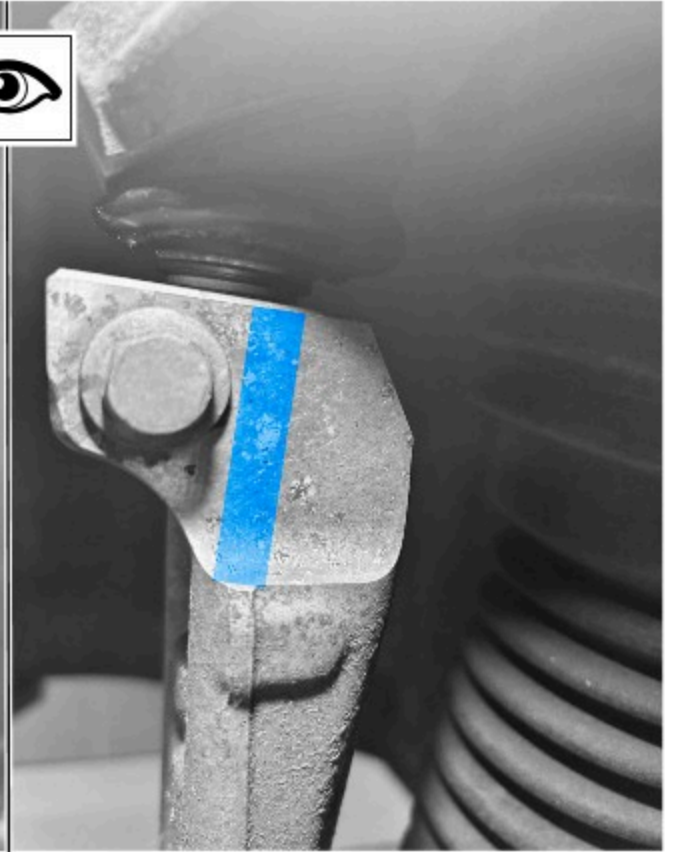
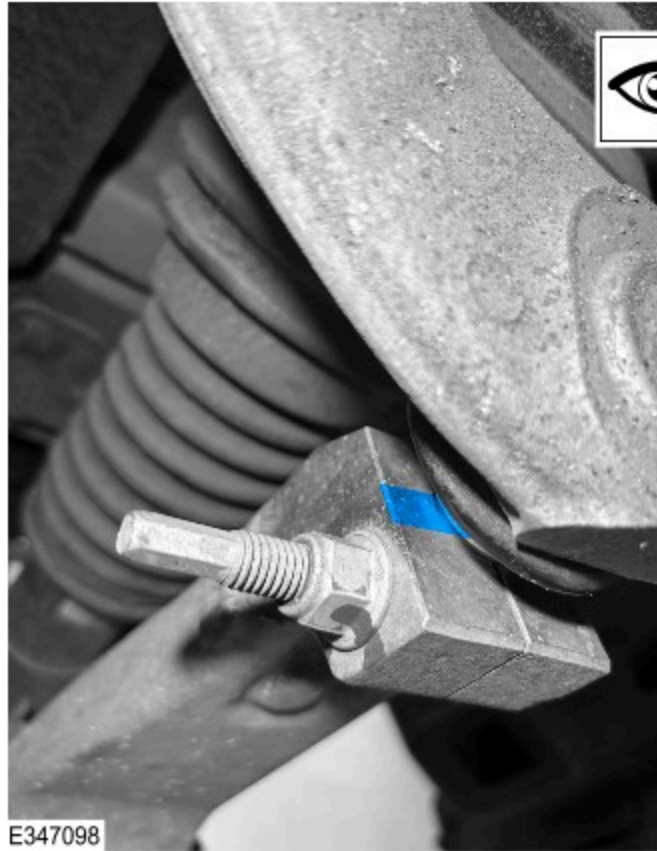
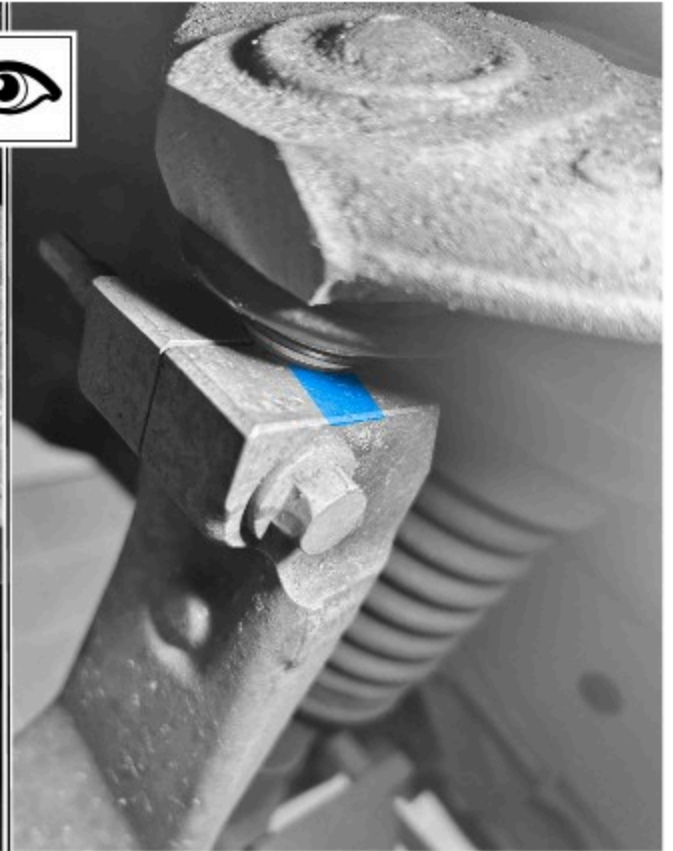
3. Carefully inspect the front knuckle for visible cracks. Examples of cracks are shown in the next step.

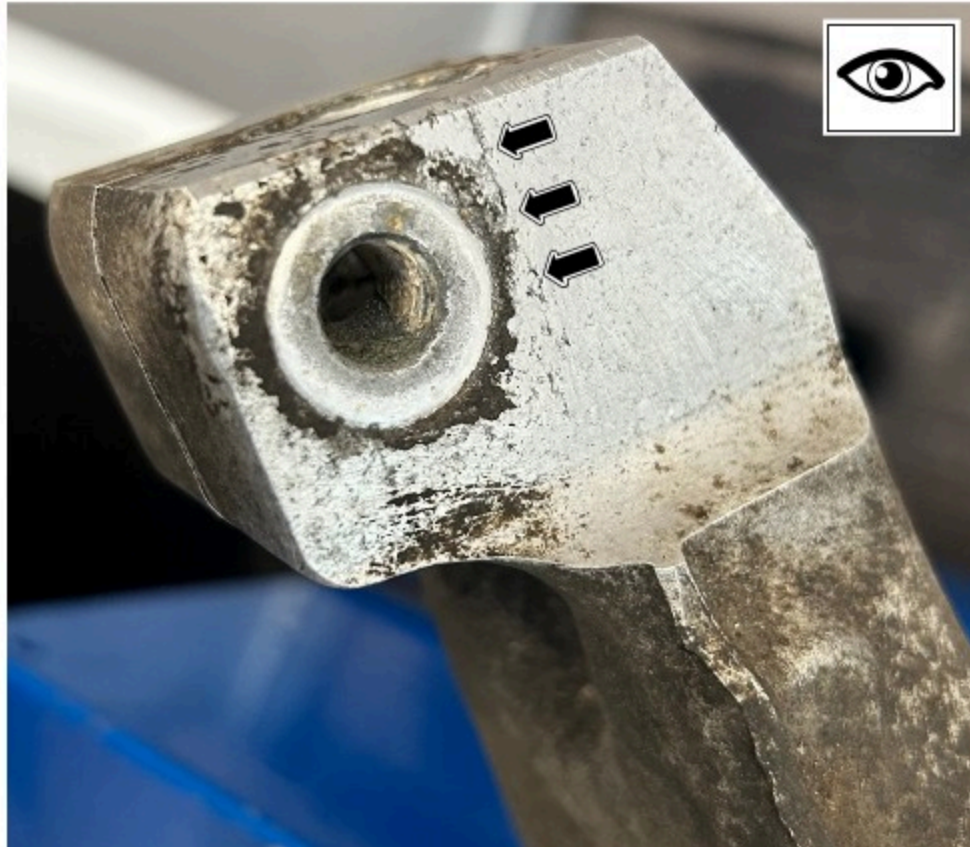
- The example illustrations are applicable to both left and right front knuckles.
- Use a suitable flashlight and / or a mirror to assist with the visual inspection.

Examples of front knuckle cracks are shown in the illustrations.

- If cracks **ARE** visible on the front knuckle, the front knuckle has **FAILED** service inspection 2. Replace the front knuckle that has **FAILED** service inspection 2 (see TOPIx Workshop Manual section 204-01: Front Suspension - Removal and Installation - Wheel Knuckle).
- If cracks **ARE NOT** visible on the front knuckle, the knuckle has **PASSED** service inspection 2. **Continue to the FRONT KNUCKLE BRACKET INSTALLATION PROCEDURE.**

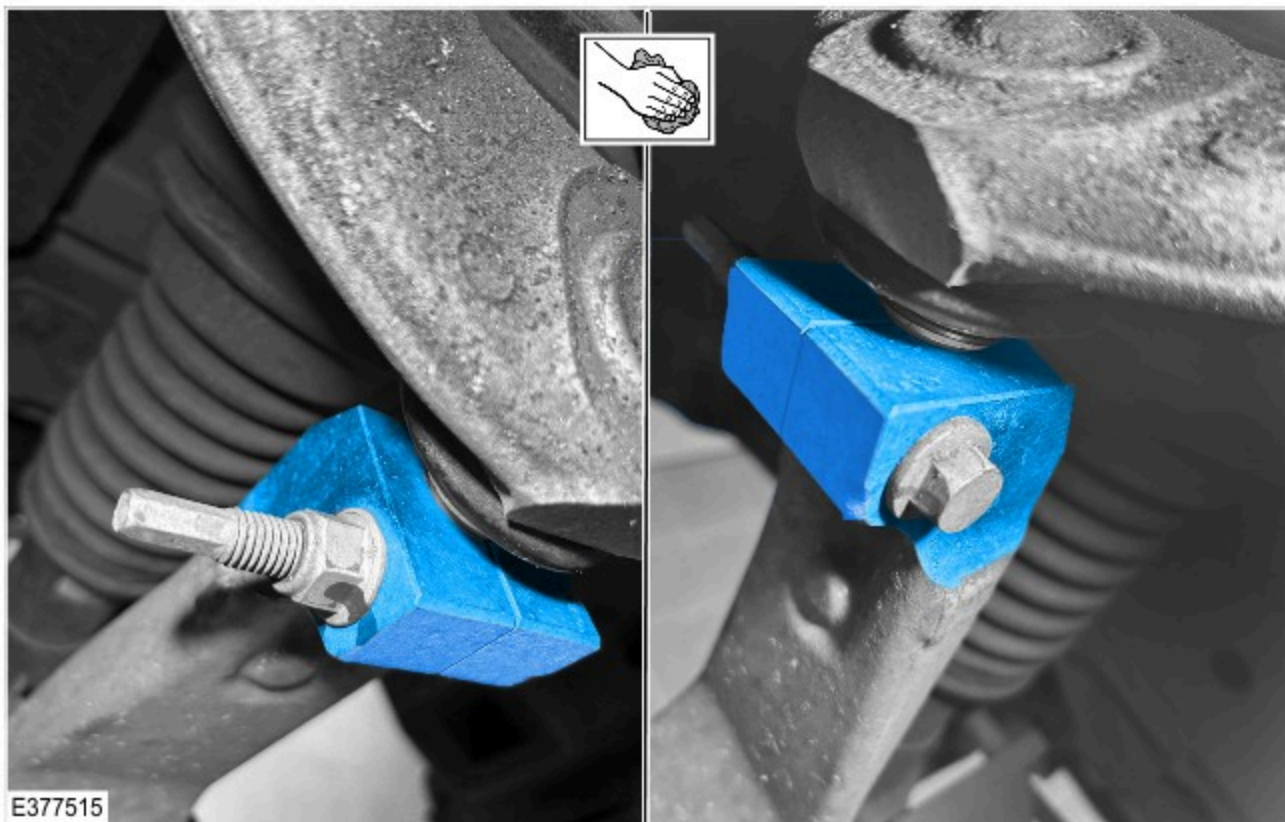
1. The area of the front knuckle shown highlighted in the illustrations must be clean and free from contamination.

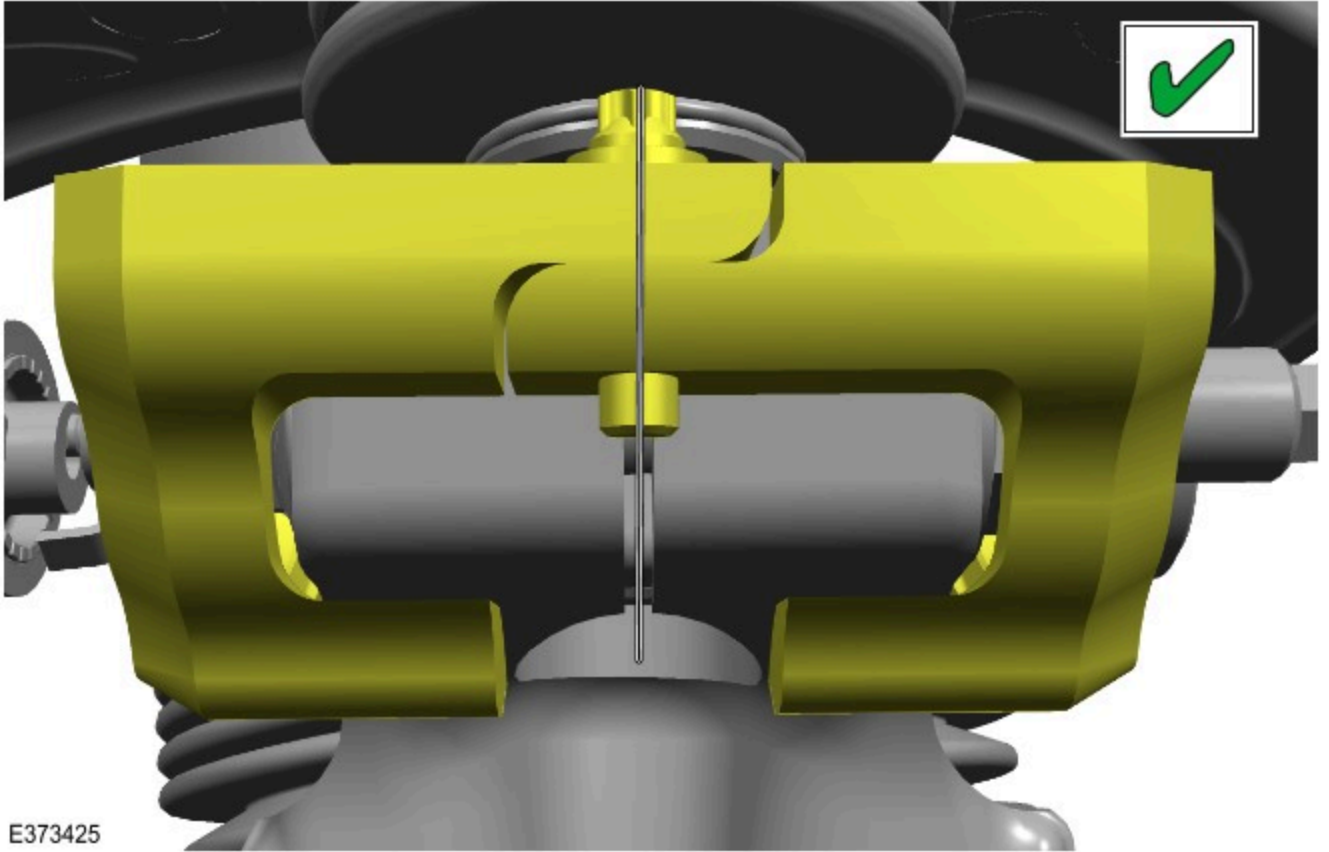
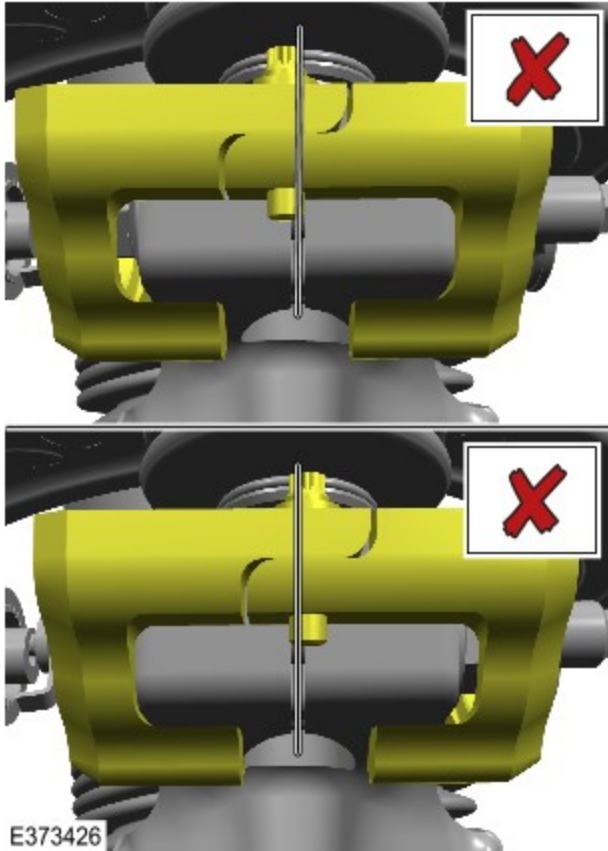
4. Align the front knuckle bracket to be central to the front knuckle.

- The front knuckle bracket must be centrally aligned to the front wheel knuckle as shown in the illustration with the **GREEN** ✓.
- The front knuckle bracket must not be aligned to the front wheel knuckle as shown in the illustrations with the **RED X**.
