SAFETY RELATED RECALL

Global Recall Action
Number: D041

Subject: Range Rover (L405) Front Suspension Knuckle Crack	Publication No.: D041
	Model: Range Rover (LG)
	Model Year: 2016
	Date of Issue: 07 November 2025

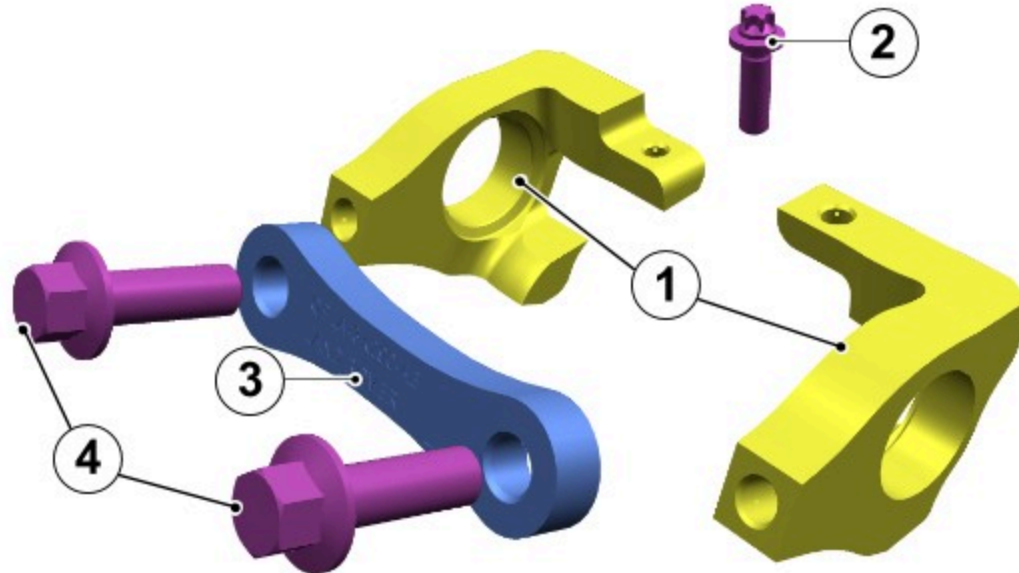
E377524

2. The illustration shows the front knuckle bracket components.

1. Front knuckle bracket side hooks.
2. Front knuckle bracket side hooks bolt.
3. Front knuckle bracket rear plate.
4. Front knuckle bracket rear plate bolts.

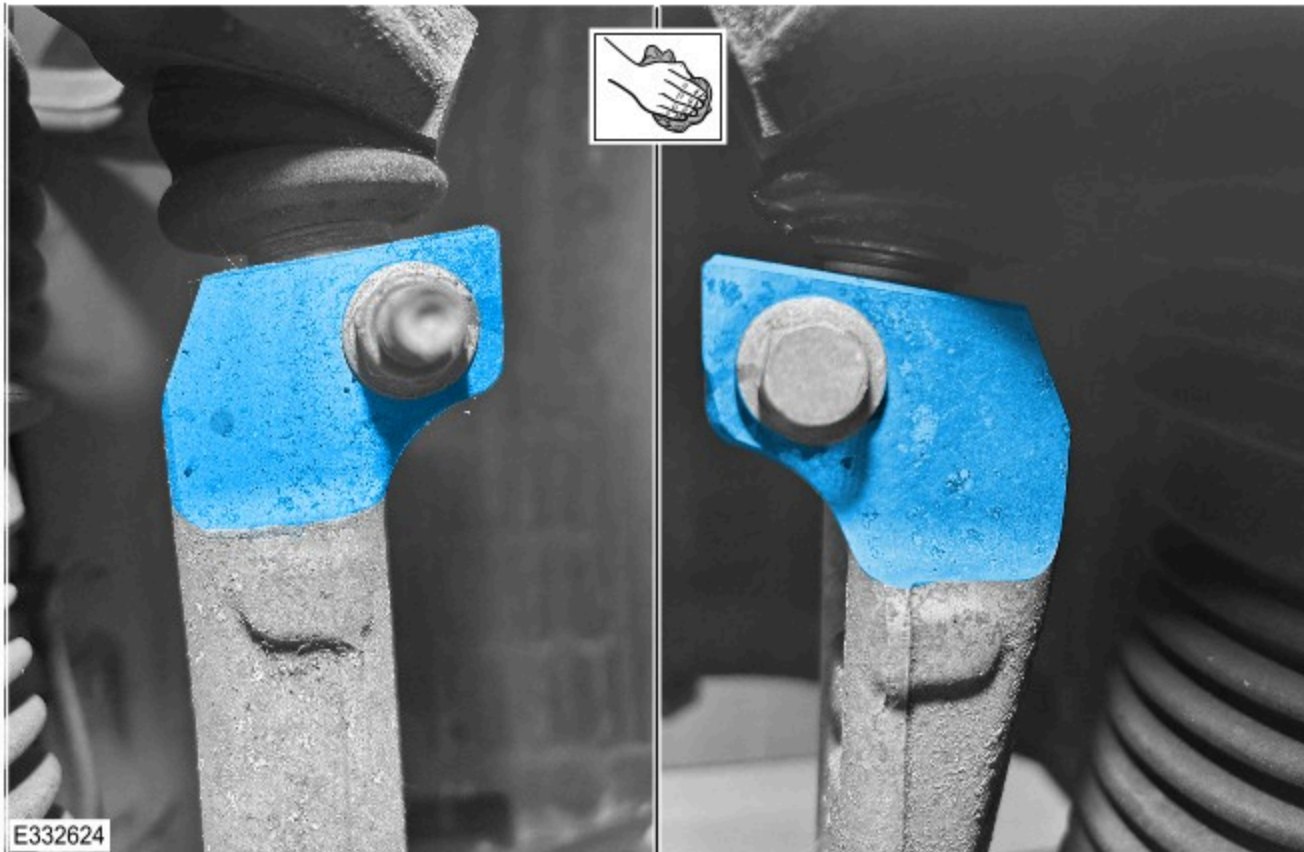
2. Use a non abrasive cloth and suitable cleaning fluid to clean the area of the front knuckle shown highlighted in the illustrations.

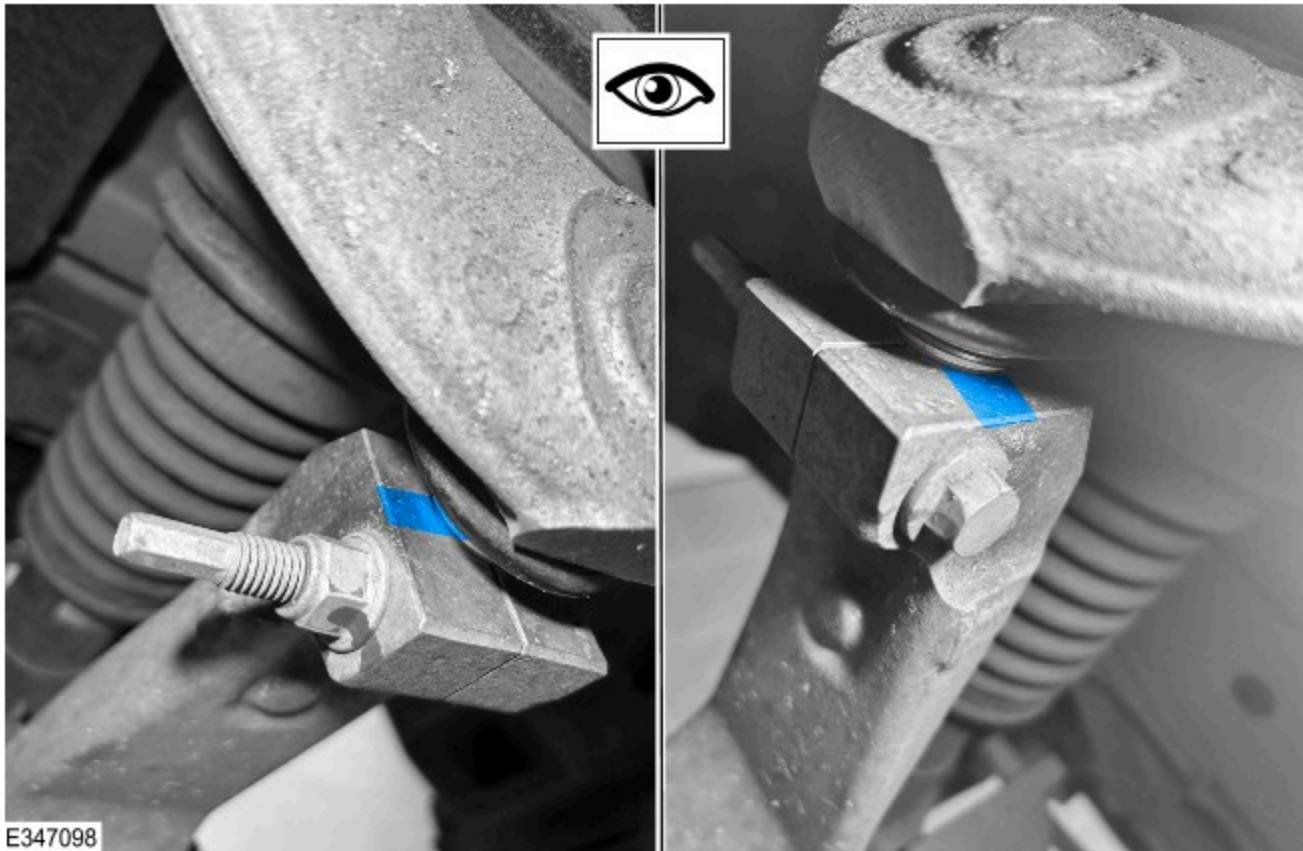
3. Carefully inspect the front knuckle for visible cracks. Examples of cracks are shown in the next step.

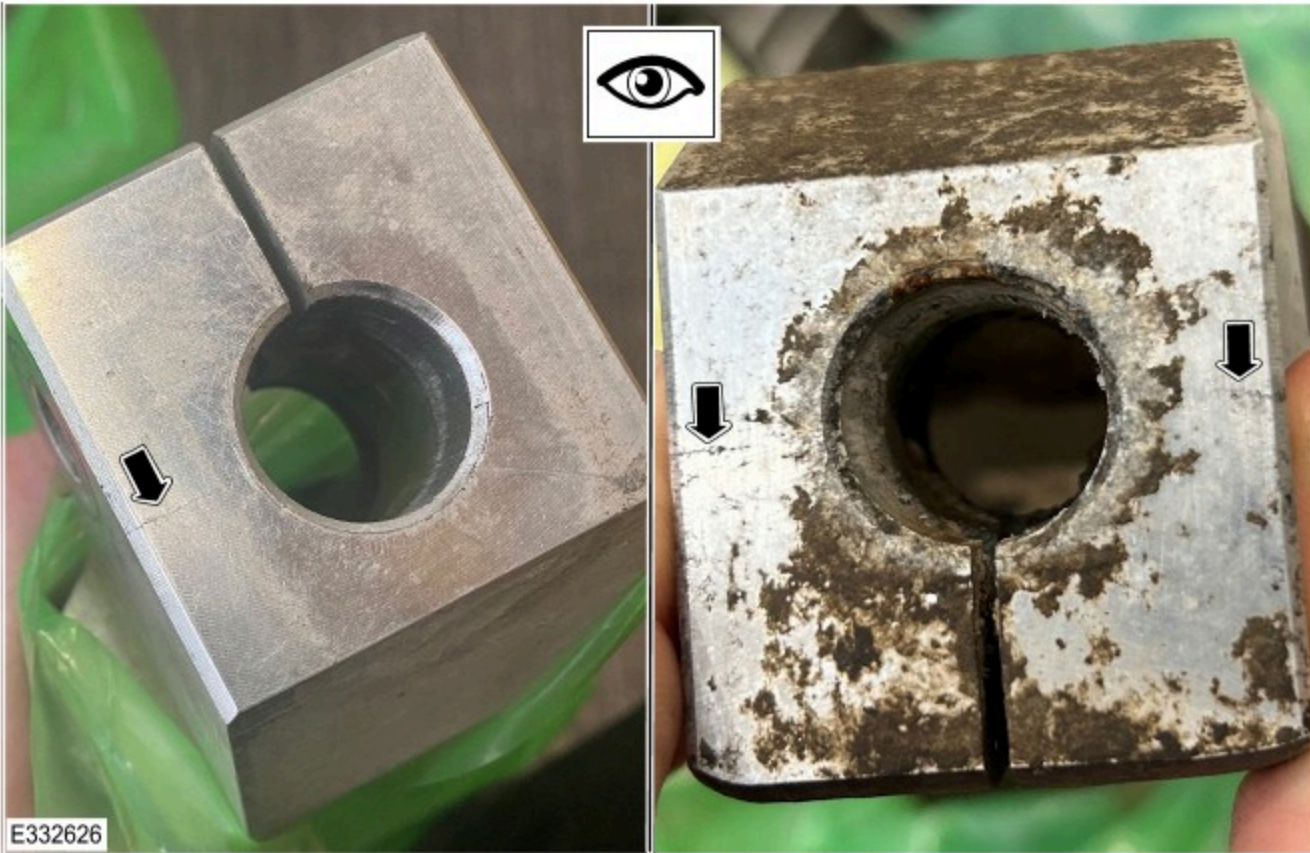
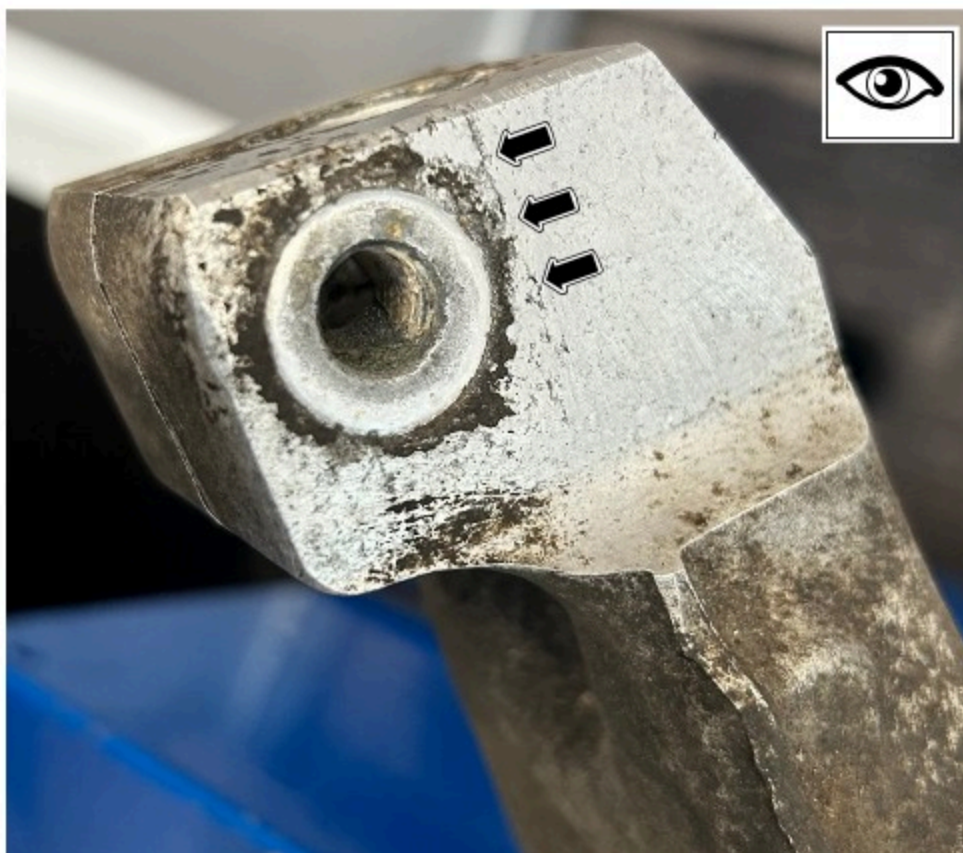
E332627

- The example illustrations are applicable to both left and right front knuckles.
- Use a suitable flashlight and / or a mirror to assist with the visual inspection.

Examples of front knuckle cracks are shown in the illustrations.

- If cracks **ARE** visible on the front knuckle, the front knuckle has **FAILED** service inspection 2. Replace the front knuckle that has **FAILED** service inspection 2 (see TOPIx Workshop Manual section 204-01: Front Suspension - Removal and Installation - Wheel Knuckle).
- If cracks **ARE NOT** visible on the front knuckle, the knuckle has **PASSED** service inspection 2. **Continue to the FRONT KNUCKLE BRACKET INSTALLATION PROCEDURE.**

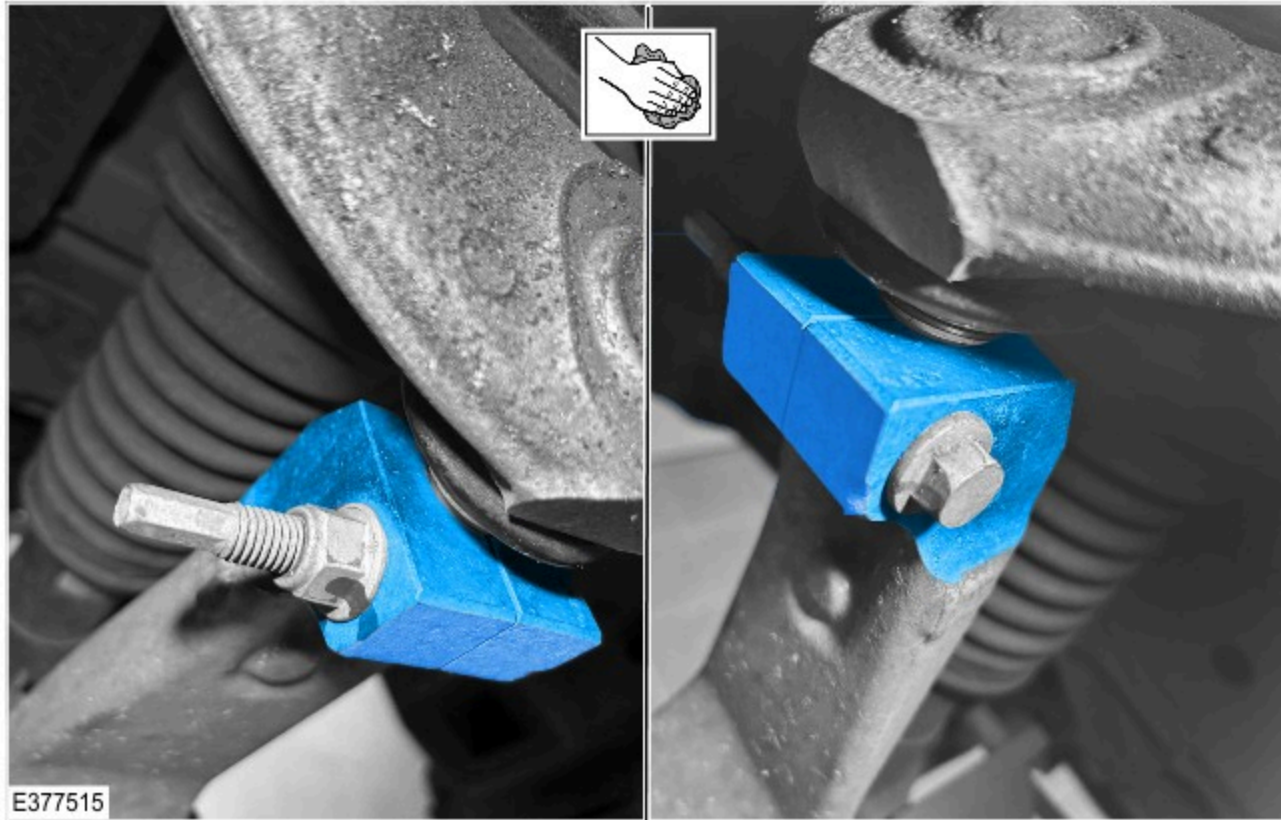
1. The area of the front knuckle shown highlighted in the illustrations must be clean and free from contamination.

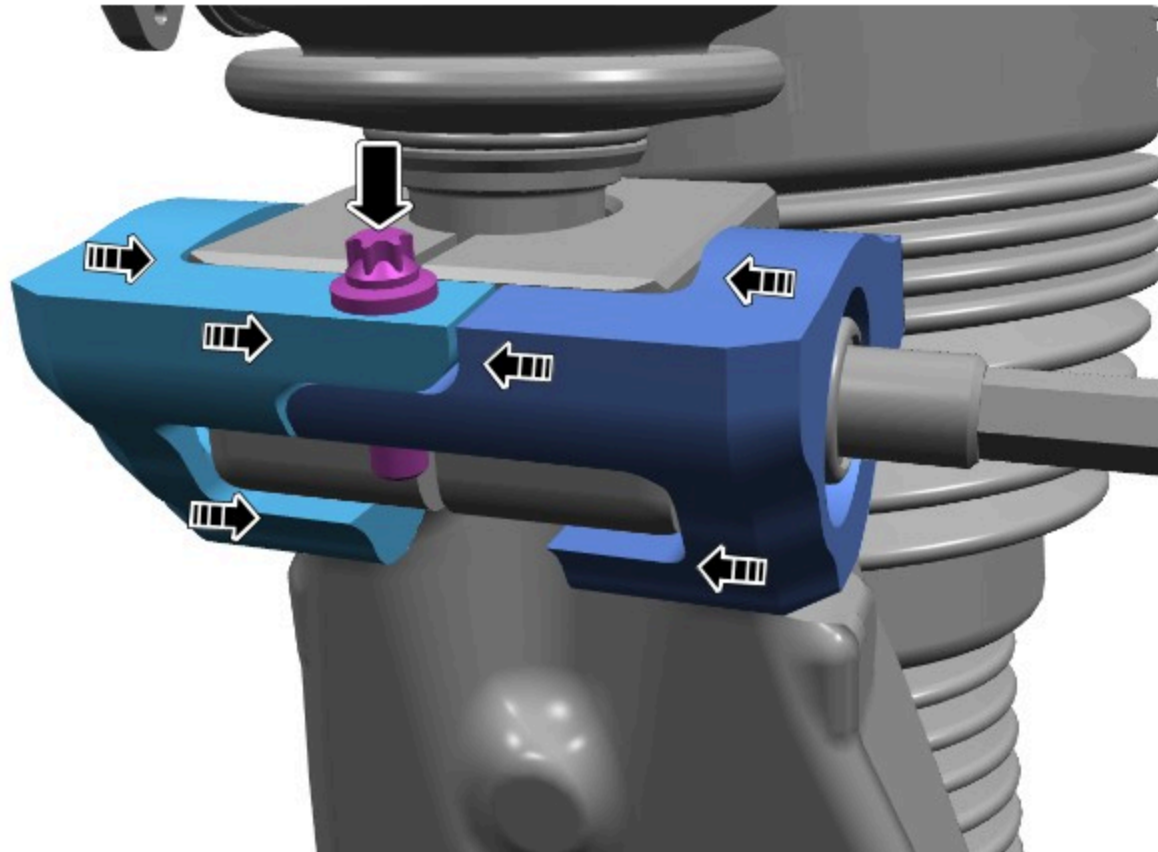
E373427

2. Install the 2 front knuckle bracket side hooks.

- Apply Loctite® 243 to the bolt.
- Install the bolt, finger tight only at this stage.

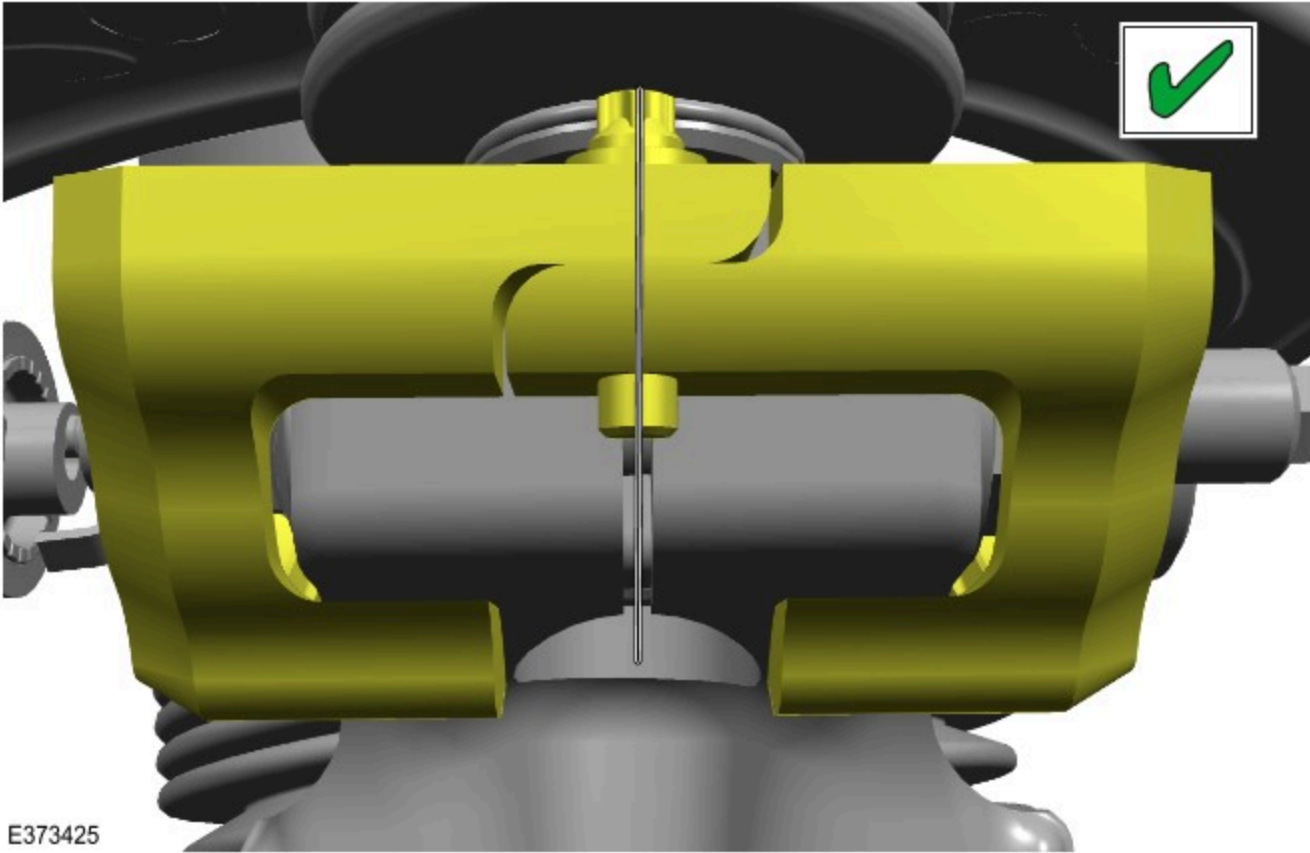
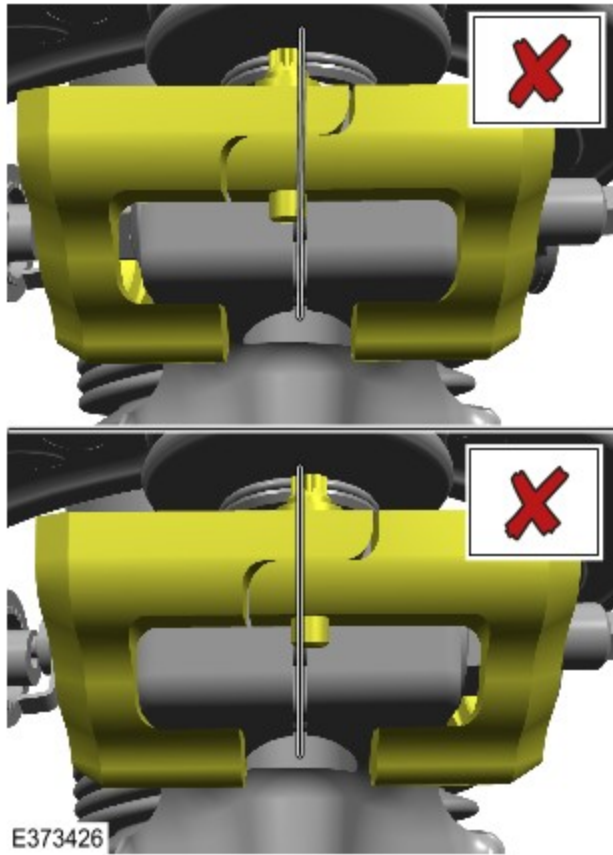
E373425

4. Align the front knuckle bracket to be central to the front knuckle.

- The front knuckle bracket must be centrally aligned to the front wheel knuckle as shown in the illustration with the **GREEN ✓**.
- The front knuckle bracket must not be aligned to the front wheel knuckle as shown in the illustrations with the **RED X**.

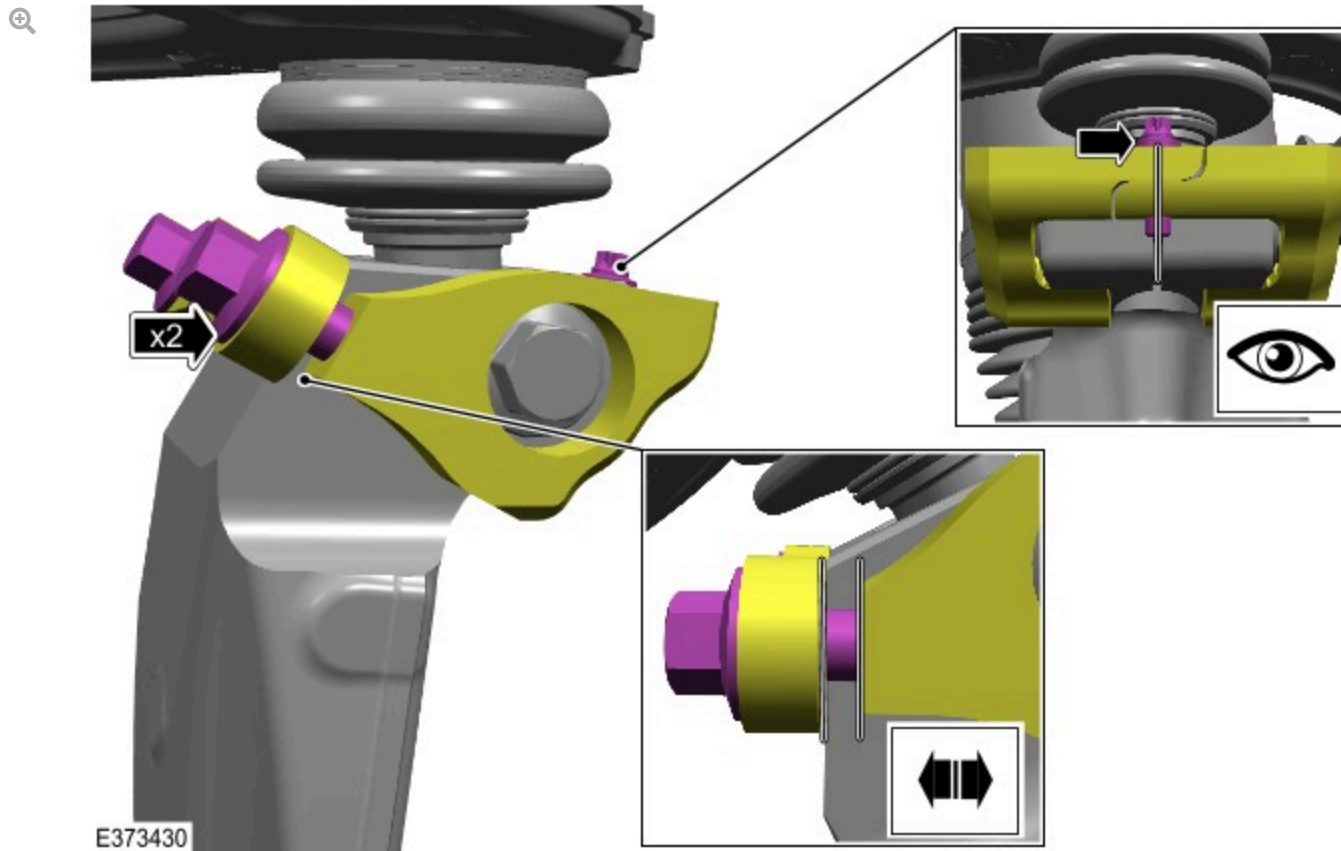
- There must be a gap between the front knuckle bracket rear plate and the 2 front knuckle bracket side hooks.
- The gap between the front knuckle bracket rear plate and the 2 front knuckle bracket side hooks must be maintained both sides of the front knuckle bracket rear plate.
- The front knuckle bracket must remain central to the front knuckle during tightening, as shown in the illustration.

Fully tighten the 3 front knuckle bracket bolts.

1. M5 Bolt: **6 Nm**
2. M8 Bolts:
 - Stage 1: **10 Nm**
 - Stage 2: **24 Nm**
