SAFETY RELATED RECALL

Global Recall Action
Number: N759v8

Subject: Range Rover (L405) Front Suspension Knuckle Crack	Publication No.: N759v8
	Model: Range Rover (LG)
	Model Year: 2014 - 2016
	Date of Issue: 20 February 2026

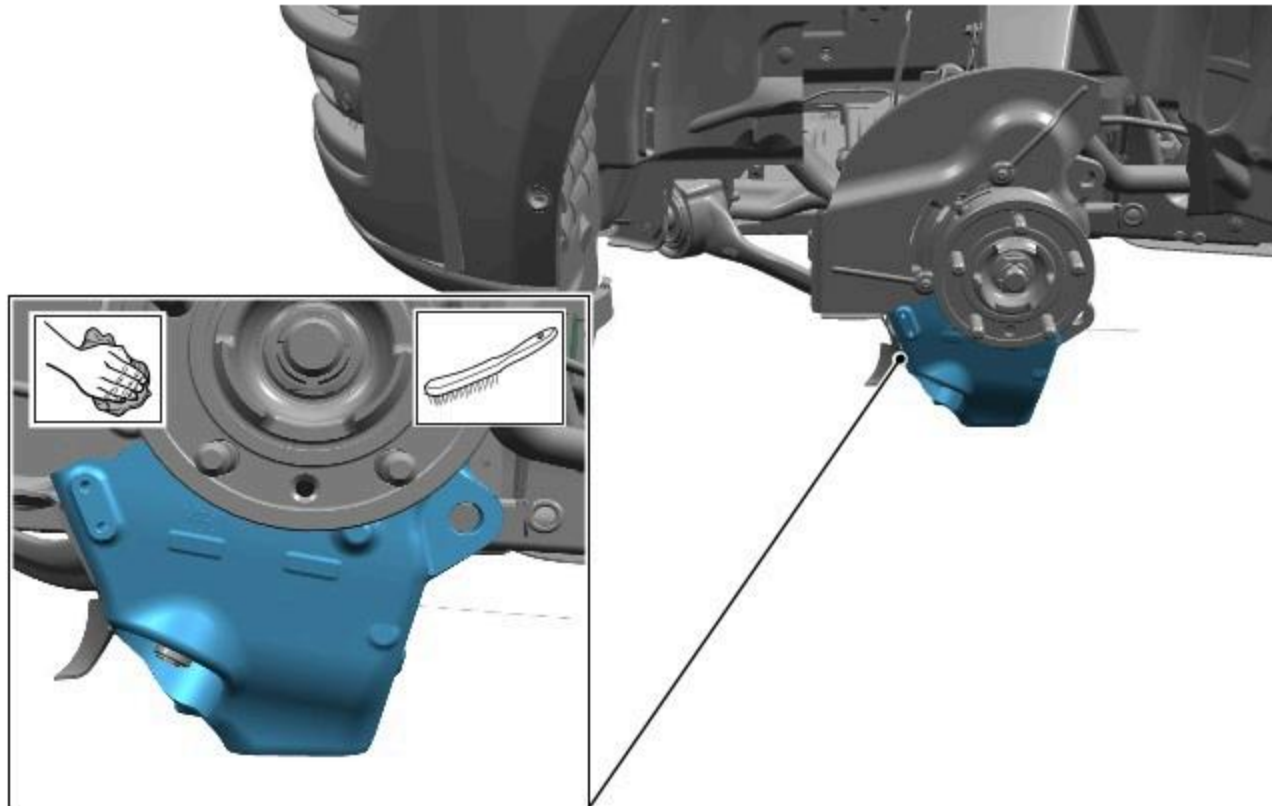
E405754

3. Using a suitable method, clean the area highlighted in the illustration.

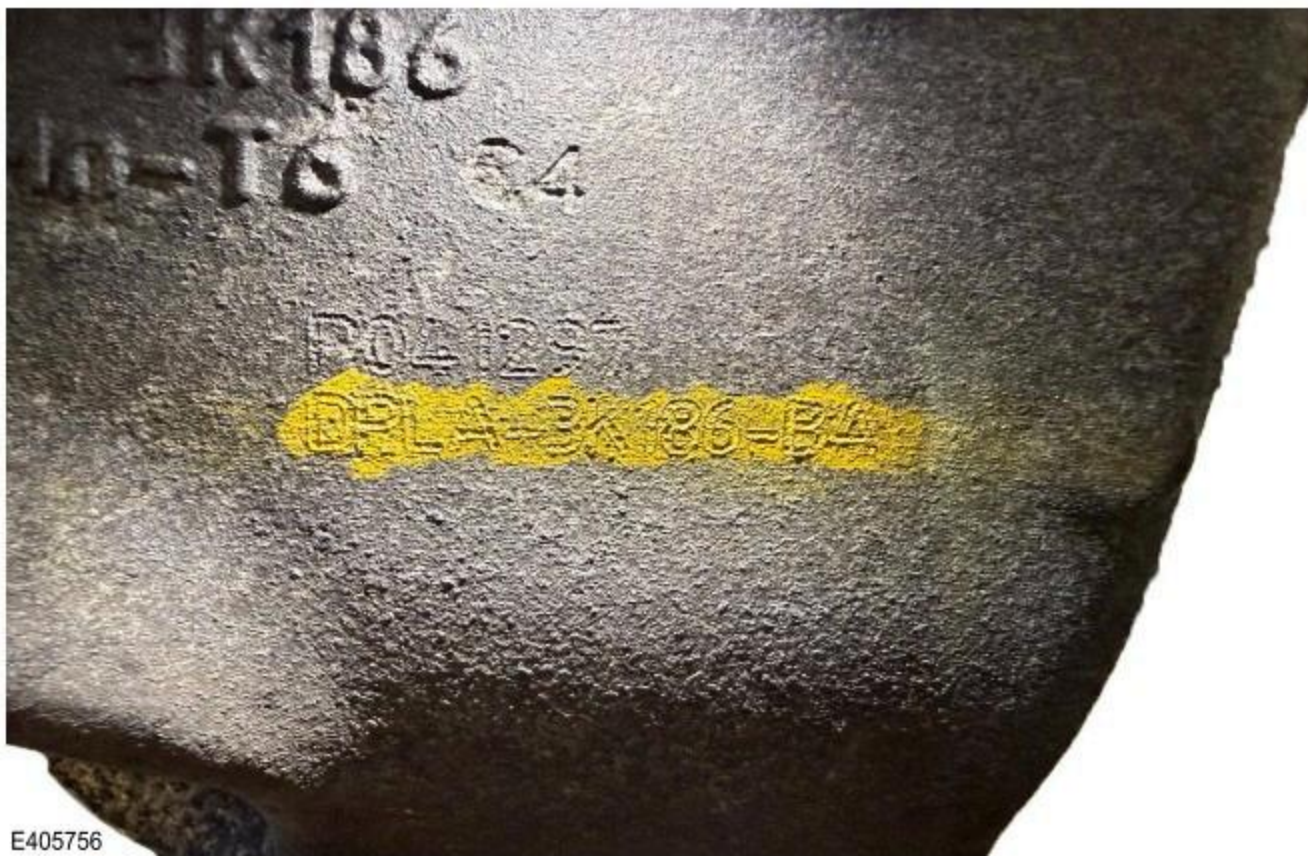
E405756

Inspect the front wheel knuckle part number.

- If the front wheel knuckle part number is any of the following part numbers, the front wheel knuckle **has FAILED** Service Inspection 2, **continue to step 7**.
 - **CPLA-3K185-BA, CPLA-3K186-BA, DPLA-3K185-BA or DPLA-3K186-BA.**
- If the front wheel knuckle part number is any of the following part numbers, the front wheel knuckle **has PASSED** Service Inspection 2, **continue to step 6**.
 - **CPLA-3K185-BB, CPLA-3K186-BB or a suffix that starts with an A (xxxx-xxxx-Ax).**

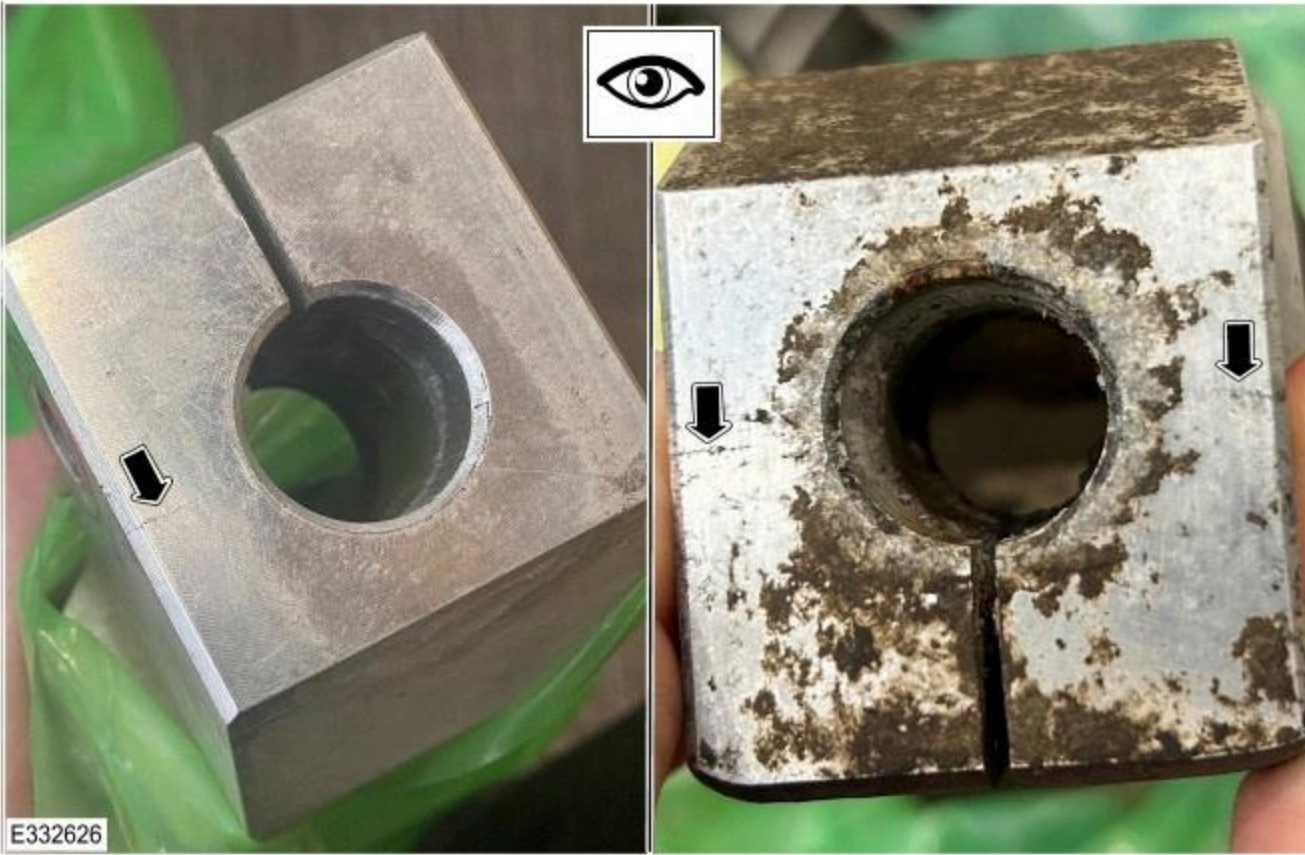
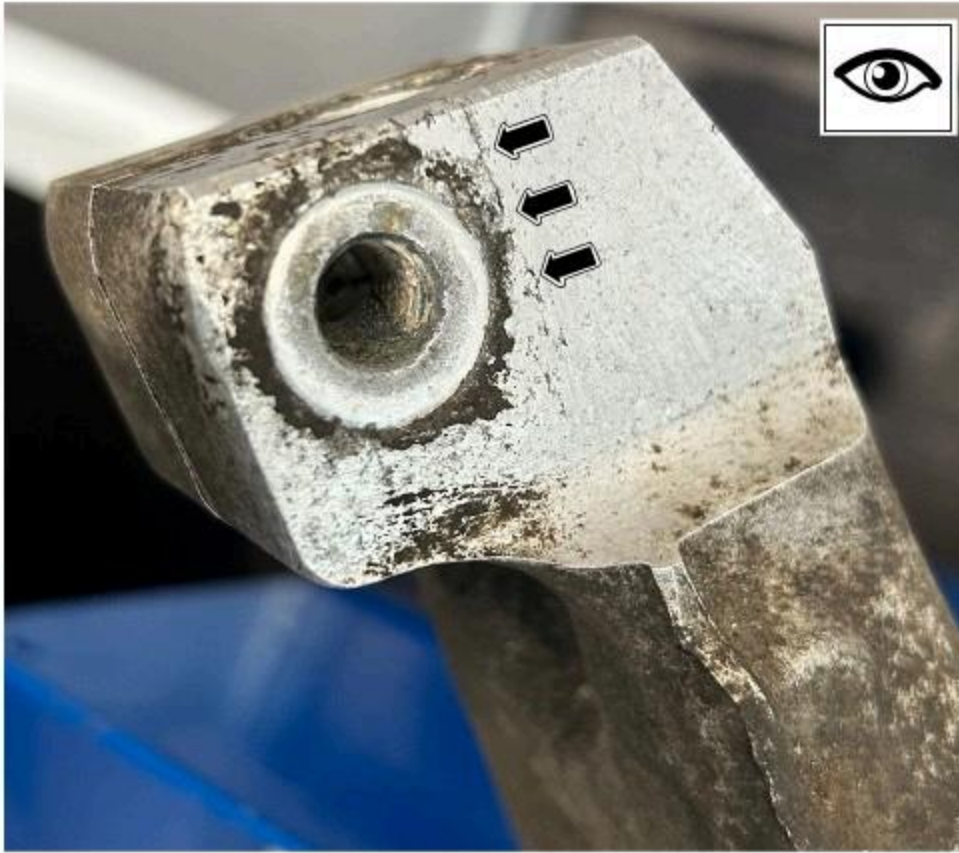
E332627

Examples of front wheel knuckle cracks are shown in the illustrations.

- If cracks **ARE** visible on the front wheel knuckle, the front wheel knuckle has **FAILED** service inspection 3. Replace the front wheel knuckle that has **FAILED** service inspection 3, continue to **FRONT WHEEL KNUCKLE REPLACEMENT**.
- If cracks **ARE NOT** visible on the front knuckle, the knuckle has **PASSED** service inspection 3. **Continue to the FRONT WHEEL KNUCKLE BRACKET INSTALLATION PROCEDURE.**

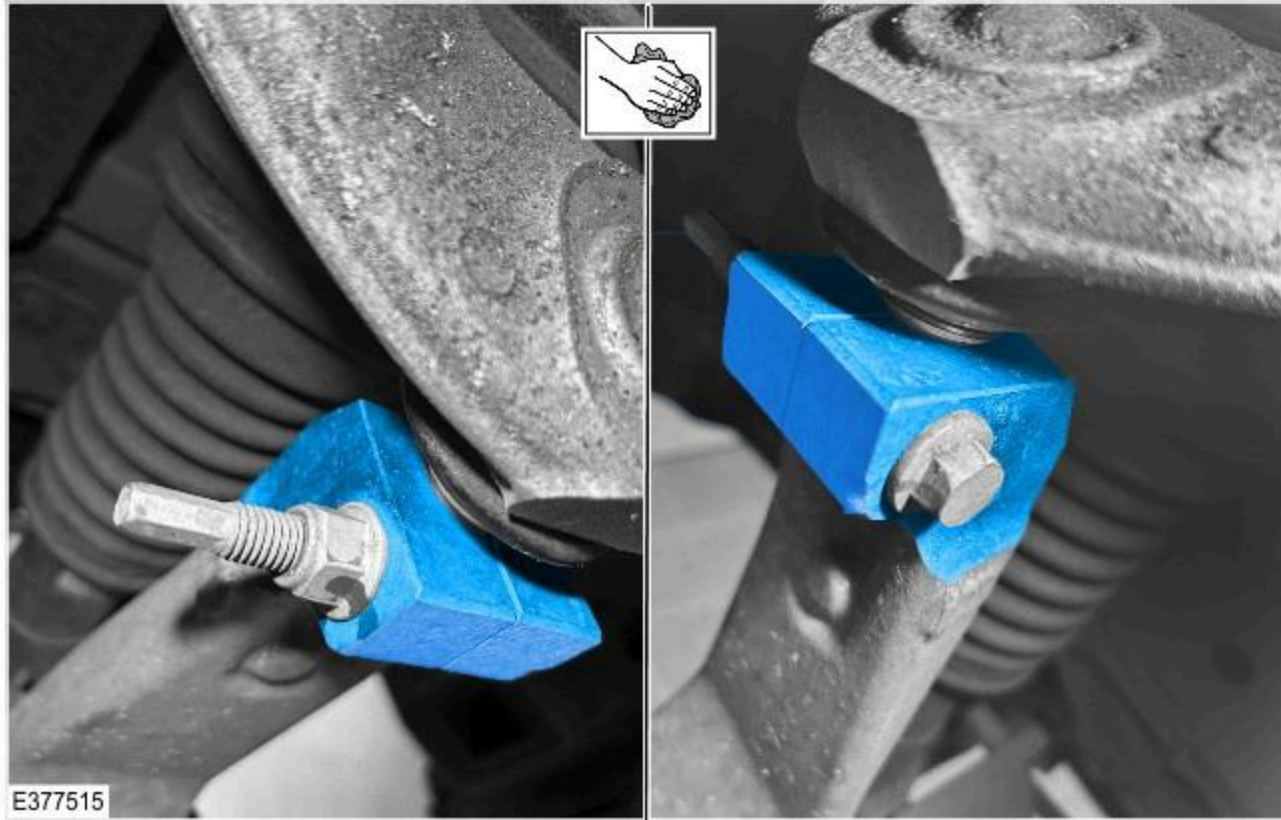
1. The area of the front knuckle shown highlighted in the illustrations must be clean and free from contamination.

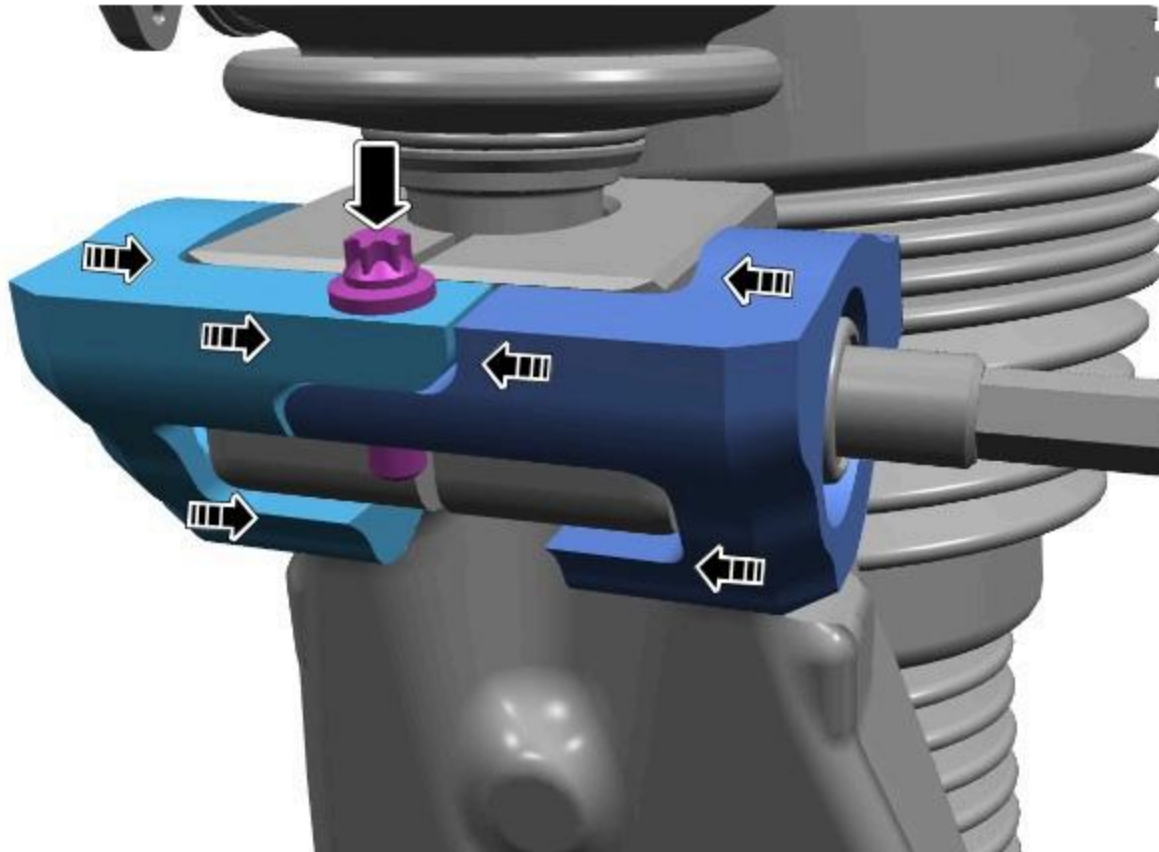
E373427

2. Install the 2 front knuckle bracket side hooks.

- Apply Loctite® 243 to the bolt.
- Install the bolt, finger tight only at this stage.

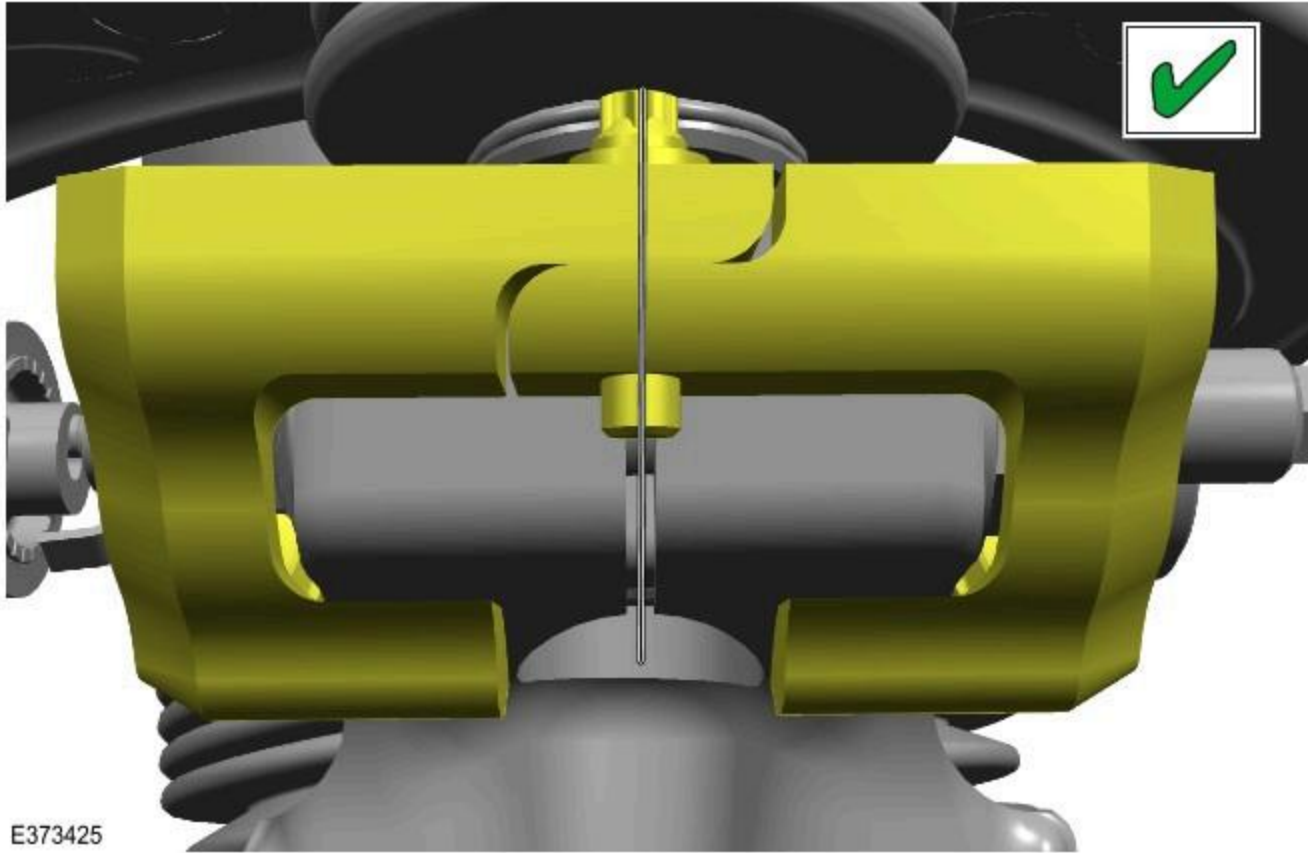
E373425

4. Align the front knuckle bracket to be central to the front knuckle.

- The front knuckle bracket must be centrally aligned to the front wheel knuckle as shown in the illustration with the **GREEN ✓**.
- The front knuckle bracket must not be aligned to the front wheel knuckle as shown in the illustrations with the **RED X**.
