# SAFETY RELATED RECALL

Global Recall Action  
Number: D027

<b>Subject:</b>  <b>Range Rover (L405) Front Suspension Knuckle Crack</b>	Publication No.: D027
	Model: Range Rover (LG)
	Model Year: 2015 - 2017
	Date of Issue: 17 April 2026

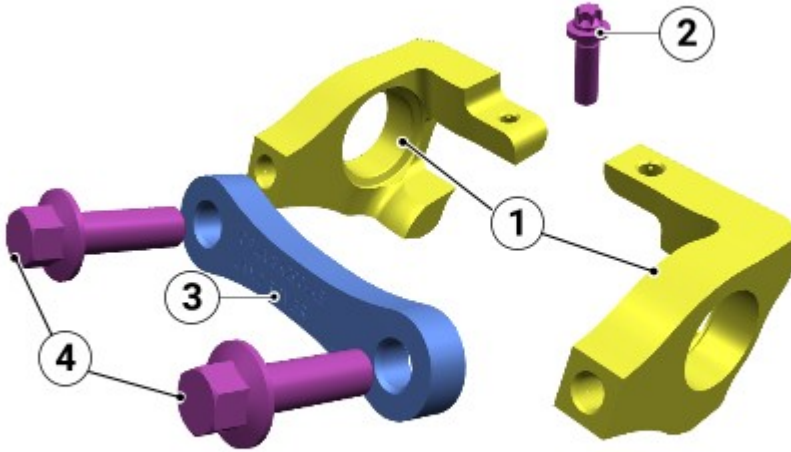
E377524

1. The illustration shows the front knuckle bracket components.

1. Front knuckle bracket side hooks.
2. Front knuckle bracket side hooks bolt.
3. Front knuckle bracket rear plate.
4. Front knuckle bracket rear plate bolts.

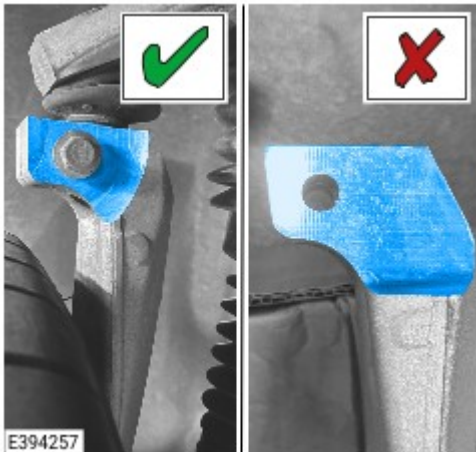
Inspect the front right wheel knuckle.

- If the front right wheel knuckle is the type shown in the illustration with the **GREEN ✓**, it has **PASSED** service inspection 1. No further action is required for the front right wheel knuckle, **continue to the next step**.
- If the front right wheel knuckle is the type shown in the illustration with the **RED X**, it has **FAILED** service inspection 1. **Continue to the next step**.

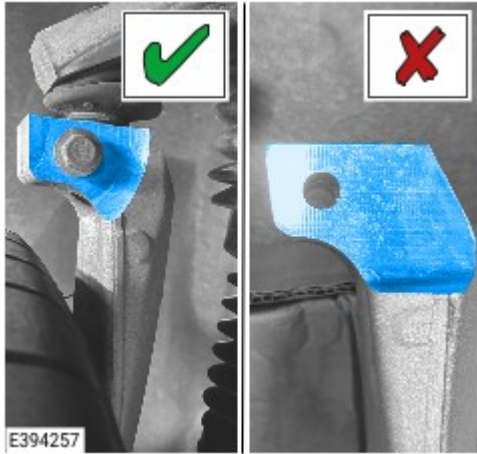
Inspect the front left wheel knuckle.

- If the front left wheel knuckle is the type shown in the illustration with the **GREEN ✓**, it has **PASSED** service inspection 1. No further action is required for the front left wheel knuckle, **continue to the next step**.
- If the front left wheel knuckle is the type shown in the illustration with the **RED X**, it has **FAILED** service inspection 1. **Continue to the next step**.

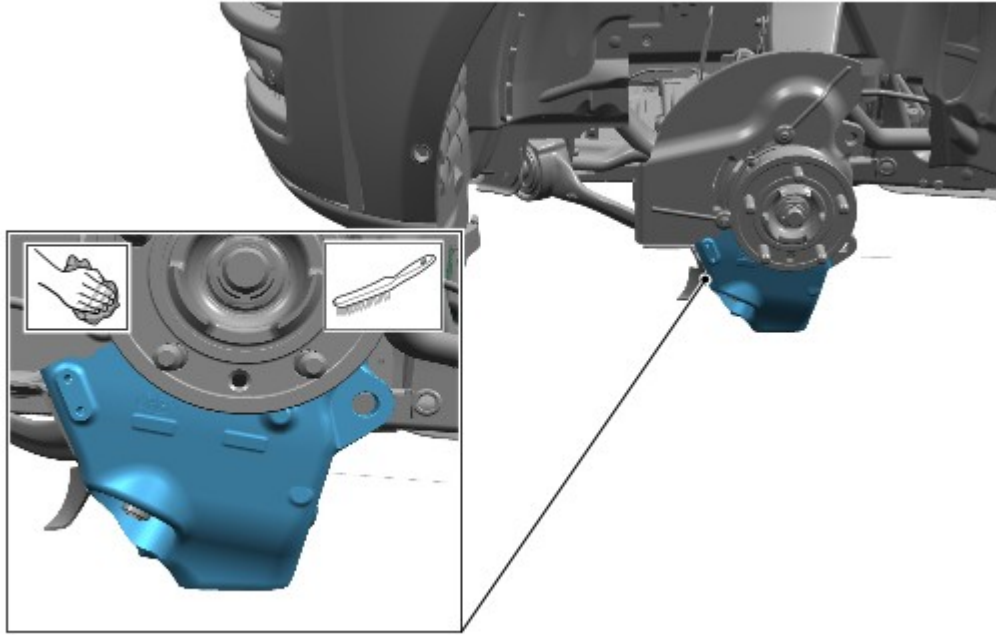
E405754

- Using a suitable method, clean the area highlighted in the illustration.

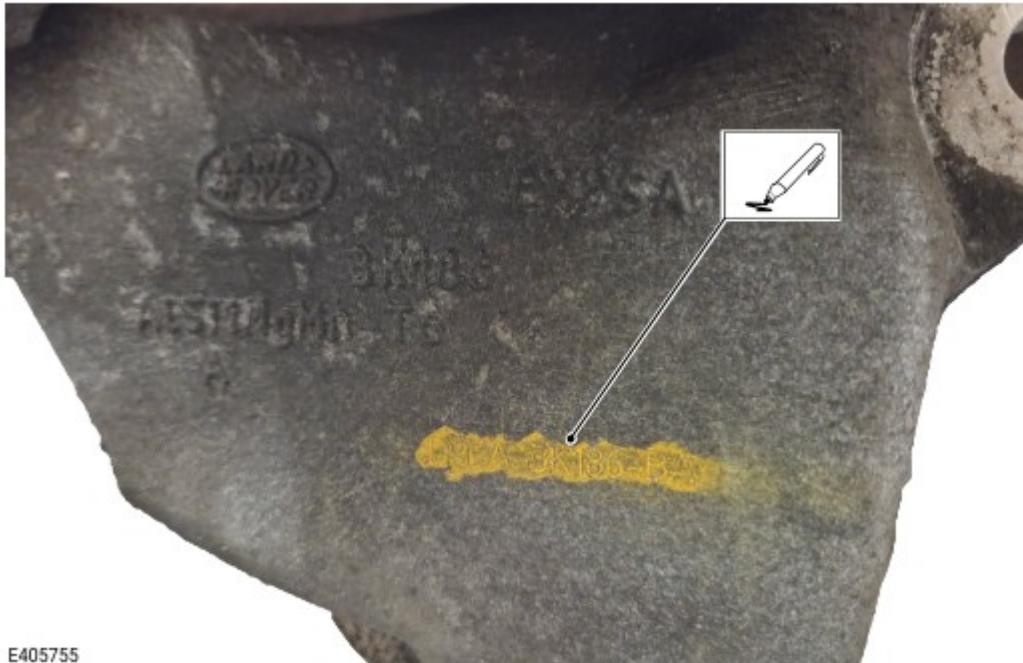
E405755

- Using a paint pen, apply paint to the front wheel knuckle part number. The part number will be in the location shown in the illustration, on every front wheel knuckle.

- Using a suitable cloth, remove excess paint from the part number.

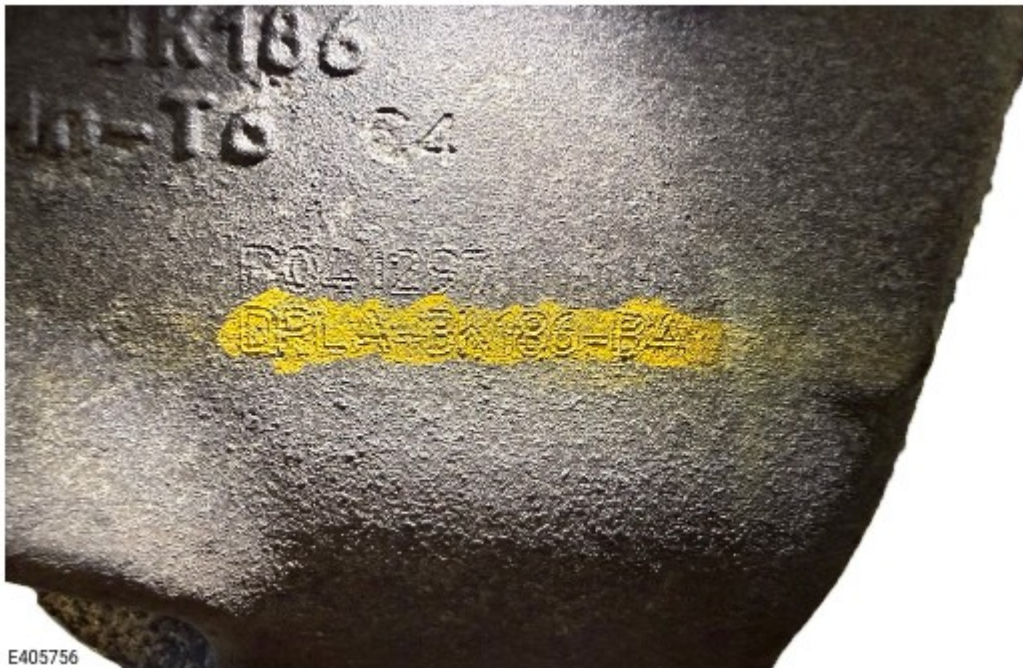
E405756

Shining a flashlight on the front wheel knuckle part number from above makes inspecting the front wheel knuckle part number easier.

Inspect the front wheel knuckle part number.

- If the front wheel knuckle part number is any of the following part numbers, the front wheel knuckle **has FAILED** Service Inspection 2, **continue to step 7**.
  - **CPLA-3K185-BA, CPLA-3K186-BA, DPLA-3K185-BA or DPLA-3K186-BA.**
- If the front wheel knuckle part number is any of the following part numbers, the front wheel knuckle **has PASSED** Service Inspection 2, **continue to step 6**.
  - **CPLA-3K185-BB, CPLA-3K186-BB or a suffix that starts with an A (xxxx-xxxx-Ax).**

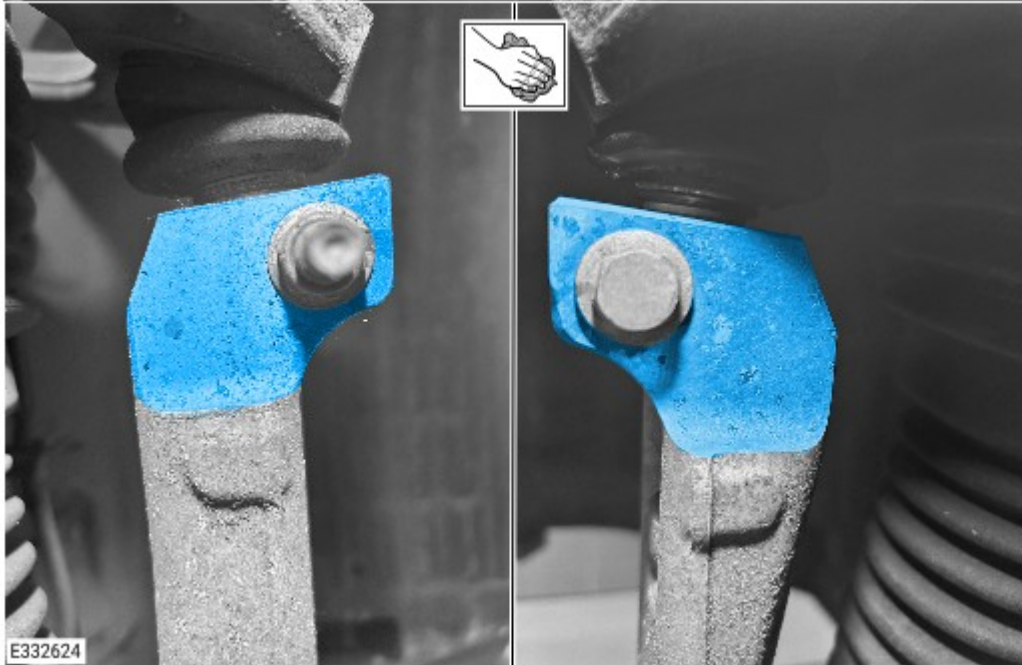
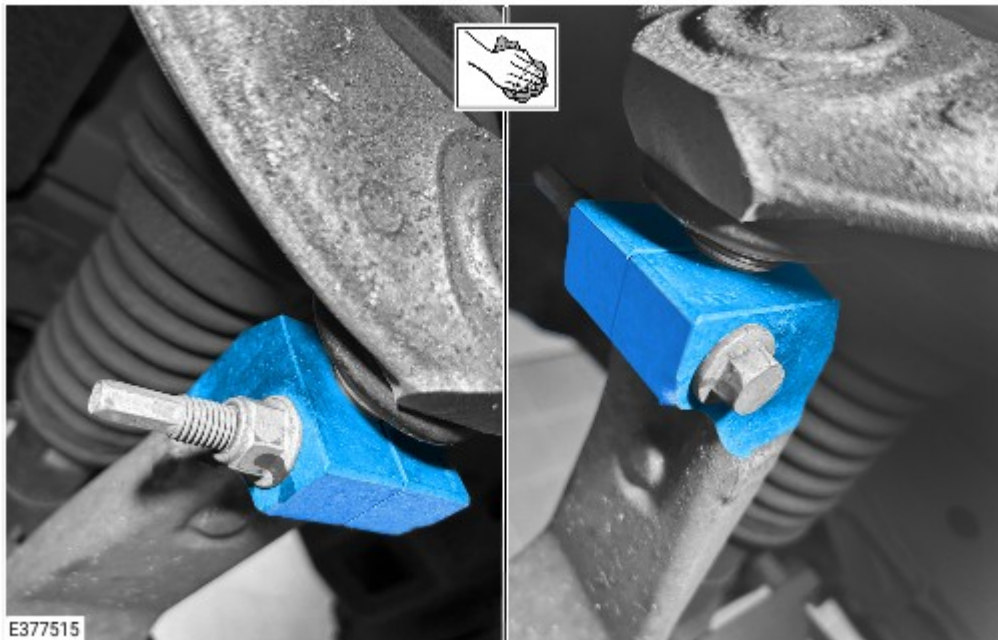
1. Use a non abrasive cloth and suitable cleaning fluid to clean the area of the front wheel knuckle shown highlighted in the illustrations.

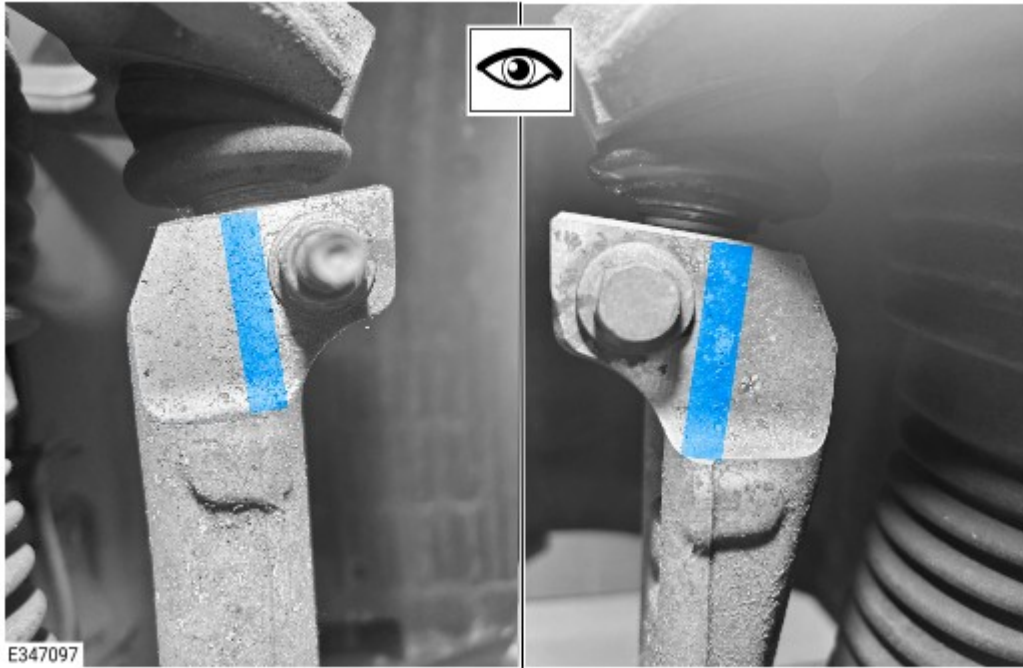
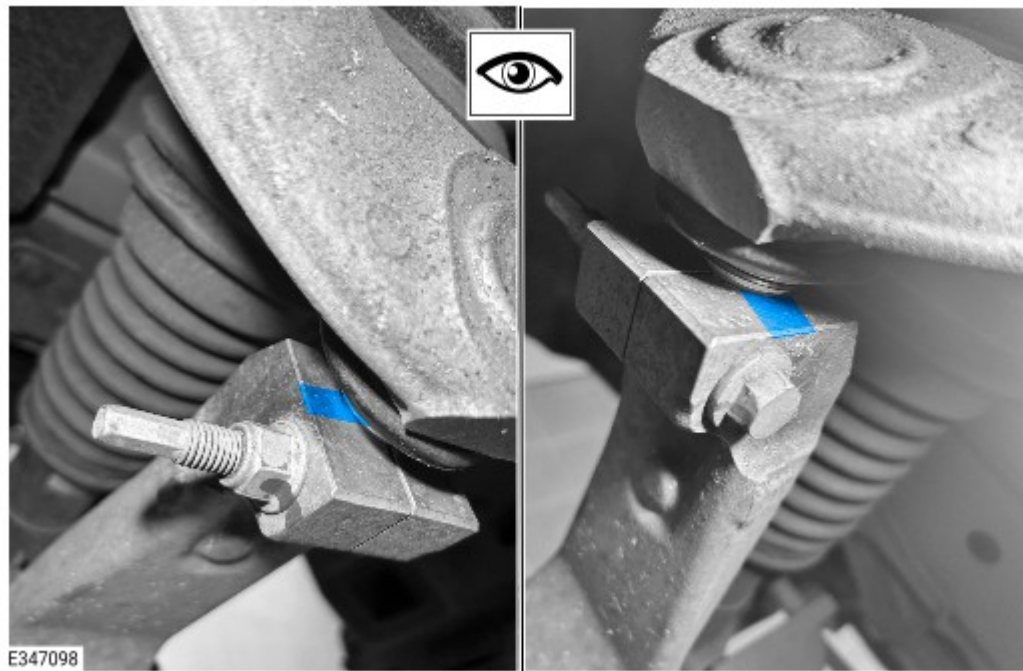
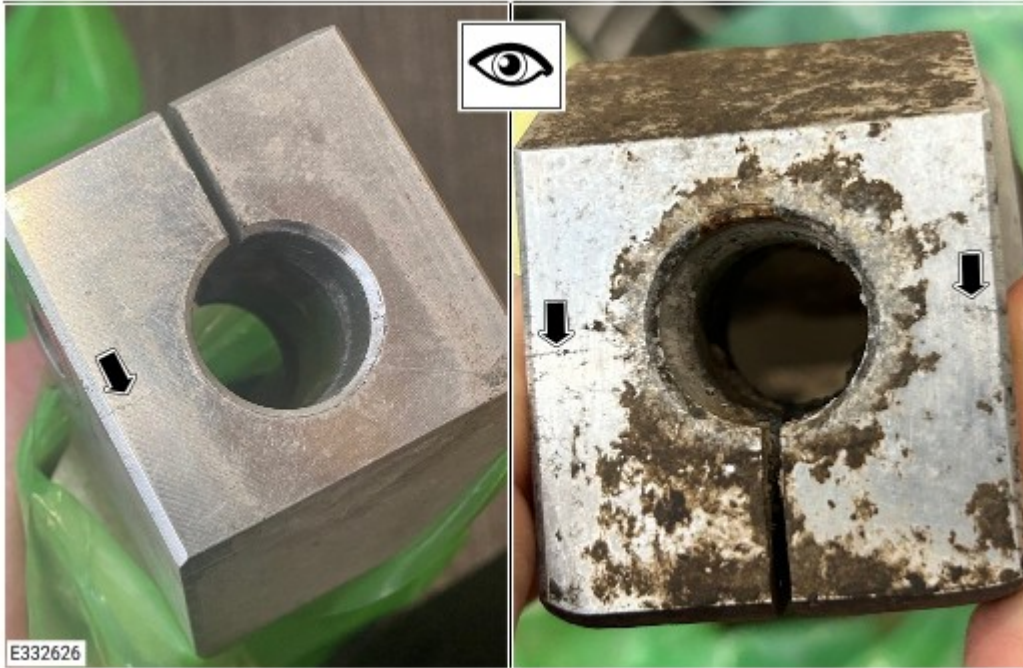
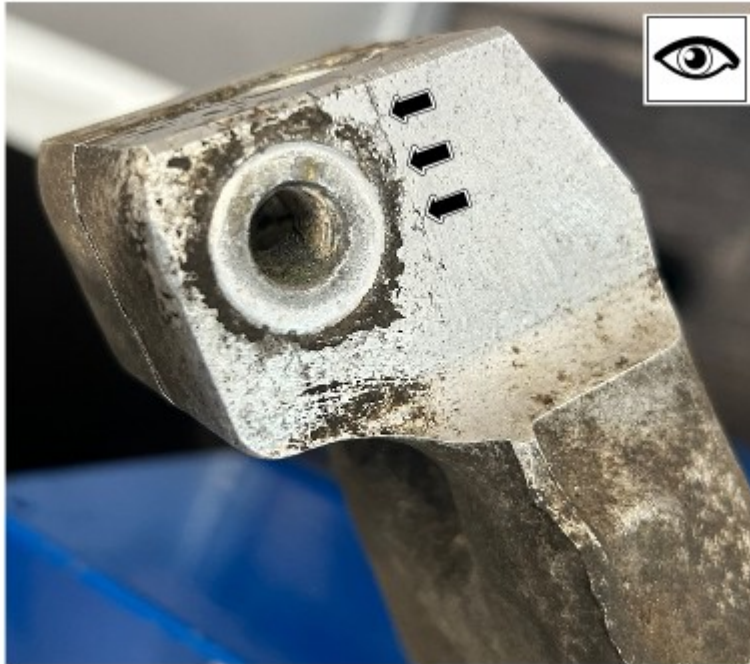
2. Carefully inspect the front wheel knuckle for visible cracks. Examples of cracks are shown in the next step.

- The example illustrations are applicable to both left and right front wheel knuckles.
- Use a suitable flashlight and / or a mirror to assist with the visual inspection.

Examples of front wheel knuckle cracks are shown in the illustrations.

- If cracks **ARE** visible on the front wheel knuckle, the front wheel knuckle has **FAILED** service inspection 3. Replace the front wheel knuckle that has **FAILED** service inspection 3, continue to **FRONT WHEEL KNUCKLE REPLACEMENT**.
- If cracks **ARE NOT** visible on the front knuckle, the knuckle has **PASSED** service inspection 3. **Continue to the FRONT WHEEL KNUCKLE BRACKET INSTALLATION PROCEDURE.**

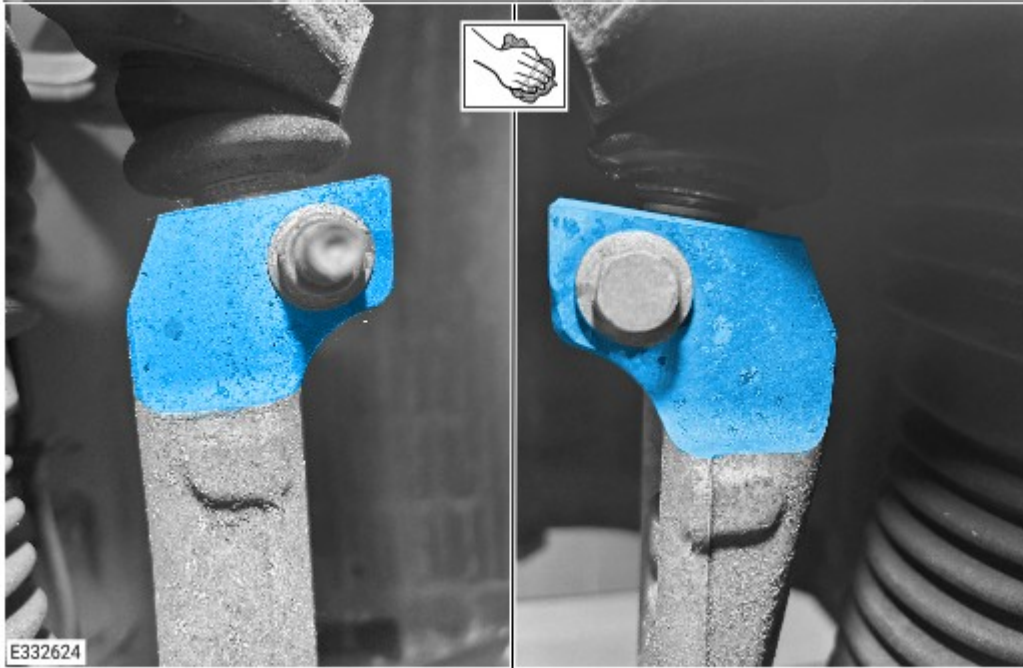
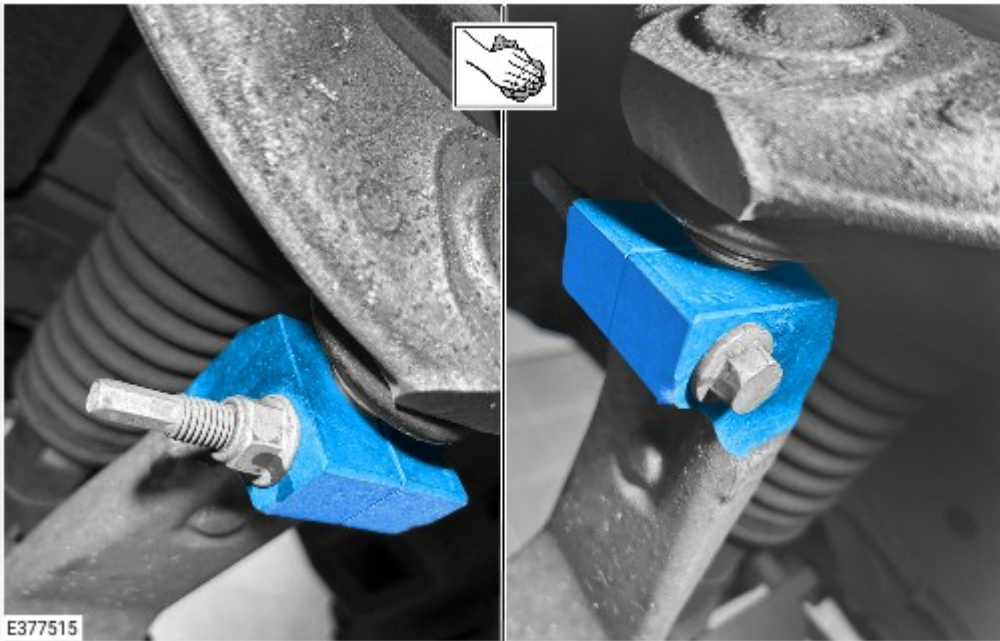
1. The area of the front knuckle shown highlighted in the illustrations must be clean and free from contamination.

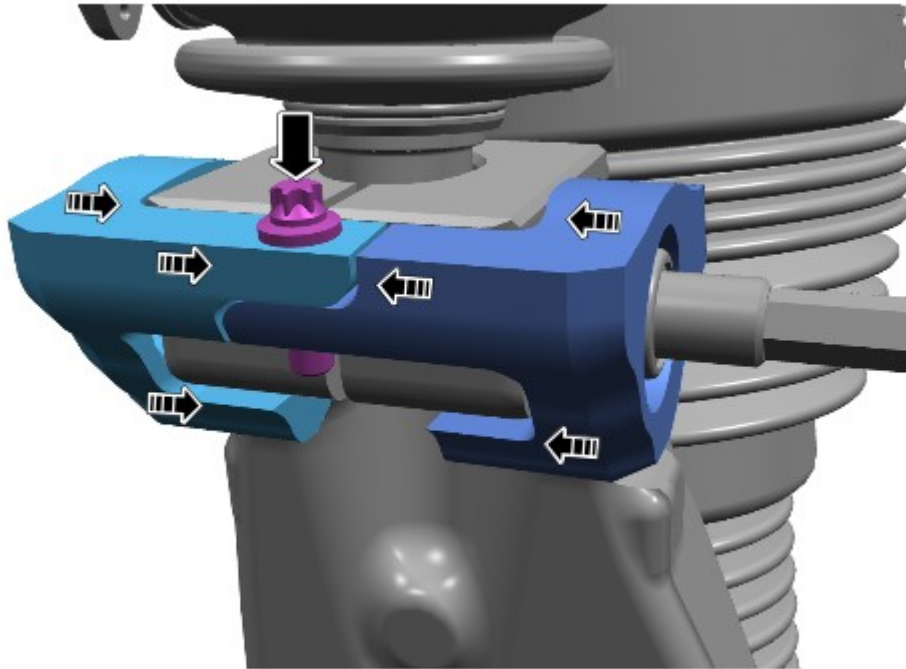
E373427

## 2. Install the 2 front knuckle bracket side hooks.

- Apply Loctite© 243 to the bolt.
- Install the bolt, finger tight only at this stage.

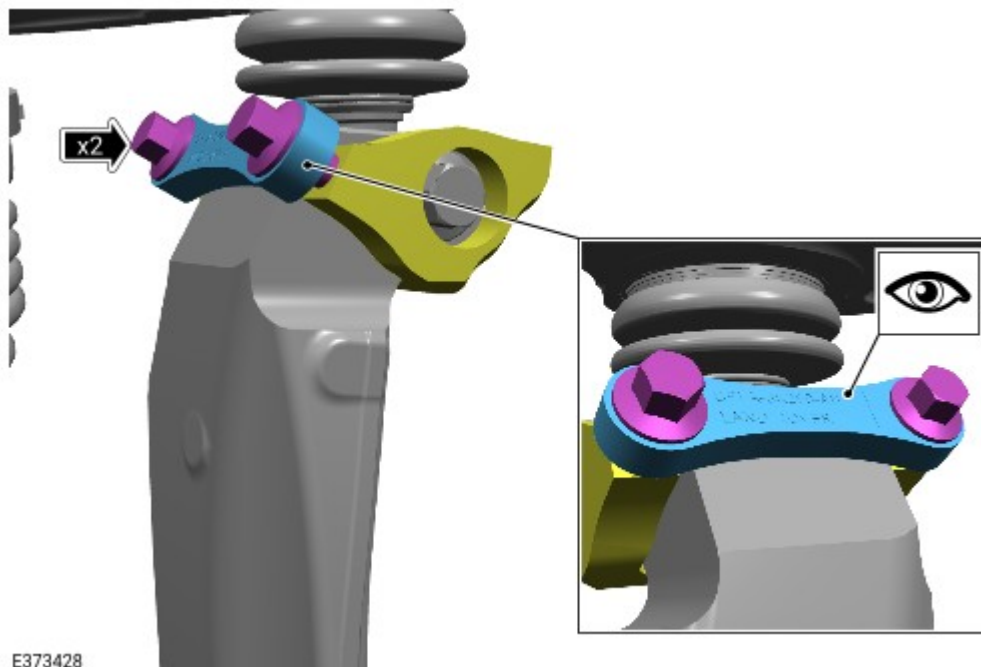
E373428

The front knuckle bracket rear plate must be installed with the part number facing outward from the front wheel knuckle.

Install the front knuckle bracket rear plate.

- Apply Loctite© 243 to the 2 bolts.
- Install the 2 bolts, finger tight only at this stage.

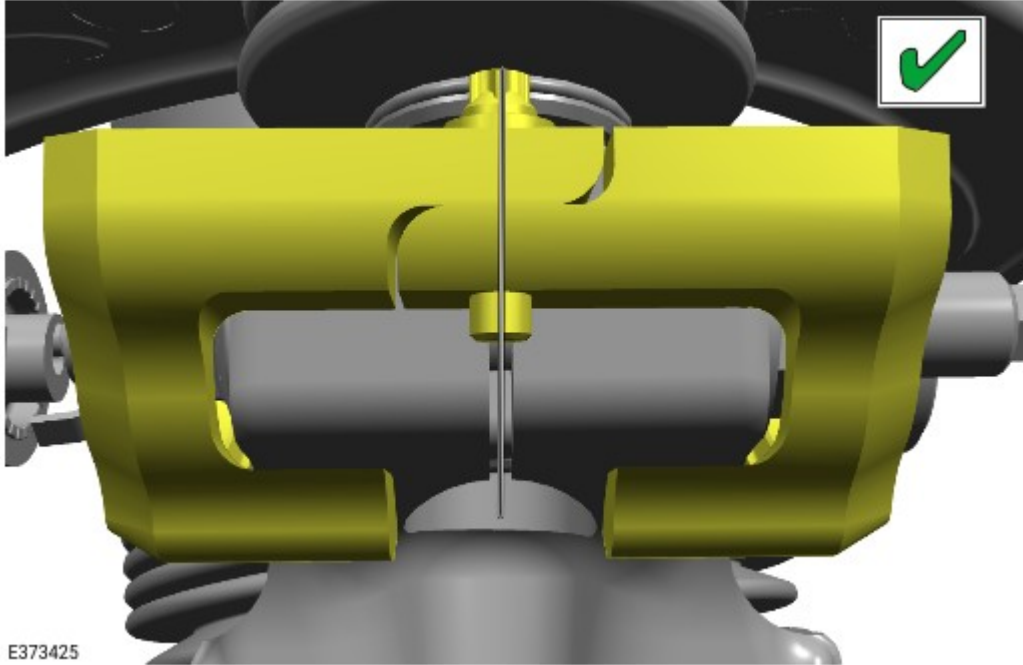
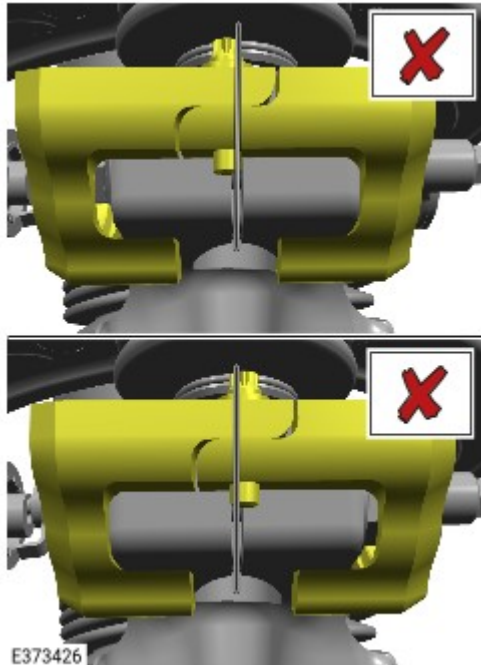
4. Align the front knuckle bracket to be central to the front knuckle.

- The front knuckle bracket must be centrally aligned to the front wheel knuckle as shown in the illustration with the **GREEN ✓**.
- The front knuckle bracket must not be aligned to the front wheel knuckle as shown in the illustrations with the **RED X**.

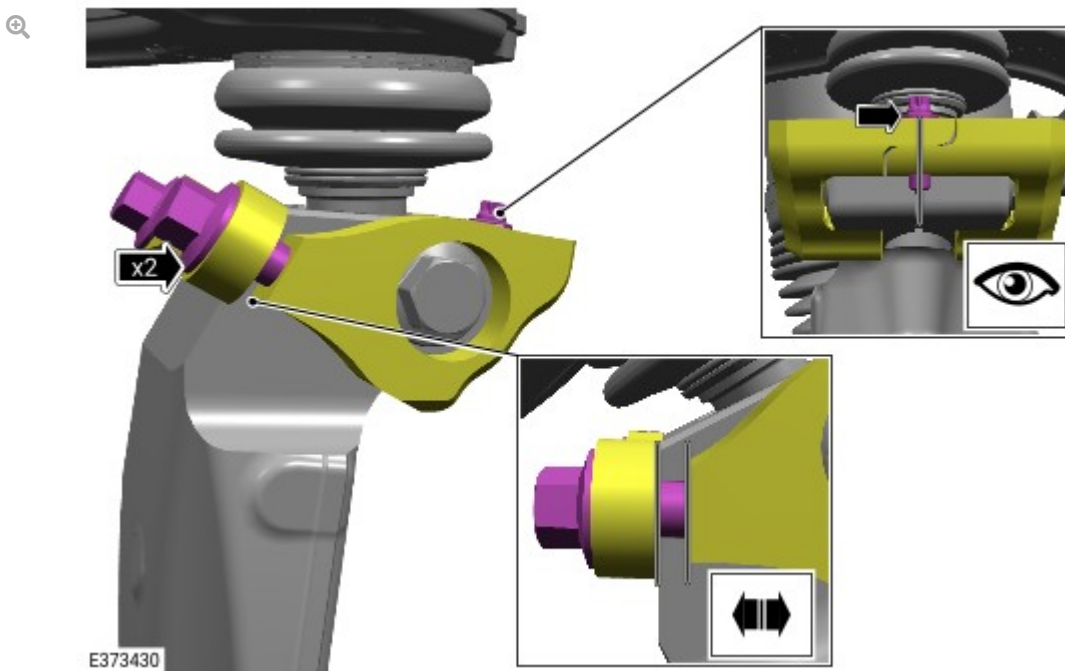
- There must be a gap between the front knuckle bracket rear plate and the 2 front knuckle bracket side hooks.
- The gap between the front knuckle bracket rear plate and the 2 front knuckle bracket side hooks must be maintained both sides of the front knuckle bracket rear plate.
- The front knuckle bracket must remain central to the front knuckle during tightening, as shown in the illustration.
- The M5 bolt torque must be checked after the 2 M8 bolts have been tightened.

Fully tighten the 3 front knuckle bracket bolts.

1. M5 Bolt: **6 Nm**
2. M8 Bolts:
  - Stage 1: **10 Nm**
  - Stage 2: **24 Nm**
3. Re-torque the M5 Bolt: **6 Nm**
