SAFETY RELATED RECALL

Global Recall Action
Number: D041v4

Subject: Range Rover (L405) Front Suspension Knuckle Crack	Publication No.: D041v4
	Model: Range Rover (LG)
	Model Year: 2016
	Date of Issue: 20 February 2026

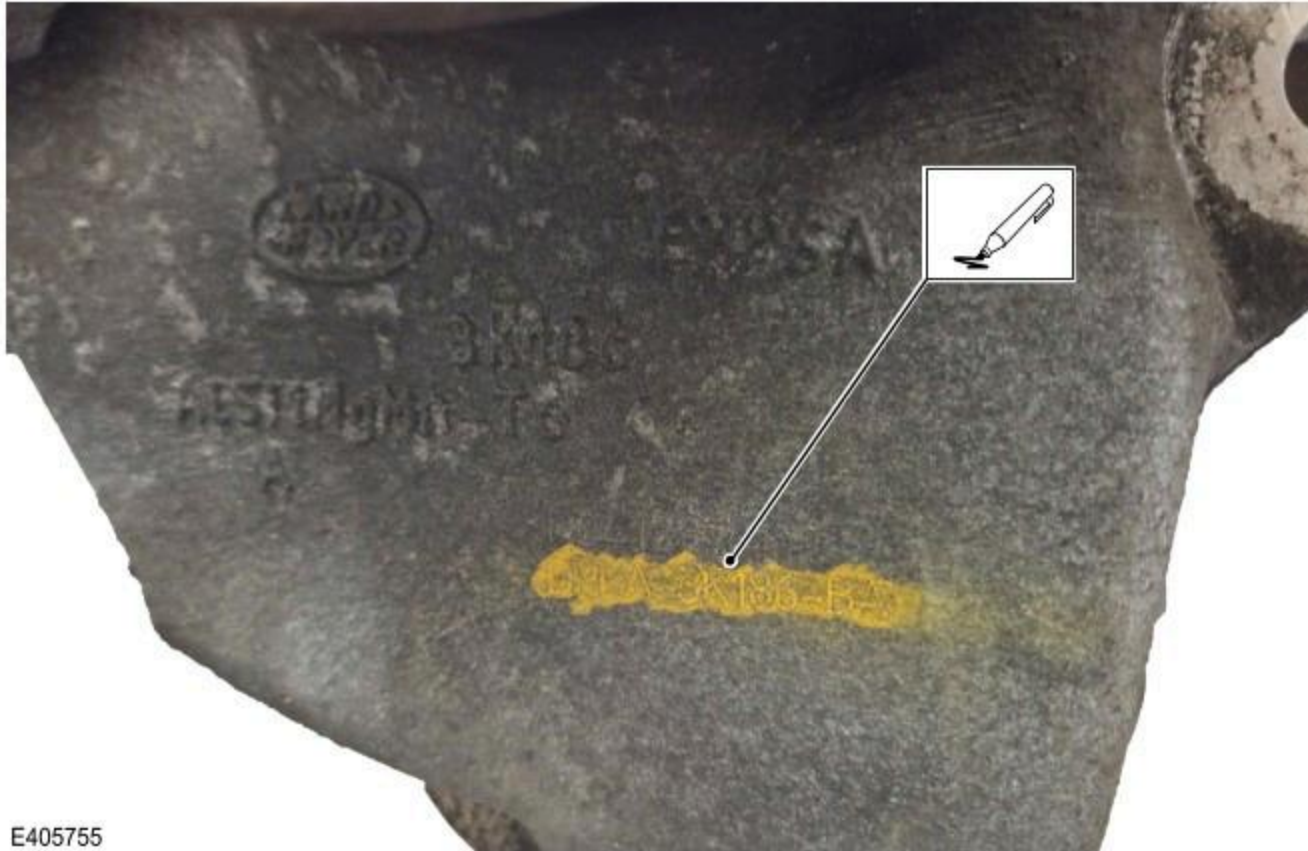
E405755

4. Using a paint pen, apply paint to the front wheel knuckle part number. The part number will be in the location shown in the illustration, on every front wheel knuckle.
 - Using a suitable cloth, remove excess paint from the part number.

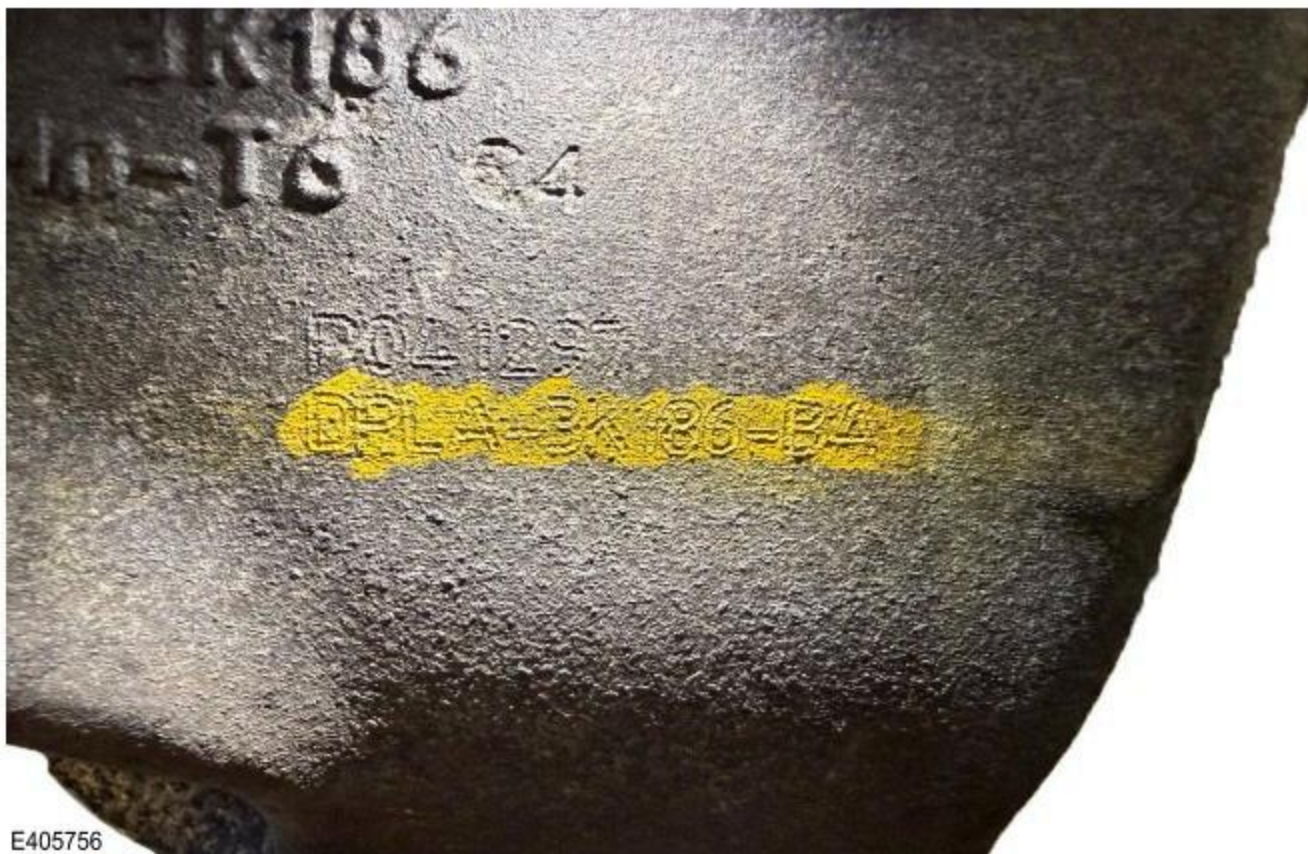
E405756

Shining a flashlight on the front wheel knuckle part number from above makes inspecting the front wheel knuckle part number easier.

Inspect the front wheel knuckle part number.

- If the front wheel knuckle part number is any of the following part numbers, the front wheel knuckle **has FAILED** Service Inspection 2, **continue to step 7**.
 - **CPLA-3K185-BA, CPLA-3K186-BA, DPLA-3K185-BA or DPLA-3K186-BA.**
- If the front wheel knuckle part number is any of the following part numbers, the front wheel knuckle **has PASSED** Service Inspection 2, **continue to step 6**.
 - **CPLA-3K185-BB, CPLA-3K186-BB or a suffix that starts with an A (xxxx-xxxx-Ax).**

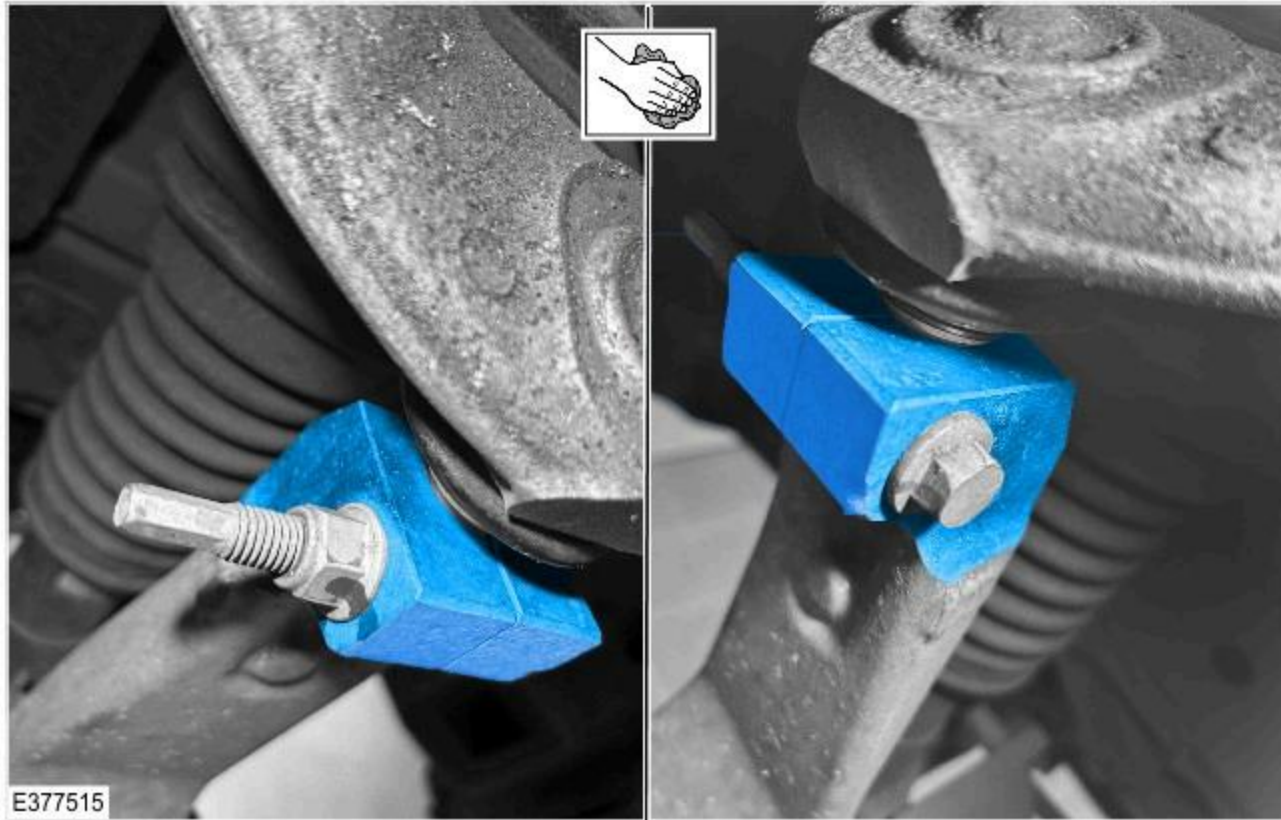
1. Use a non abrasive cloth and suitable cleaning fluid to clean the area of the front wheel knuckle shown highlighted in the illustrations.

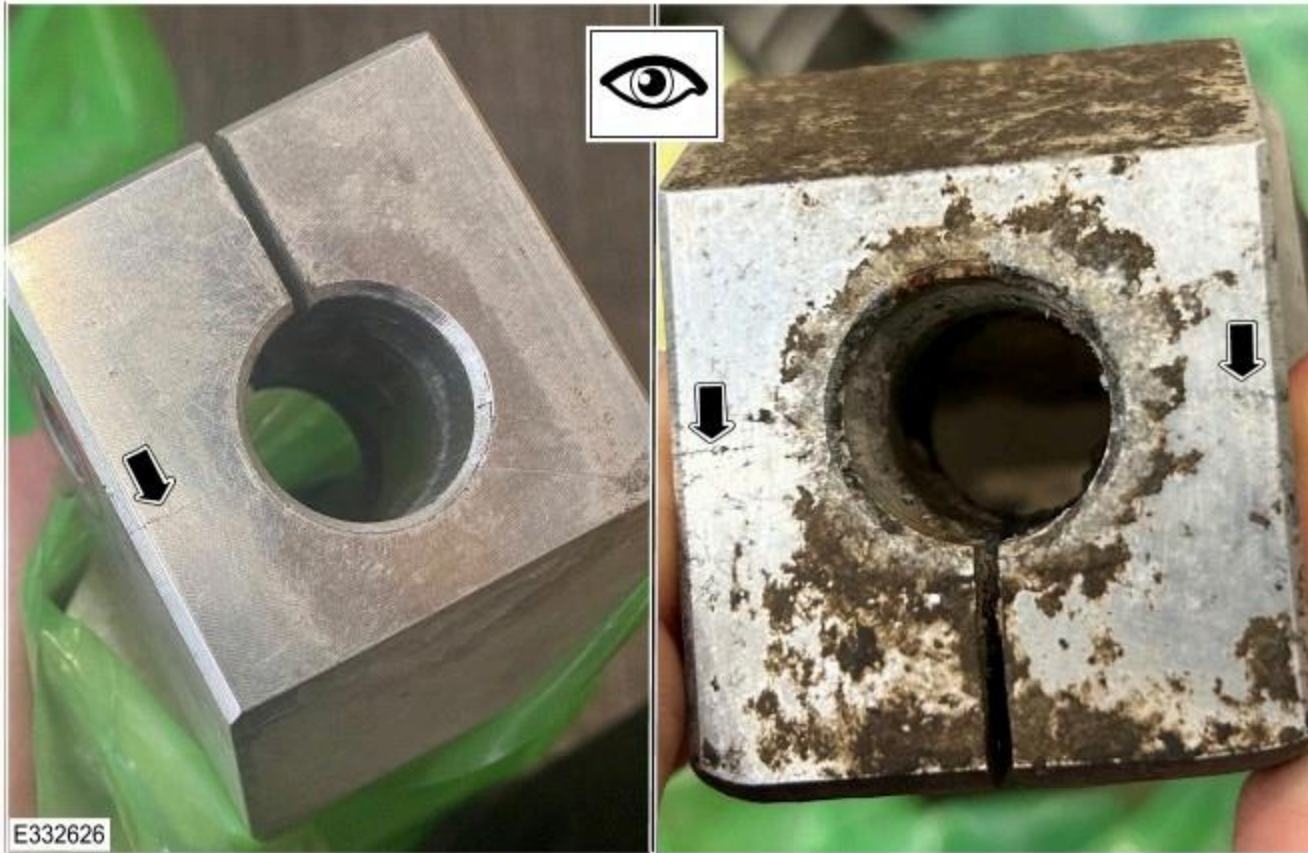
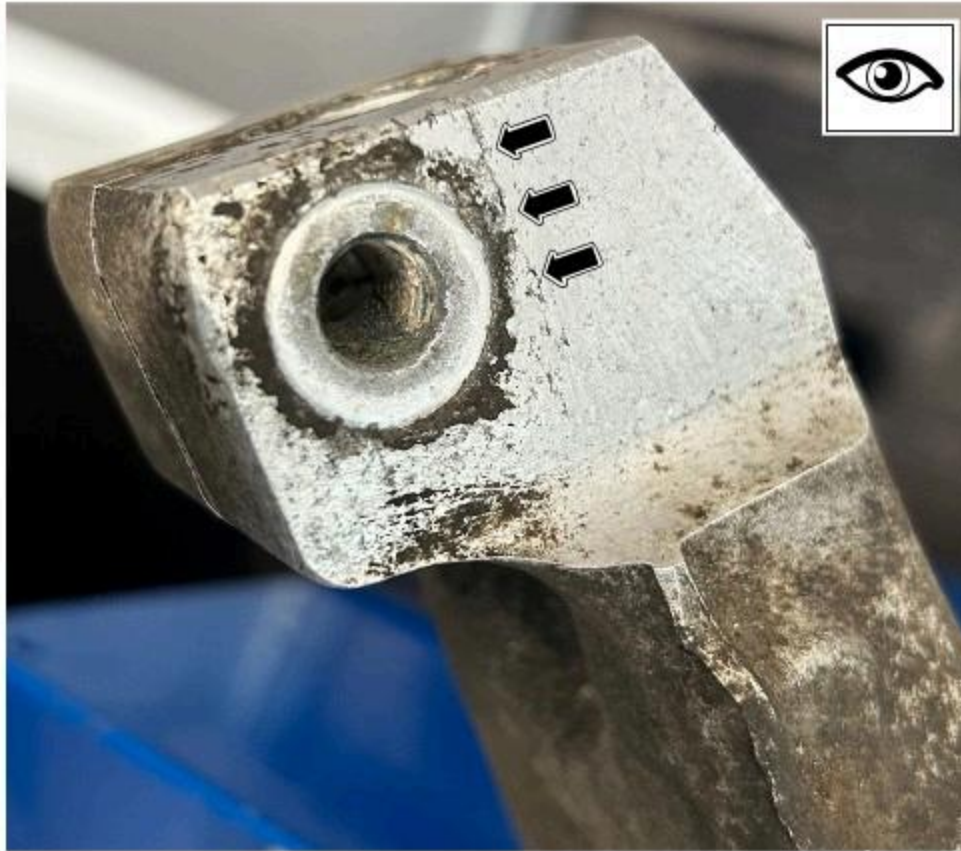
E332627

- The example illustrations are applicable to both left and right front wheel knuckles.
- Use a suitable flashlight and / or a mirror to assist with the visual inspection.

Examples of front wheel knuckle cracks are shown in the illustrations.

- If cracks **ARE** visible on the front wheel knuckle, the front wheel knuckle has **FAILED** service inspection 3. Replace the front wheel knuckle that has **FAILED** service inspection 3, continue to **FRONT WHEEL KNUCKLE REPLACEMENT**.
- If cracks **ARE NOT** visible on the front knuckle, the knuckle has **PASSED** service inspection 3. **Continue to the FRONT WHEEL KNUCKLE BRACKET INSTALLATION PROCEDURE.**

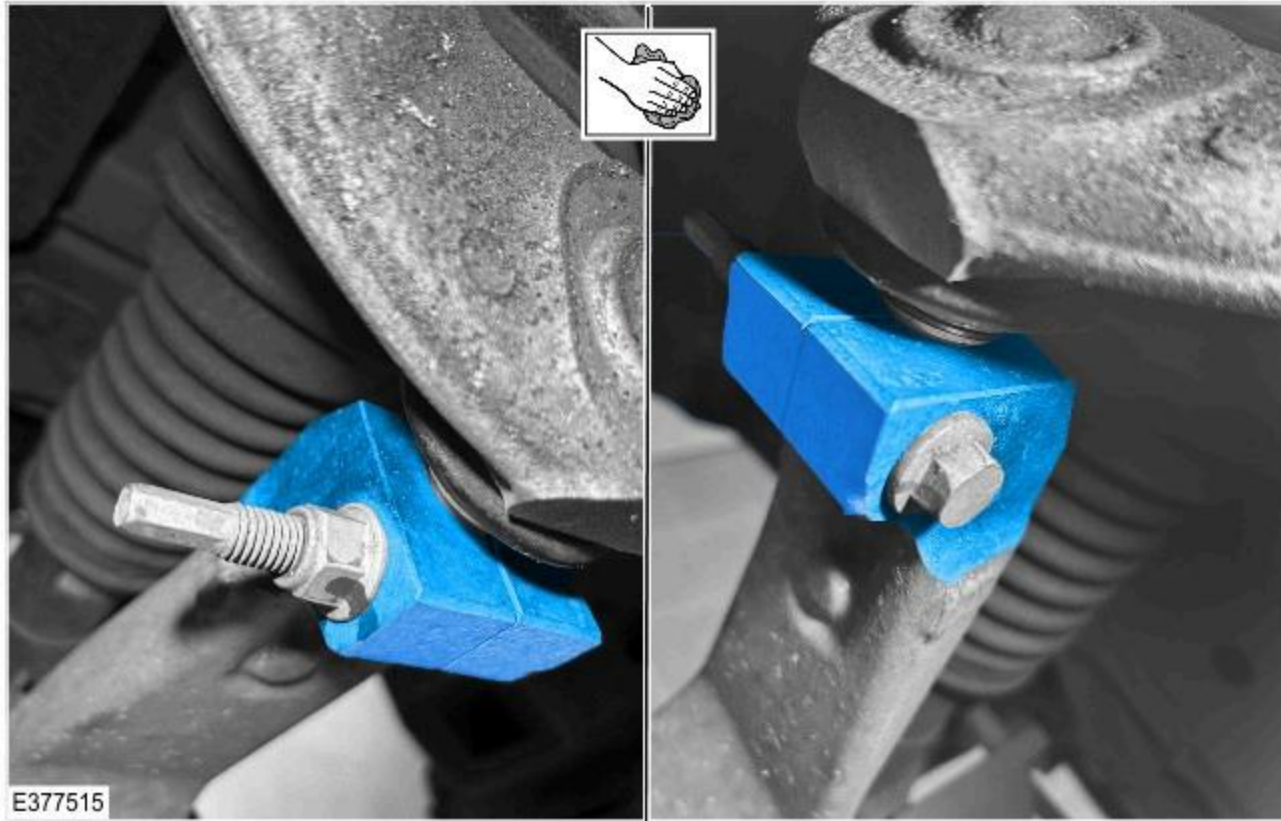
1. The area of the front knuckle shown highlighted in the illustrations must be clean and free from contamination.

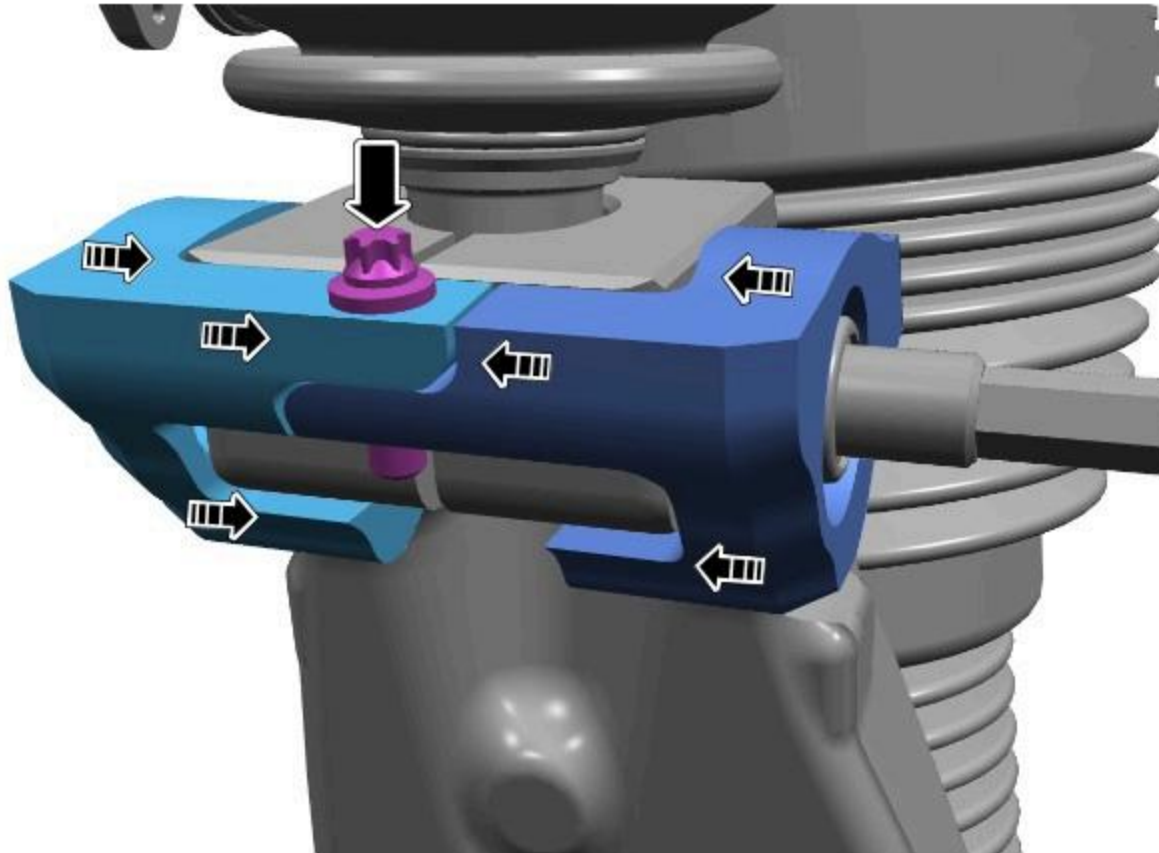
E373427

2. Install the 2 front knuckle bracket side hooks.

- Apply Loctite® 243 to the bolt.
- Install the bolt, finger tight only at this stage.
