SAFETY RELATED RECALL

Global Recall Action
Number: N759v7

Subject: Range Rover (L405) Front Suspension Knuckle Crack	Publication No.: N759v7
	Model: Range Rover (LG)
	Model Year: 2014 - 2016
	Date of Issue: 16 February 2026

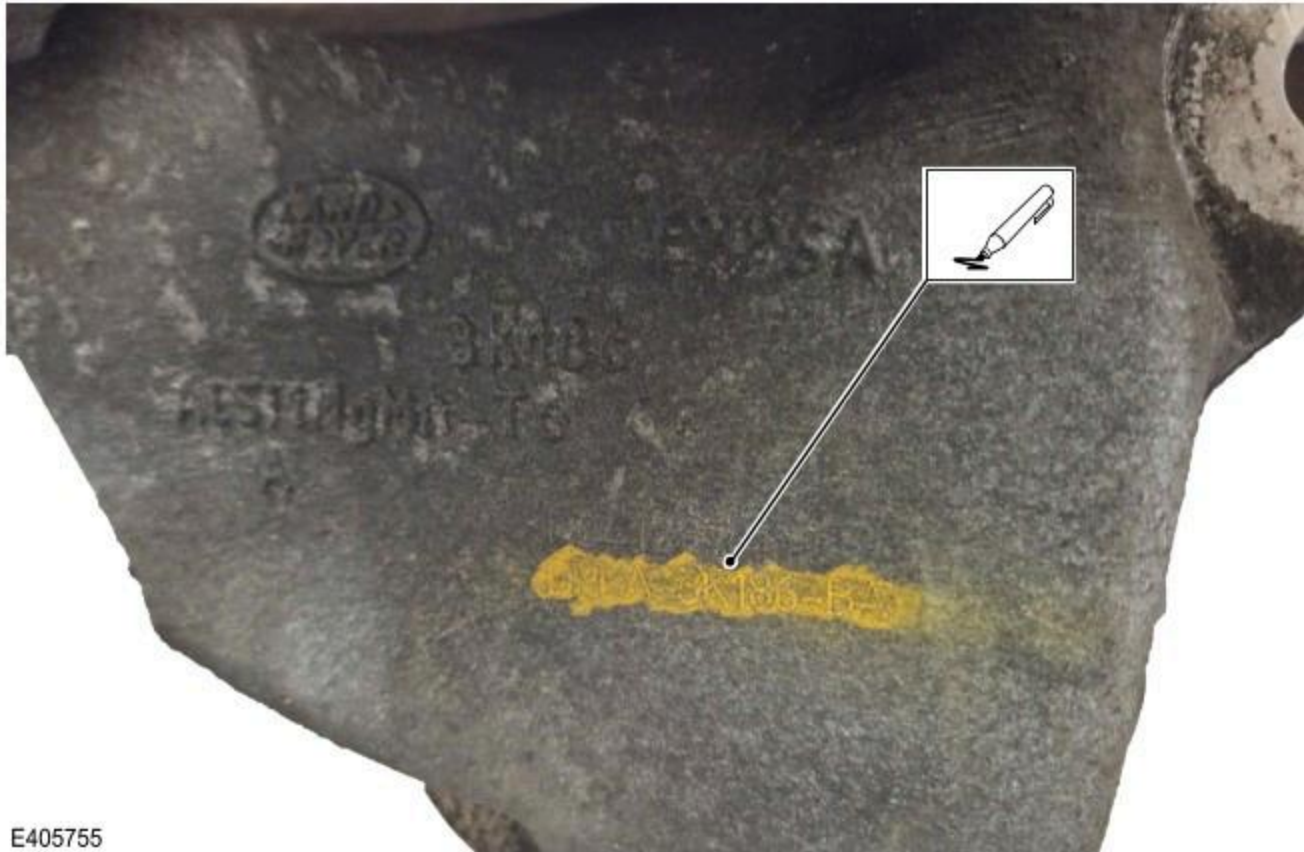
E405755

4. Using a paint pen, apply paint to the front wheel knuckle part number. The part number will be in the location shown in the illustration, on every front wheel knuckle.
 - Using a suitable cloth, remove excess paint from the part number.

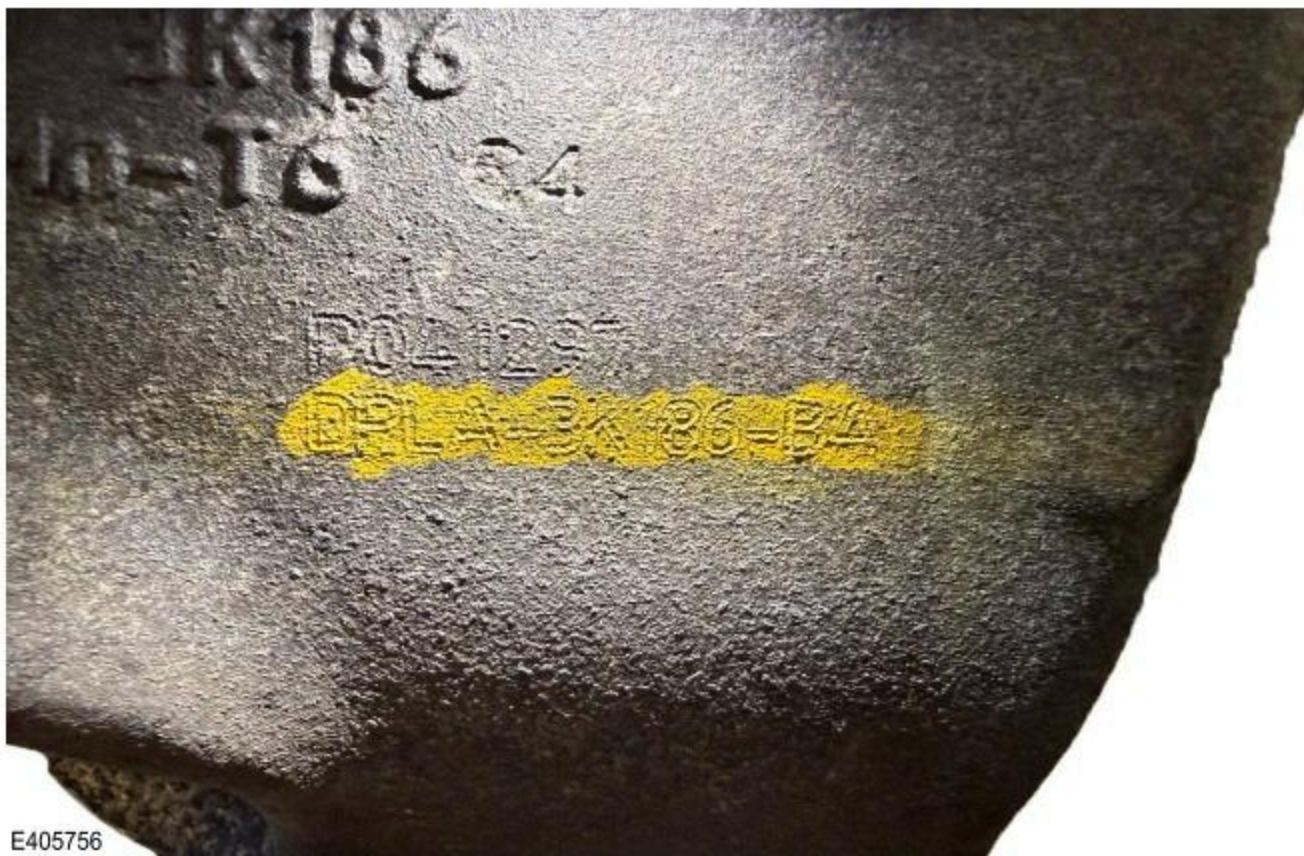
E405756

Inspect the front wheel knuckle part number.

- If the front wheel knuckle part number is any of the following part numbers, the front wheel knuckle **has FAILED** Service Inspection 2, **continue to step 7**.
 - **CPLA-3K185-BA, CPLA-3K186-BA, DPLA-3K185-BA or DPLA-3K186-BA.**
- If the front wheel knuckle part number is any of the following part numbers, the front wheel knuckle **has PASSED** Service Inspection 2, **continue to step 6**.
 - **CPLA-3K185-BB, CPLA-3K186-BB or a suffix that starts with an A (xxxx-xxxx-Ax).**

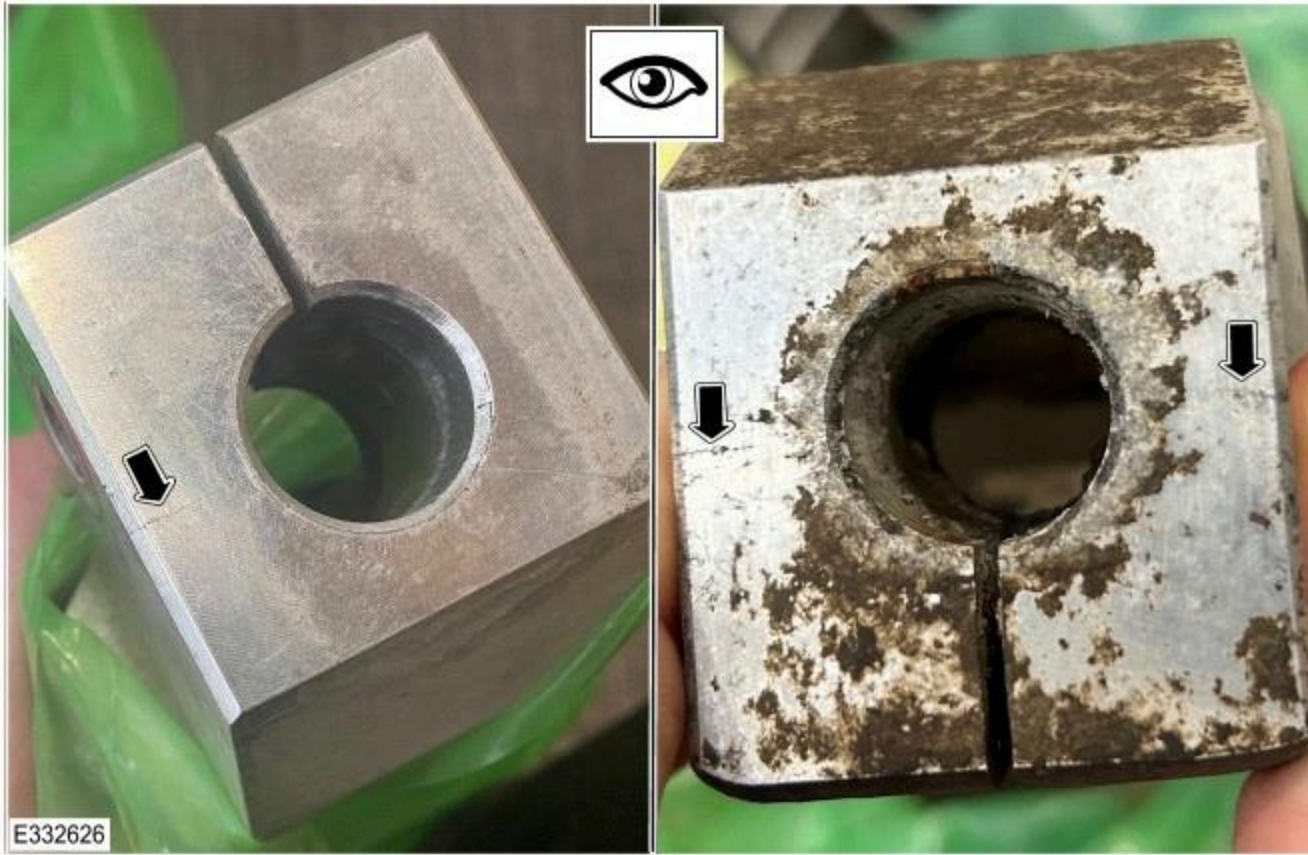
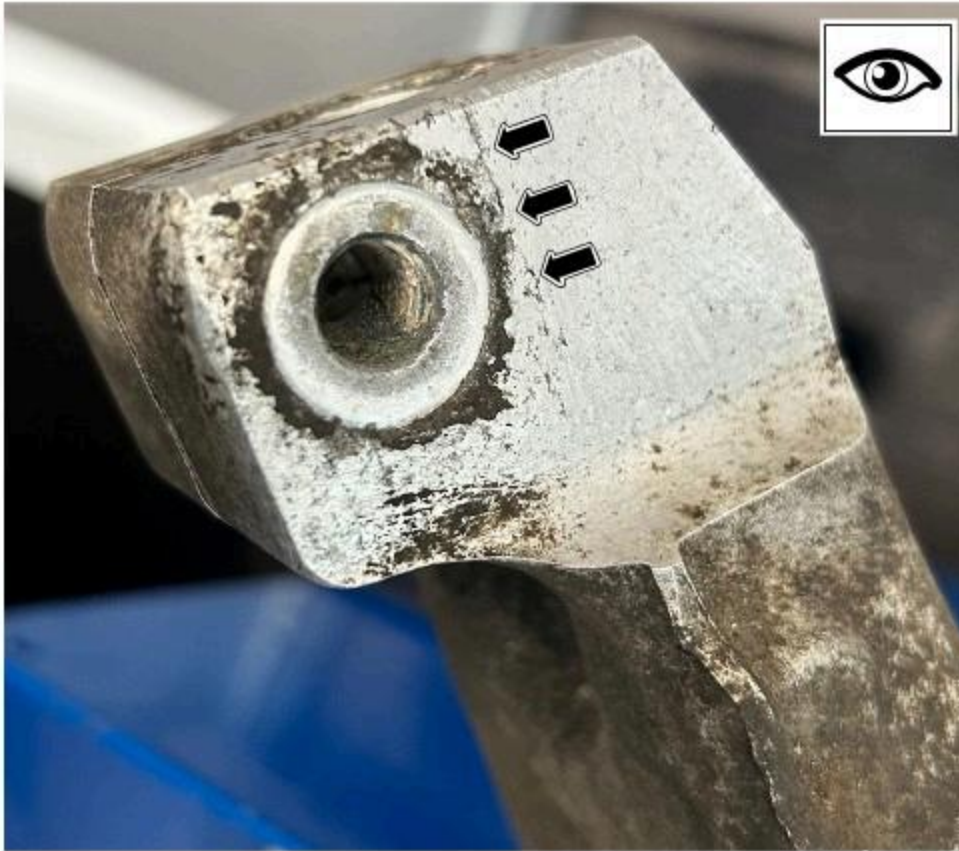
E332627

- The example illustrations are applicable to both left and right front wheel knuckles.
- Use a suitable flashlight and / or a mirror to assist with the visual inspection.

Examples of front wheel knuckle cracks are shown in the illustrations.

- If cracks **ARE** visible on the front wheel knuckle, the front wheel knuckle has **FAILED** service inspection 3. Replace the front wheel knuckle that has **FAILED** service inspection 3, continue to **FRONT WHEEL KNUCKLE REPLACEMENT**.
- If cracks **ARE NOT** visible on the front knuckle, the knuckle has **PASSED** service inspection 3. **Continue to the FRONT WHEEL KNUCKLE BRACKET INSTALLATION PROCEDURE.**
