SAFETY ADVISORY # 25-472

Pivot Bunk Hardware

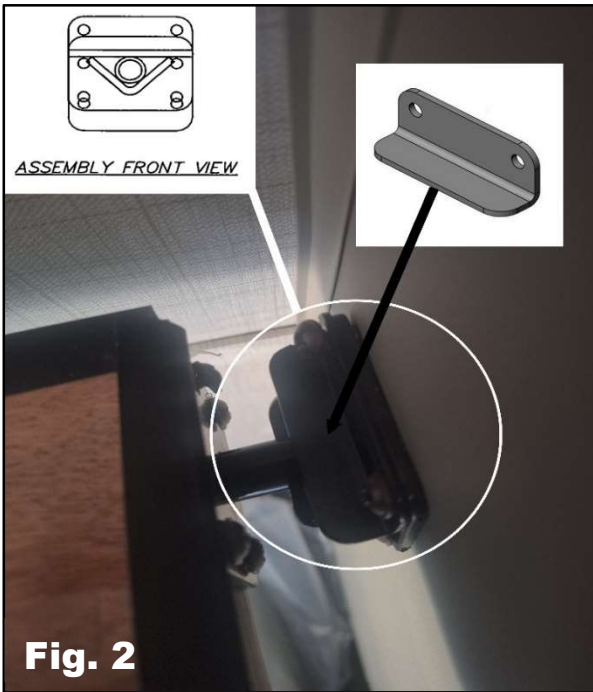
Set the bunk bed mattress aside. Identify the restraint bracket that is mounted over top of the rear wall bracket. Use a screw gun and bit to remove the two screws securing it to the wall. Set the restraint bracket and screws aside. Repeat this process on the opposite side of the bunk frame. See Fig. 2.

Mount the bunk frame back into place by aligning the four bunk brackets to rest inside the mounted wall brackets. Take the restraint brackets and screws (set aside in Step 3) and secure them over both rear wall brackets. See Fig. 2.

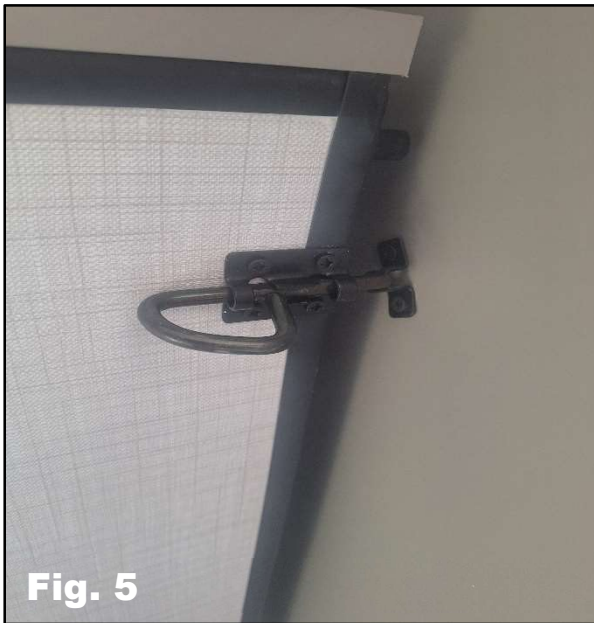
Lift the front of the bunk frame upward to ensure that the bunk latch bolts align with the strike plates mounted on the side walls. If misaligned, remove the screws securing the strike plate and remount with proper alignment. See Fig. 5.
