Technical Service Bulletin

GROUP	NUMBER
RECALL	25-01-074H
DATE	MODEL(S)
OCTOBER 2025	SANTA FE (MX5A) TUCSON (NX4A)

SUBJECT: ENGINE REPLACEMENT DUE TO INSUFFICIENT CONNECTING ROD BOLT TORQUE (RECALL 281)

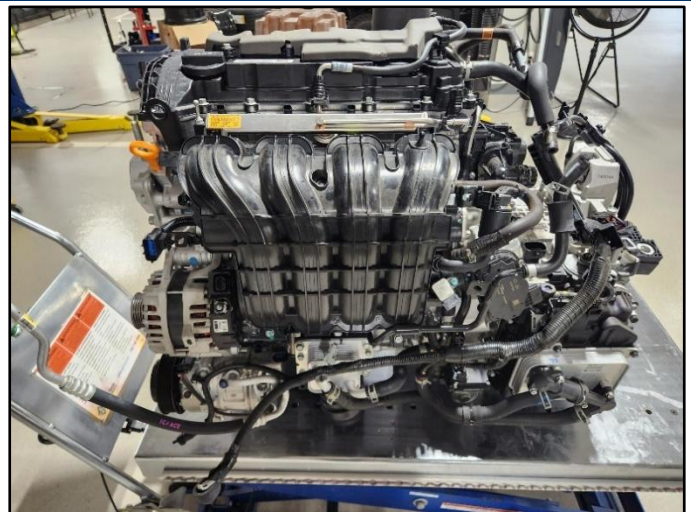
1. Remove the engine sub-assembly referring to the shop manual:
 - Santa Fe (MX5A):
Engine Mechanical System > Engine and Transaxle Assembly > Engine and Transaxle Assembly > Removal
 - Tucson (NX4A):
Engine Mechanical System > Engine and Transaxle Assembly > Engine and Transaxle Assembly > Repair Procedures

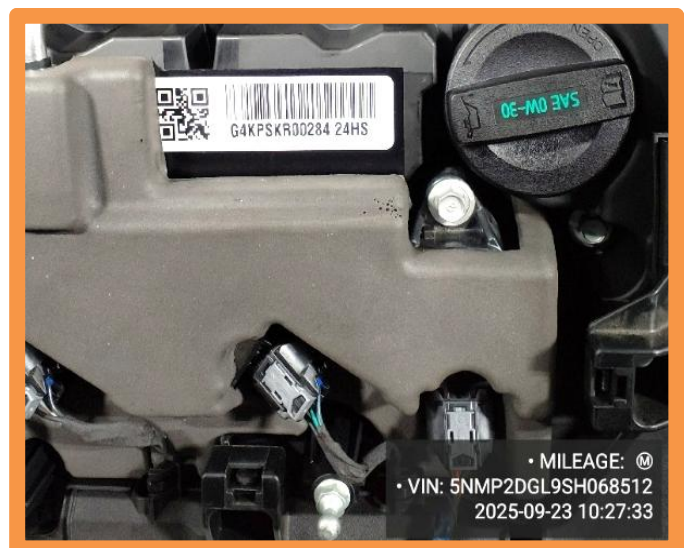
Using the STUI camera function, take a photo of the **new** engine sub-assembly's serial number.

NOTE: If the STUI camera function is **NOT** used, write the last 6 digits of the VIN and date of repair on a piece of paper to include in the photo.

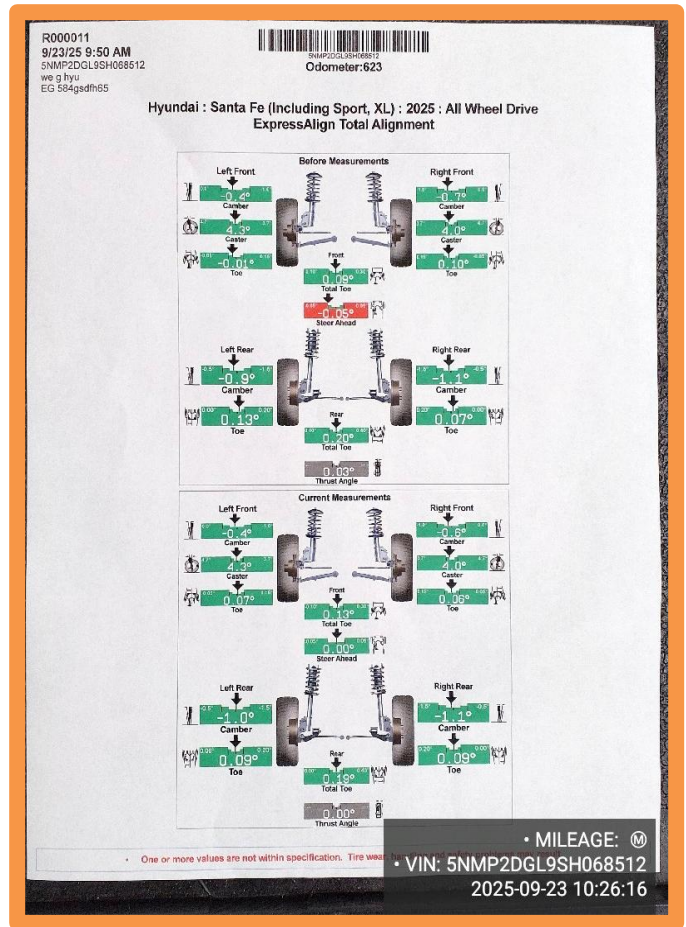
Using the STUI camera function, take a photo of the completed alignment sheet clearly showing the VIN and date of alignment.

NOTE: If the STUI camera function is **NOT** used, write the last 6 digits of the VIN and date of alignment on a piece of paper to include in the photo.

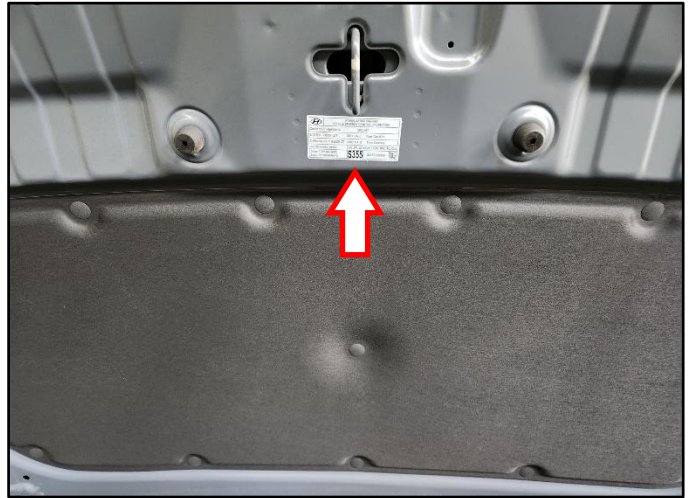
1. Fill in the Dealer Code and Date on the Campaign Sticker, and apply adjacent to the existing Emission Label, on the underside of the hood, as shown.

Be sure to clean the mounting surface to ensure proper label adhesion.
