## Volvo Car Customer Service

QB Instruction VCC-522169-3

| <b>Title</b> | Cover bumper, repair | <b>Page</b> | 1 ( 4 ) |

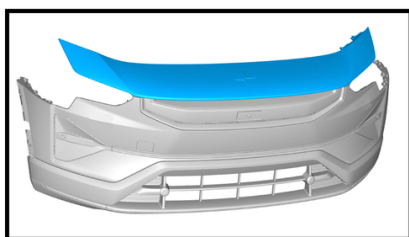
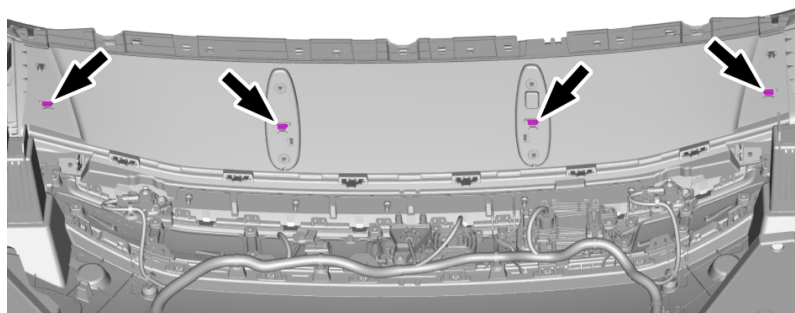
Release the locks.  
Remove the marked part.

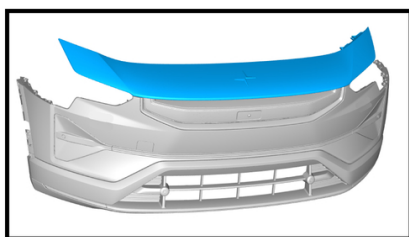
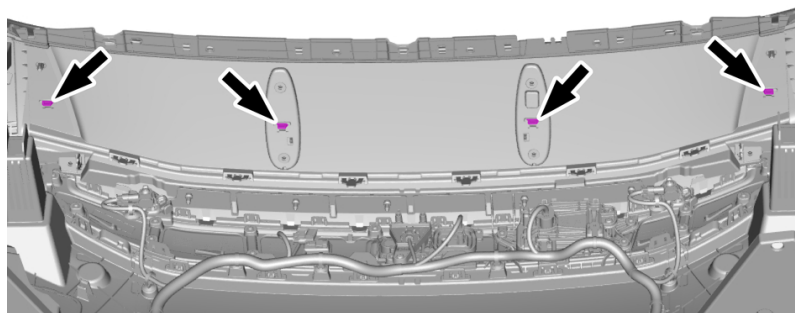
**Note! Make sure that a new component is installed.**

**Note! A click confirms that the component is in the correct position.**

Install the marked component.

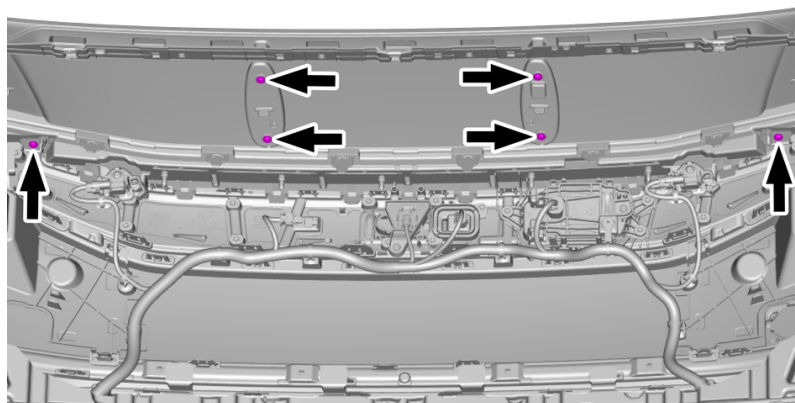
Install the screws.

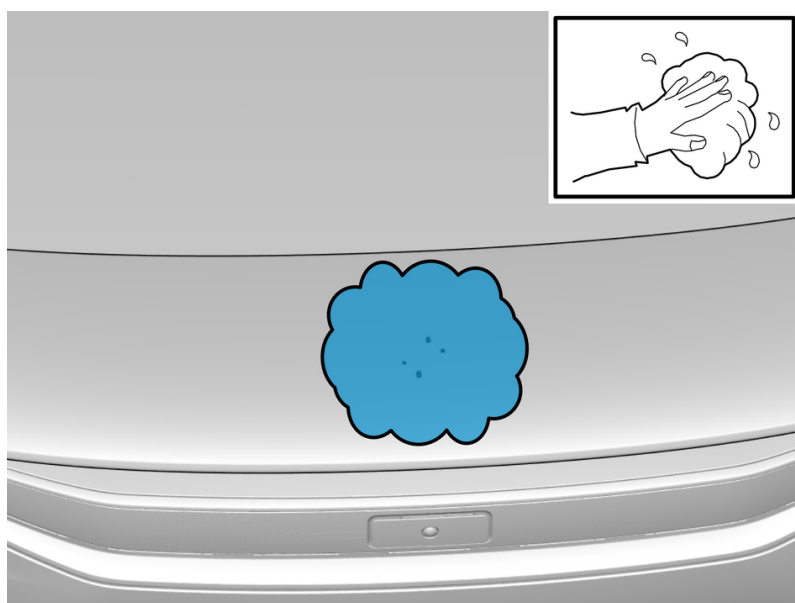
Clean the marked area.

**Use:** Isopropanol ,

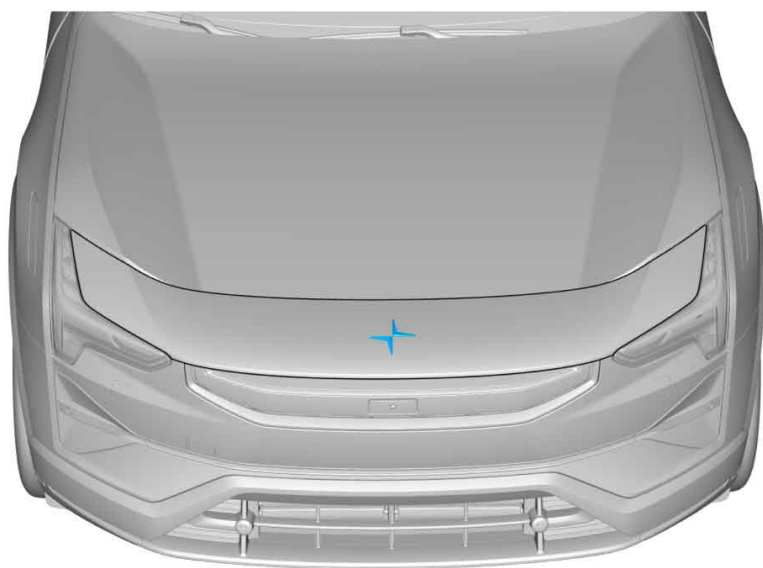
Install the marked component.
