# Recall Bulletin 250829REV

| <b>RECALL BULLETIN:</b><br><b>250829REV</b> | <p>The purpose of this Recall Service Bulletin is to inform REV Recreation Group dealers of the need to inspect and perform needed repairs to the 35-amp waste tank macerator fuse, the fuse block terminals and fuse location diagram key. This affects certain model year 2023-2026 (AMC) American Eagle, American Dream, 2023 and 2024 American Tradition and 2025-2026 Fleetwood Palisade motorhomes. A list of affected motorhome serial numbers appears at the end of this Recall bulletin.</p> |
| <b>SUBJECT:</b><br><b>MACERATOR FUSE</b><br><b>BLOCK HOUSING -</b><br><b>Diagram Key</b> | <p><b><u>WARRANTY LABOR ALLOWANCE:</u></b><br/> Recall 250829REV Macerator Fuse Housing (Prior Authorization required).<br/> Use Flat Rate Codes: 6322 11 Inspected/Non-Defective (AMC Only)<br/> Time Allowed: .25 hr.</p> |

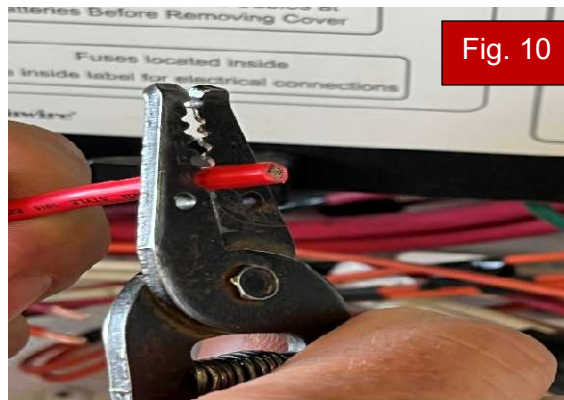
14. With all four (4) wires stripped, add the designated wire connectors to the inline fuse holder wires, making sure to properly crimp on each end.

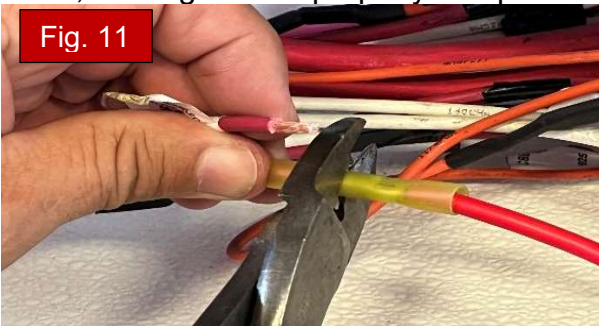
15. Next crimp on the connectors to the main SANI-CON wires, making sure to properly crimp on each end Fig 11

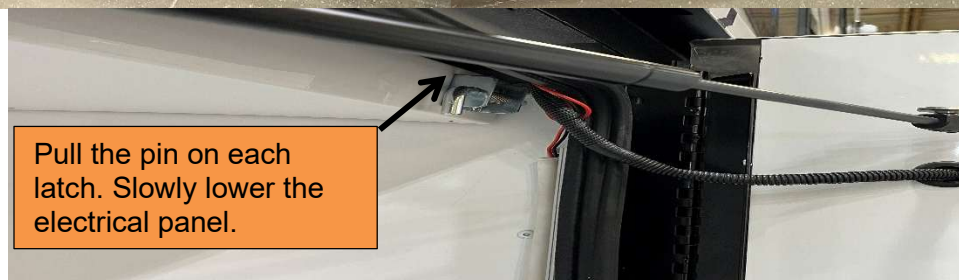
3. Then go to the passenger side electrical panel compartment located in front of the rear axle. Open the door and locate the interior latches in the upper corners as shown below in Fig 2.

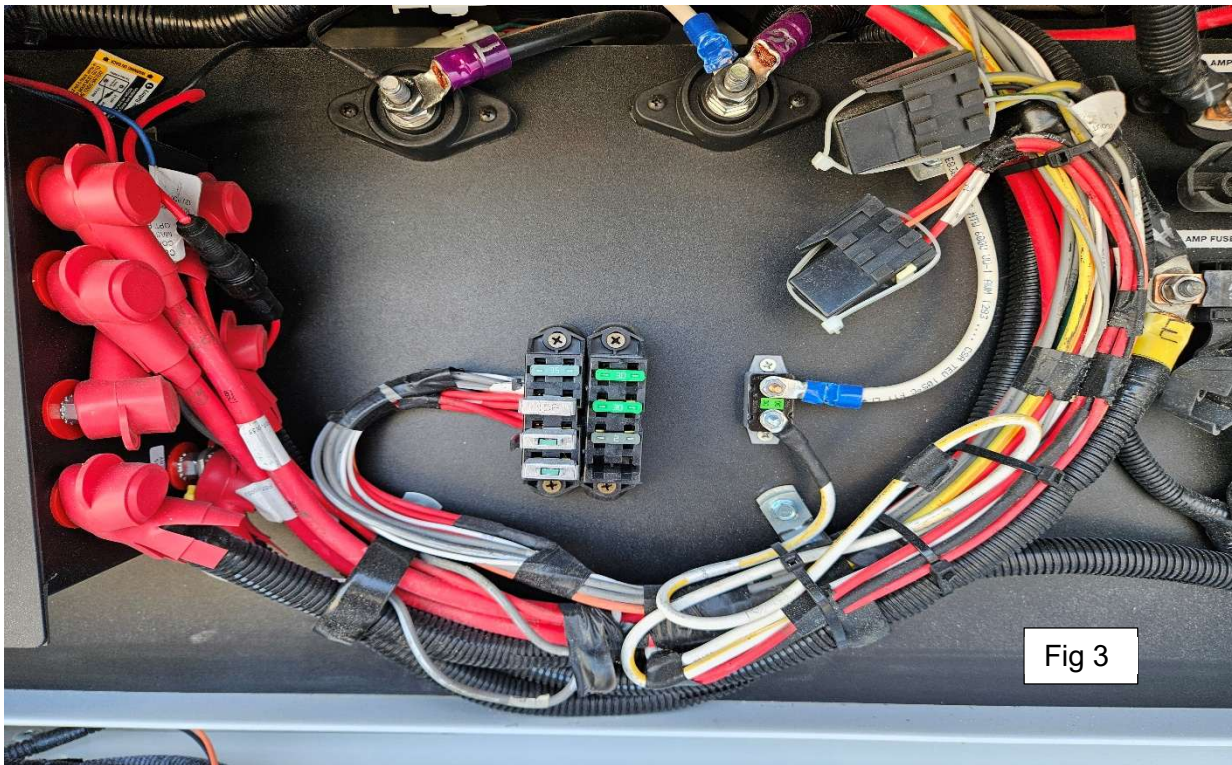
Fig 3

Mid-year 2025 and 26 model year American Eagle and Dream **pre-repair view** shown below (Fig 3)

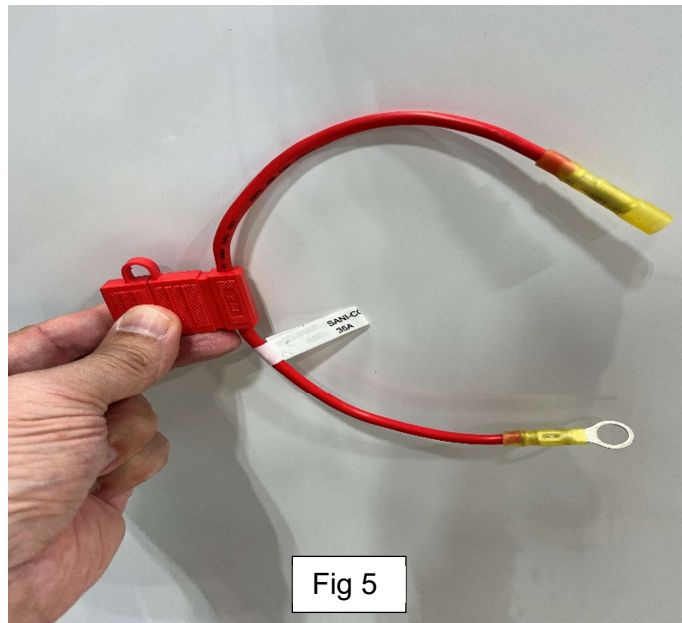
8. Locate the inline fuse holder, 1 diagram key (must have **W12-10009** in the lower corner) SANI-CON label, 1 butt connector and 1 ring connector and 1 new 35 AMP fuse with the name **LITTLEFUZE** on it from the Parts Kit from REV RV. Do not substitute fuse brands.
9. Cut the inline fuse holder wire in the middle.
10. Strip both ends of the inline fuse wire.
11. Crimp on the butt connector as shown below in Fig 5.
12. Crimp on the ring terminal as shown below. Apply heat to shrink and seal the connector.
13. Install the SANI-CON 35 A - **label** on the wire as shown below from the parts kit.
