# SAFETY RECALL

## Side Curtain Airbag

Reference: 87C / NHTSA 25V-573

2025 (RU) Chrysler Pacifica  
2025 (RU) Chrysler Voyager

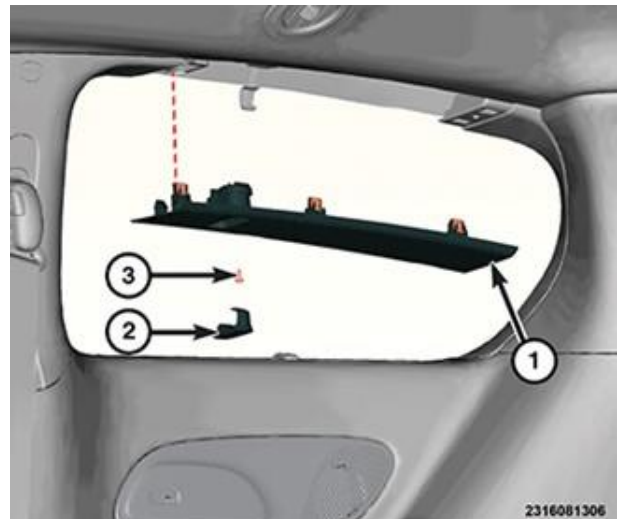
**Figure 9 – C-Pillar Extension Trim**

18. Remove the fastener cover then remove the fastener securing the D-pillar trim panel (Figure 8).
19. Using a trim stick or equivalent, release the retaining clips at the rear and top of the D-pillar trim panel (Figure 8).
20. Using a trim stick release the bottom of the D-pillar trim panel from the quarter trim panel, then pull at the front edge to release the front retaining clips (Figure 8).
21. Disconnect the liftgate switch.
22. Using a flat bladed tool, press the tab to disengage the airbag tether and slide it out of D-pillar trim panel (Figure 8).
23. For RIGHT side of vehicle open the coat hook and remove the screw.
24. Using a trim stick or equivalent, remove the C-pillar extension trim panel (Figure 9).

- 1 - C-Pillar Extension Trim Panel
- 2 - Coat Hook
- 3 - Screw

88. For RIGHT side of vehicle, install the C-pillar extension trim panel engaging the retaining clips, install the screw, tighten securely then close the coat hook (Figure 9).
