**SAFETY RECALL**  
NORTH AMERICA  
**Side Curtain Airbag**

Reference: 86C / NHTSA 25V-573

FCA US LLC

2025 (RU) Chrysler Pacifica  
2025 (RU) Chrysler Voyager

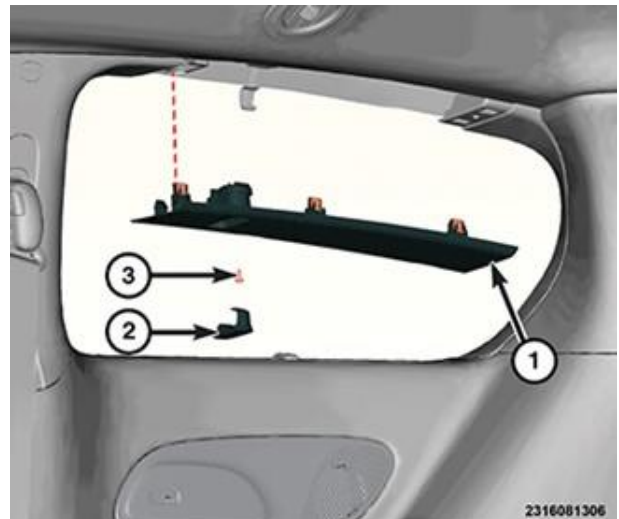
**Figure 9 – C-Pillar Extension Trim**

- 1 - C-Pillar Extension Trim Panel
- 2 - Coat Hook
- 3 - Screw

18. Remove the fastener cover then remove the fastener securing the D-pillar trim panel (Figure 8).
19. Using a trim stick or equivalent, release the retaining clips at the rear and top of the D-pillar trim panel (Figure 8).
20. Using a trim stick release the bottom of the D-pillar trim panel from the quarter trim panel, then pull at the front edge to release the front retaining clips (Figure 8).
21. Disconnect the liftgate switch.
22. Using a flat bladed tool, press the tab to disengage the airbag tether and slide it out of D-pillar trim panel (Figure 8).
23. For RIGHT side of vehicle open the coat hook and remove the screw.
24. Using a trim stick or equivalent, remove the C-pillar extension trim panel (Figure 9).

88. For RIGHT side of vehicle, install the C-pillar extension trim panel engaging the retaining clips, install the screw, tighten securely then close the coat hook (Figure 9).
