**SAFETY RECALL**  
NORTH AMERICA  
**Side Curtain Airbag**

Reference: 82C / NHTSA 25V-573

FCA US LLC

2025 (RU) Chrysler Pacifica  
2025 (RU) Chrysler Voyager

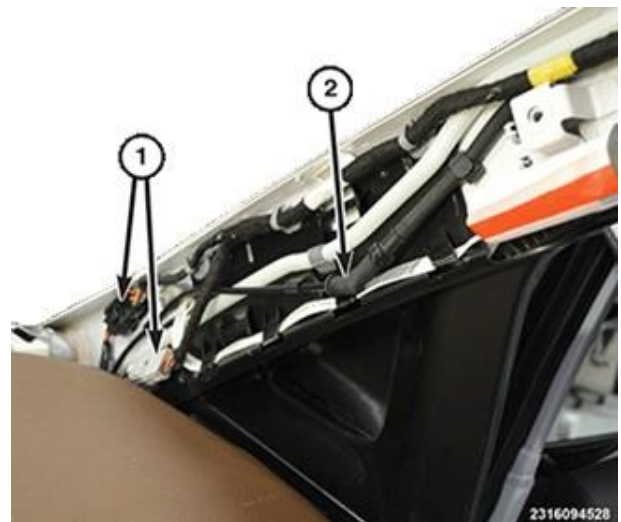
**Figure 3 – A-Pillar**

- 1 - Wire Harness Connectors
- 2 - Washer Hose

10. Disconnect the wire harness connectors and unclip the wire harness from the passenger side A-pillar (Figure 3).
11. Disconnect the rear washer hose (and unclip the hose from the passenger side A-pillar, if equipped (Figure 3)).

**NOTE: Washer fluid may drain from this hose when disconnection. Use a container to catch the fluid, then plug the hose with a suitable stopper.**
