## PRODUCT CAMPAIGN BULLETIN

**APPLICABILITY:** 2023-2025 MY Solterra

**NUMBER:** WRD-25R

**SUBJECT:** Safety Recall and Stop Sale: Solterra HVAC  
 ECU Reprogramming

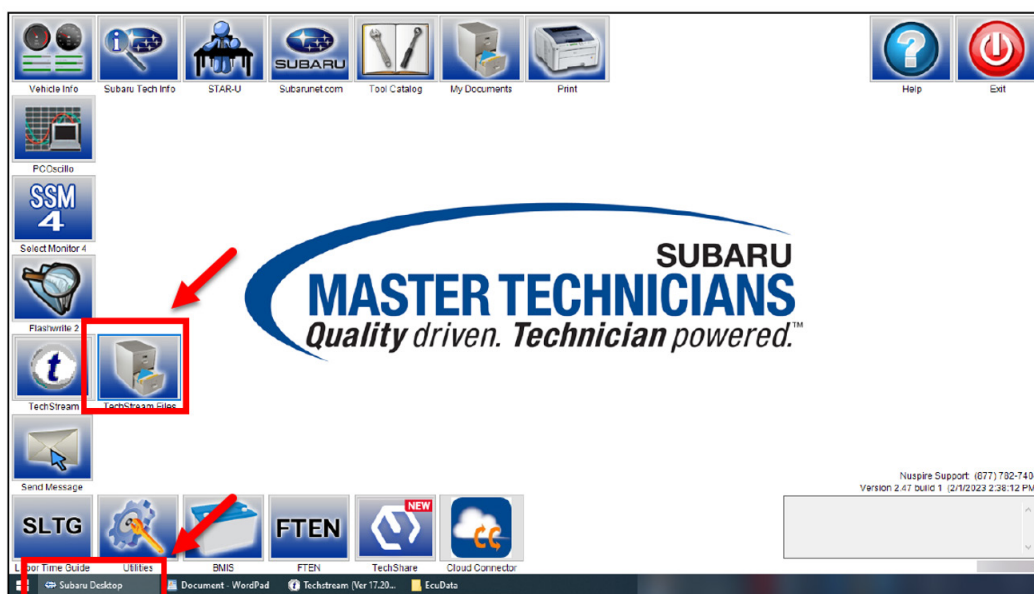
The following files can be located in the ECU Data folder within the TechStream files located on the Subaru Desktop.

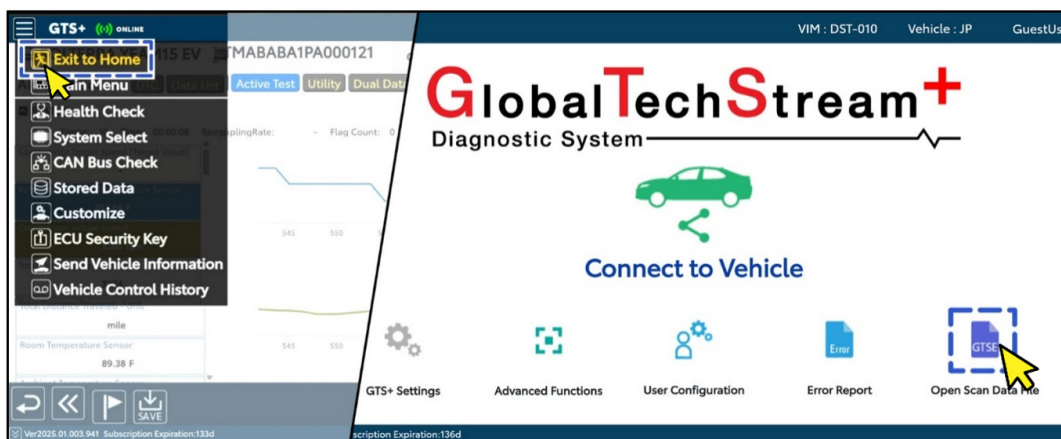
**STEP 15:** Select “Exit to Home” located in the top left corner of the GTS+ application. The home screen will then be displayed. Select the “Open Scan Data File” icon.

Select the saved file and click “OK” to continue.

**NOTE:** The file size, date, and time can help ensure the correct file is selected.

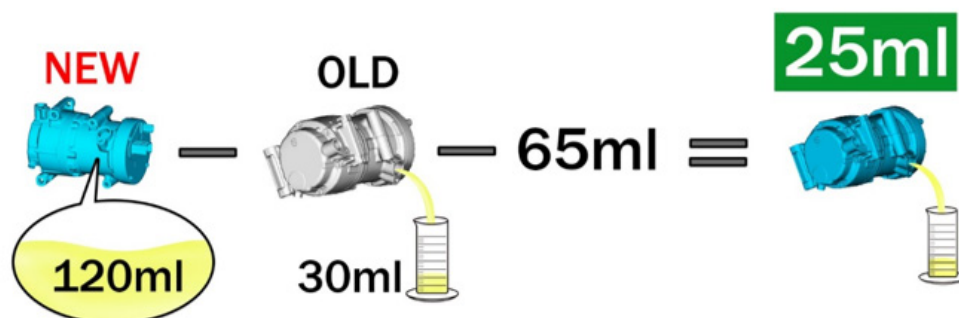
- If there is less than 55ml, you will need to drain the oil from the new compressor.

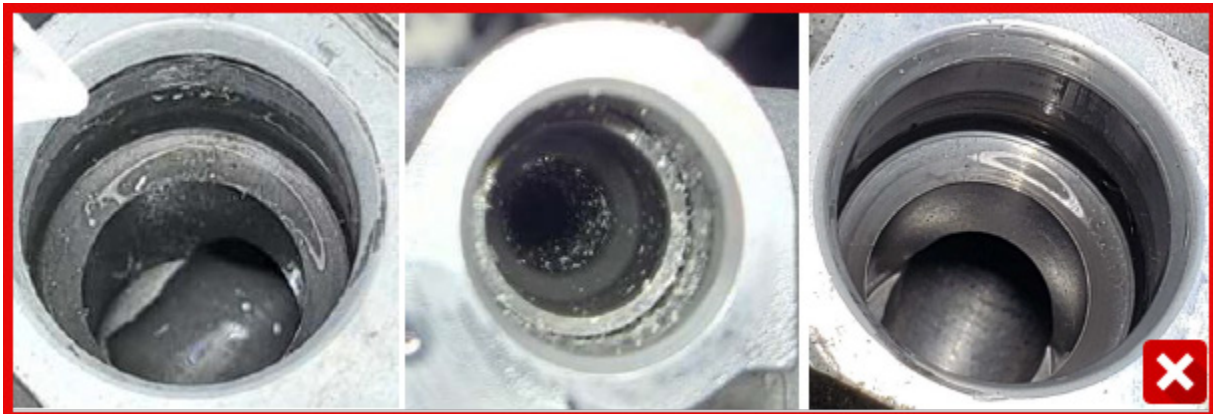
**NOTE:** Blackened oil is not a sign of debris. Metal flakes/debris is a sign of failure.

Example images of foreign material found at the A/C compressor discharge port connection:

**YES:** Replace the compressor and receiver dryer.

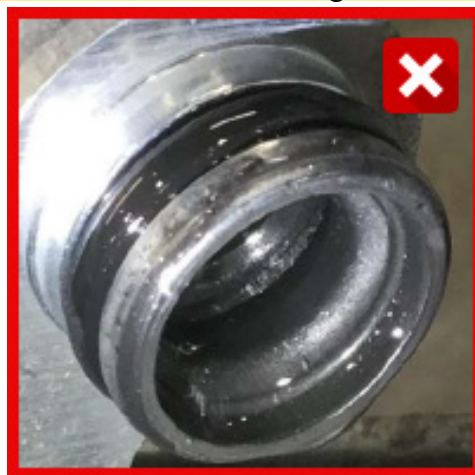
Example image of foreign material found at the A/C discharge hose connection:

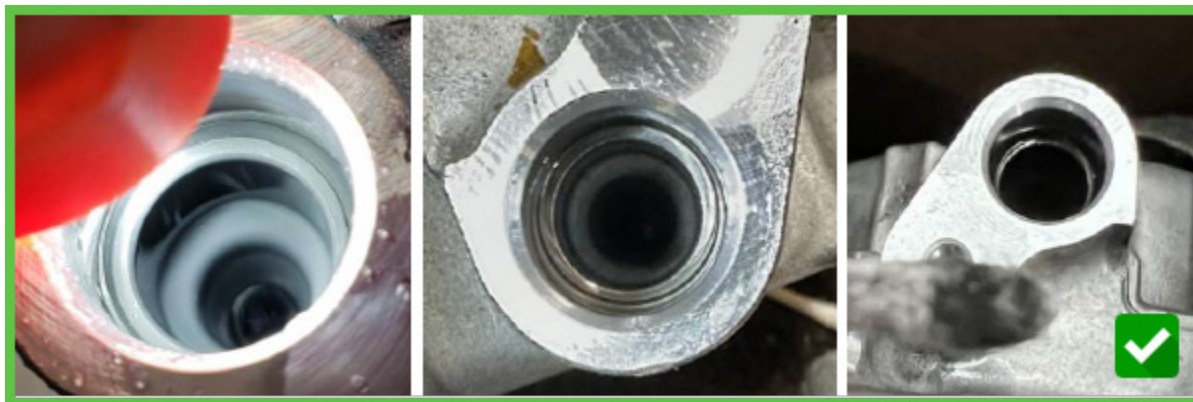
Example images of foreign material **NOT** detected at the A/C compressor discharge port connections.

**NO:** Replace the compressor **ONLY**.
