RAM Remedy available for

- 2018 (D2) Ram 3500 Pickup
- 2018 (DJ) Ram 2500 Pickup
- 2018 (DS) Ram 1500 Pickup
- 2018 (DF) Ram 3500 GVWR less than 10,000 lbs Cab Chassis

SAFETY RECALL
NORTH AMERICA
Curtain Airbag Inflator

Reference: 92C / NHTSA 25V-592

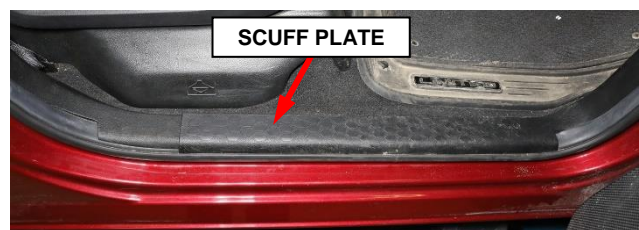
Figure 5 – Door Sill Scuff Plates

10. Release the front and rear door sill scuff plates on either side of the B pillar lower trim panel to allow for removal of the B-pillar lower trim panel (Figure 5).

49. Install the seat belt turning loop cover (Figure 7).
50. Position the B-pillar lower trim panel and engage the retaining clips fully (Figure 6).
51. Position the front and rear door sill scuff plates and engage the retainers (Figure 5).

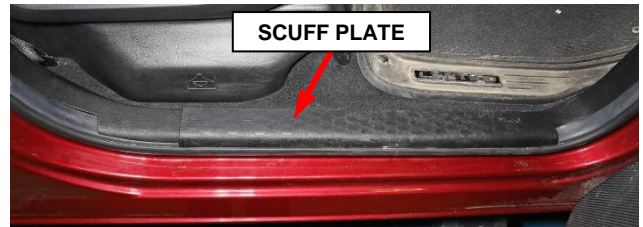
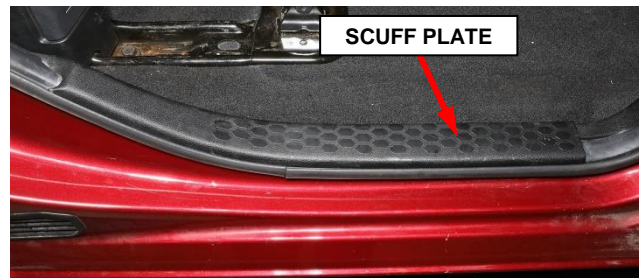
Figure 24 – Door Sill Scuff Plates

9. Release the front and rear door sill scuff plates on either side of the B pillar lower trim panel to allow for removal of the B-pillar lower trim panel (Figure 24).

- 60. Install the B-pillar upper trim panel (1) and engage the retaining clips fully (Figure 27).
- 61. Install the grab handle bolts and tighten to 5 N·m (44 in. lbs.). Close the fastener covers (2) (Figure 27).
- 62. Remove and **DISCARD** the bolt retainer and the bolt from the seat belt turning loop, save the spacer washer for reuse (Figure 40).
- 63. Using a **NEW** bolt and reusing the spacer washer, install the turning loop then tighten the bolt to 40 N·m (30 ft. lbs.) (Figure 26).
- 64. Install the seat belt turning loop cover (Figure 26).
- 65. Position the B-pillar lower trim panel and engage the retaining clips fully (Figure 25).
- 66. Position the front and rear door sill scuff plates and engage the retainers (Figure 24).
