SAFETY RECALL
 NORTH AMERICA
Curtain Airbag Inflator

Reference: 91C / NHTSA 25V-592

RAM Remedy available for
 2018 (D2) Ram 3500 Pickup
 2018 (DJ) Ram 2500 Pickup
 2018 (DS) Ram 1500 Pickup

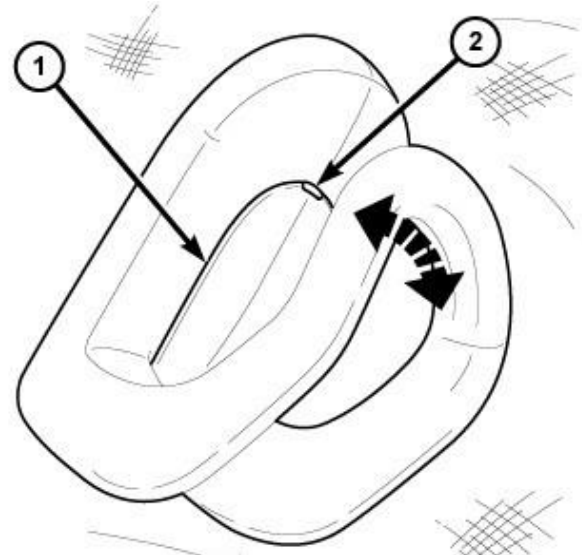
Figure 9 – Coat Hook

16. Using a small flat bladed tool, open the coat hook screw cover (2) then remove the screw and coat hook (Figure 9).

44. Position the coat hooks (5) onto the headliner and install the screws tightening securely into the mounting clips then close the screw cap fully (Figure 9).

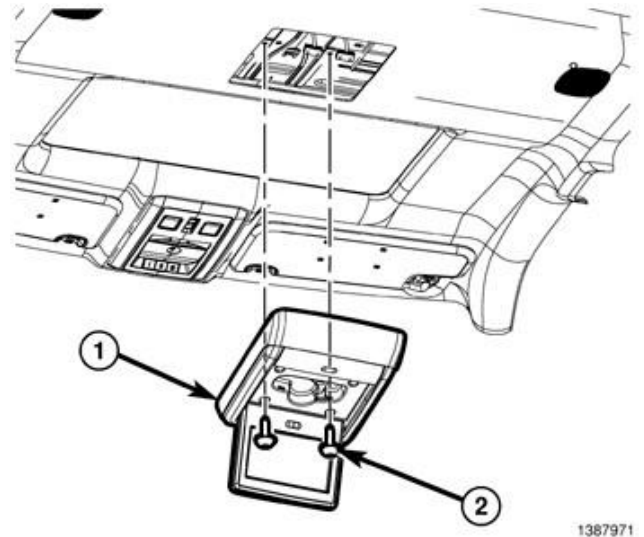
Figure 12 – Rear Seat DVD Monitor

19. If equipped with DVD monitor, remove the screws (2) and separate the monitor (1) from the roof (Figure 12).

39. Tilt the rear view mirror down to allow it to support the headliner (Figure 15).
40. Reattach any headliner wiring harness clips (3) removed from the A-pillar to allow slack while lowering headliner (Figure 14).
41. If equipped with DVD monitor, connect the DVD monitor electrical connectors (1) (Figure 13). Position the DVD monitor to the roof then install and tighten the screws (2) (Figure 12).

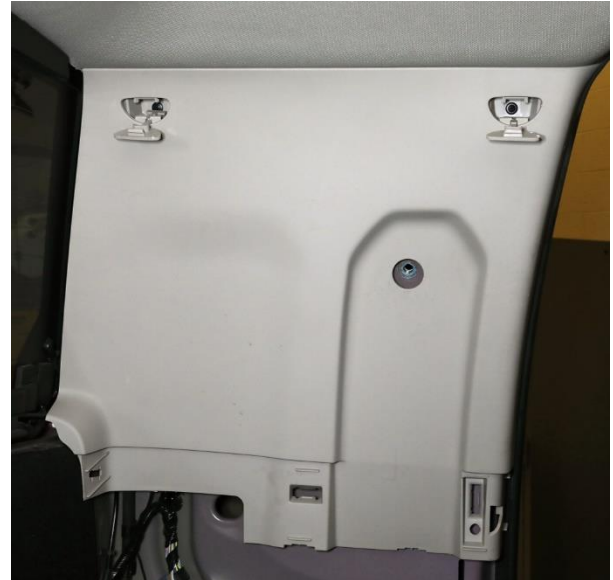
Figure 30 – C-Pillar Upper Trim Panel Fasteners

18. Using a trim stick or equivalent, release the B-pillar airbag applique then remove the screw that secures the upper trim panel (Figure 30).

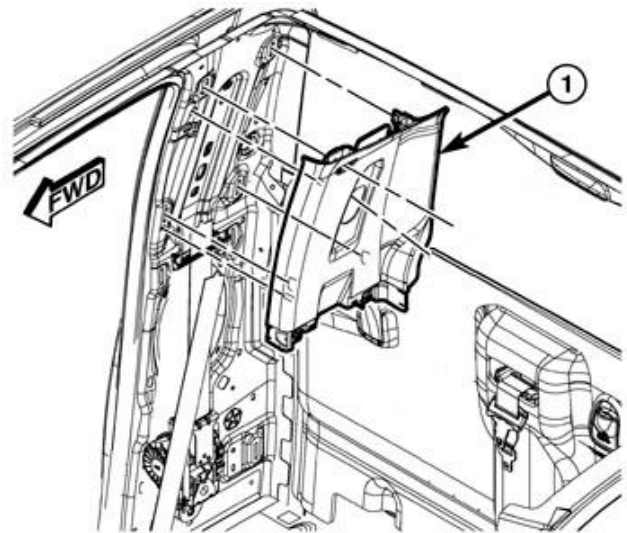
Figure 31 – C-Pillar Upper Trim Panel

19. Release the retaining clips and remove the C-pillar upper trim panel (1) (Figure 31).
