**SAFETY RECALL**  
 NORTH AMERICA  
**Curtain Airbag Inflator**

Reference: 91C / NHTSA 25V-592

**RAM** Remedy available for  
 2018 (D2) Ram 3500 Pickup  
 2018 (DJ) Ram 2500 Pickup  
 2018 (DS) Ram 1500 Pickup

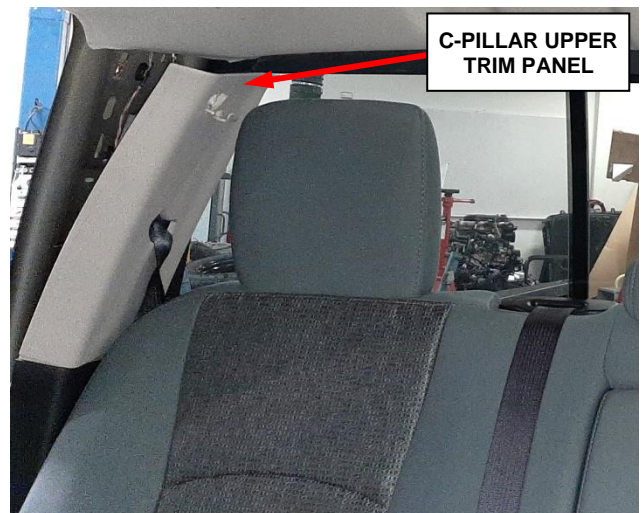
**Figure 11 – C-Pillar Trim Panels**

18. Release the retaining clips and tilt the top of the C-pillar upper trim panel inward (Figure 11).

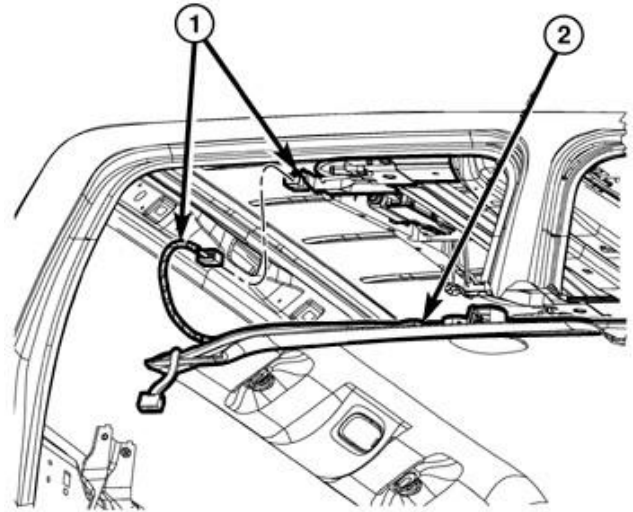
**Figure 16 – Headliner Harness**

**NOTE: It will not be necessary to remove the headliner from the vehicle.**

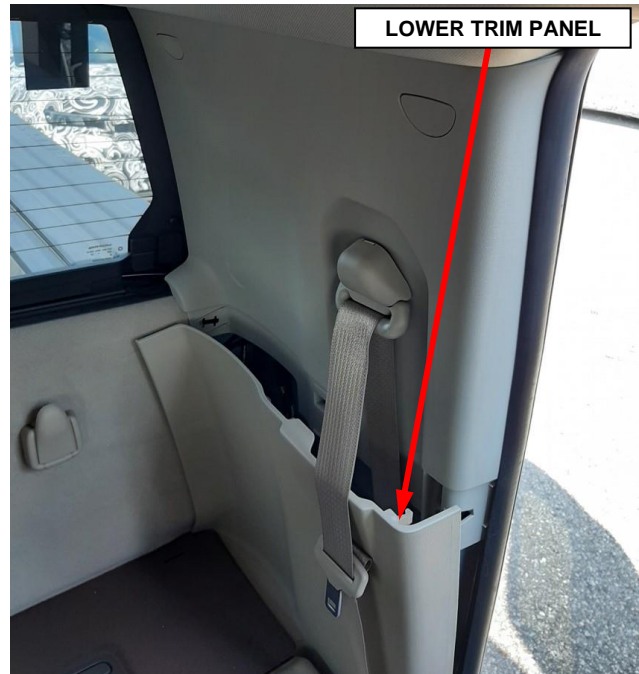
**Figure 28 – C-Pillar Lower Trim Panel**

- 16. Release the upper retaining clips of the lower C-pillar trim panel to allow for removal of the upper C pillar trim panel (Figure 28).
