RAM Remedy available for
 2018 (D2) Ram 3500 Pickup
 2018 (DJ) Ram 2500 Pickup
 2018 (DS) Ram 1500 Pickup

SYMPTOM DESCRIPTION

The Curtain Airbag (CAB) inflator on about 120 of the above vehicles may rupture result in compressed gas rapidly escaping from the inflator and material potentially being propelled into the vehicle. Material being propelled into an occupied vehicle may cause injury.

SAFETY RECALL
NORTH AMERICA
Curtain Airbag Inflator

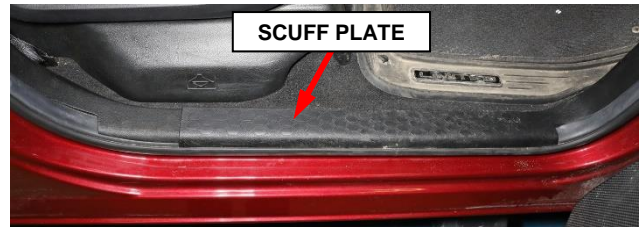
Figure 24 – Door Sill Scuff Plates

9. Release the front and rear door sill scuff plates on either side of the B pillar lower trim panel to allow for removal of the B-pillar lower trim panel (Figure 24).

NOTE: Ensure that all C-pillar fasteners are installed/engaged properly.
60. Install the B-pillar upper trim panel (1) and engage the retaining clips fully (Figure 27).
61. Install the grab handle bolts and tighten to 5 N·m (44 in. lbs.). Close the fastener covers (2) (Figure 27).
62. Remove and **DISCARD** the bolt retainer and the bolt from the seat belt turning loop, save the spacer washer for reuse (Figure 40).
63. Using a **NEW** bolt and reusing the spacer washer, install the turning loop then tighten the bolt to 40 N·m (30 ft. lbs.) (Figure 26).
64. Install the seat belt turning loop cover (Figure 26).
65. Position the B-pillar lower trim panel and engage the retaining clips fully (Figure 25).
66. Position the front and rear door sill scuff plates and engage the retainers (Figure 24).
