SAFETY RECALL
 NORTH AMERICA
Curtain Airbag Inflator

Reference: 83C / NHTSA 25V-592

FCA US LLC

RAM Remedy available for
 2018 (D2) Ram 3500 Pickup
 2018 (DJ) Ram 2500 Pickup
 2018 (DS) Ram 1500 Pickup

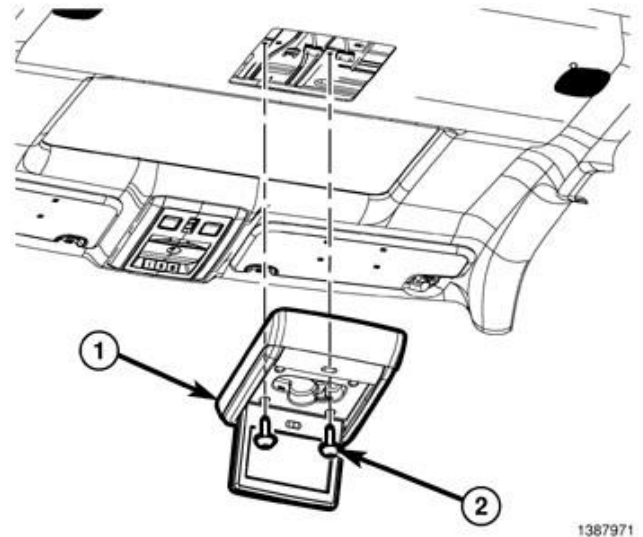
Figure 12 – Rear Seat DVD Monitor

19. If equipped with DVD monitor, remove the screws (2) and separate the monitor (1) from the roof (Figure 12).

39. Tilt the rear view mirror down to allow it to support the headliner (Figure 15).
40. Reattach any headliner wiring harness clips (3) removed from the A-pillar to allow slack while lowering headliner (Figure 14).
41. If equipped with DVD monitor, connect the DVD monitor electrical connectors (1) (Figure 13). Position the DVD monitor to the roof then install and tighten the screws (2) (Figure 12).
