# Technical Service Bulletin

GROUP <b>RECALL</b>	NUMBER <b>25-01-033H</b>
DATE <b>SEPTEMBER 2025</b>	MODEL(S) <b>IONIQ 5 (NEA EV)</b>

**SUBJECT:** REAR SUSPENSION TOE AND CAMBER BOLTS REPLACEMENT, ALIGNMENT, AND TIRE INSPECTION (RECALL 284)

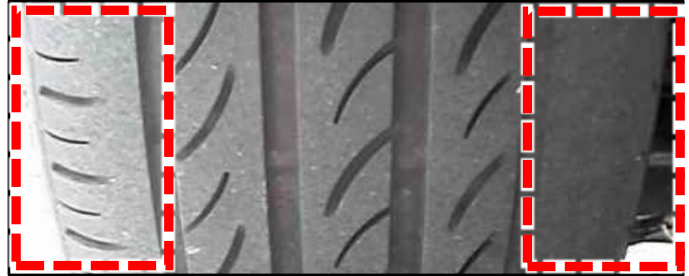
Shoulder Wear: Photo is for illustrative purposes.

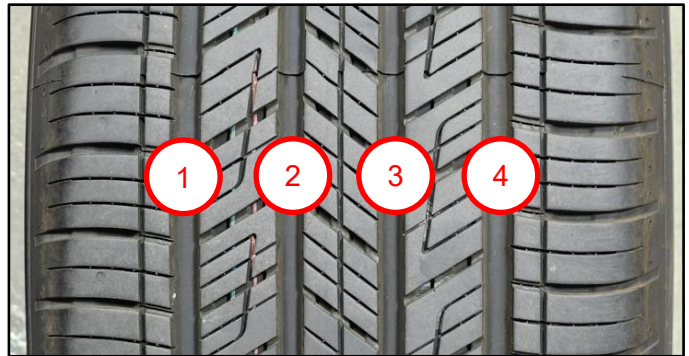
Evenly Worn Example: Pass			
Grooves			
1	2	3	4
8/32nd	8/32nd	8/32nd	8/32nd

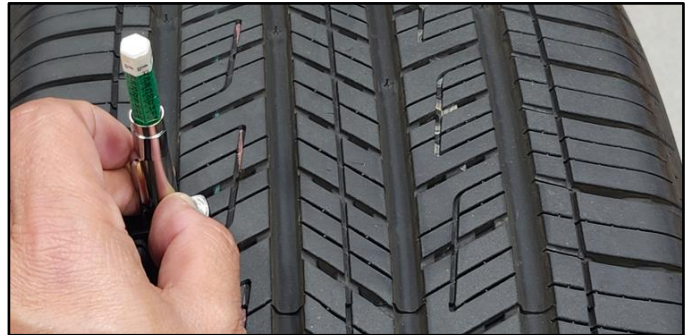
Unevenly Worn Example: Fail			
Grooves			
1	2	3	4
8/32nd	8/32nd	8/32nd	7/32nd
