**HYUNDAI**
Technical Service Bulletin

| GROUP RECALL | NUMBER 25-01-085H |
| DATE NOVEMBER 2025 | MODEL(S) PALISADE (LX2) |

SUBJECT: FIRST & SECOND ROW SEAT BELT BUCKLE REPLACEMENT
(RECALL 283)

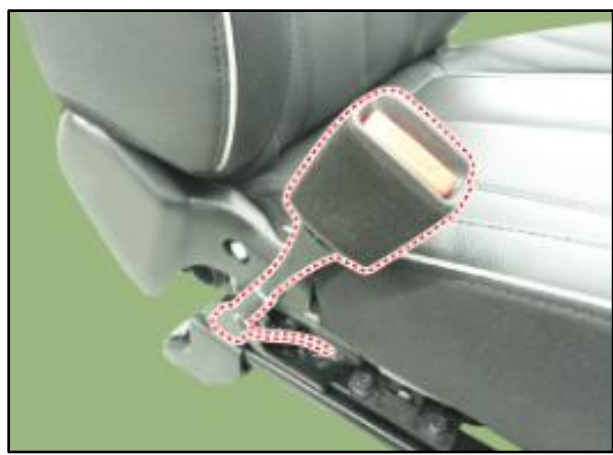
Description: Certain Palisade (LX2) vehicles are equipped with seat belt buckle assemblies in the front row and second row outer seating positions that may contain out-of-specification components manufactured by the supplier. These components can cause interference within the latch channel, potentially increasing friction, particularly under cold ambient temperatures. Improperly produced seat belt buckles, combined with slow insertion of the seat belt tongue plate, may prevent the seat belt buckle from fully latching. An inability to fasten the seat belt in an occupied seat could increase the risk of injury to occupant(s) during a crash. Follow the information in this TSB to replace the outer seat belt buckle assemblies.

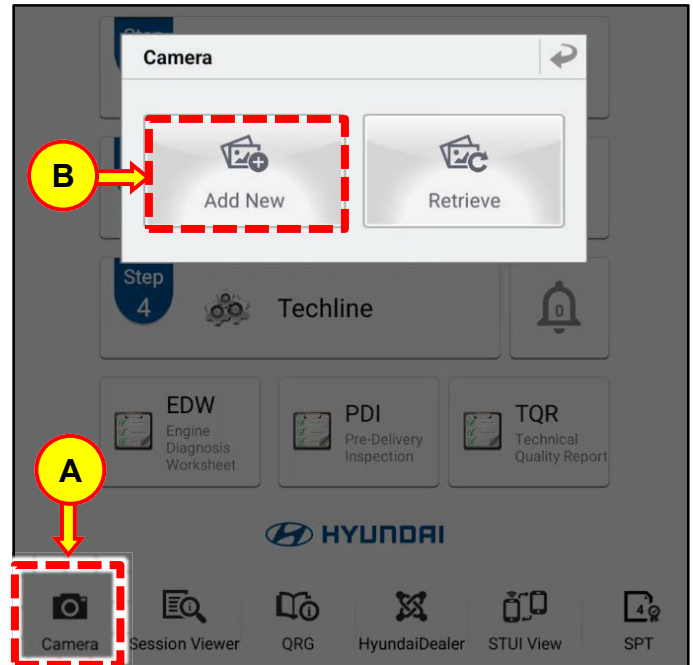
1. Connect GDS to the vehicle and select **AUTO VIN**.
2. Select **Camera** (A) from the Main Menu.
3. Select **Add New** (B).

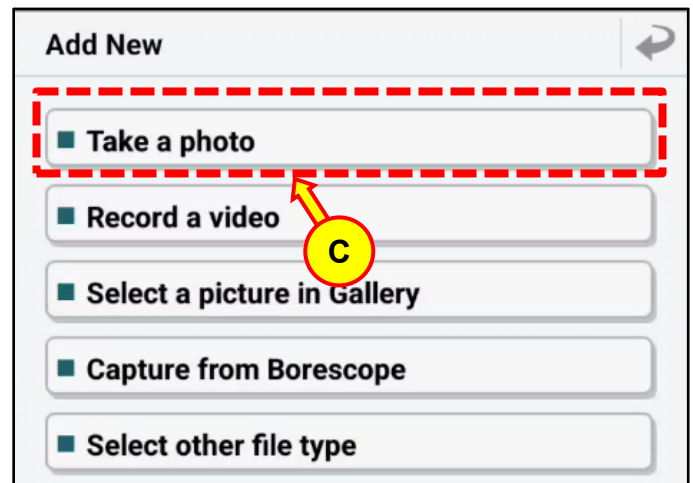
4. Select **Take a photo** (C).

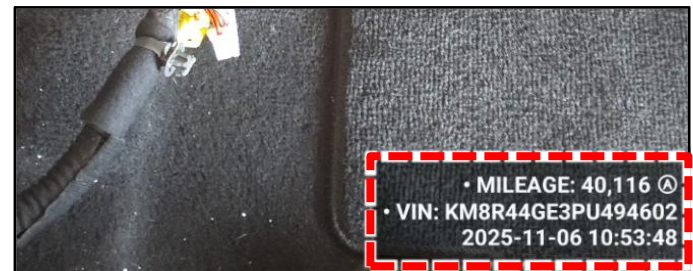
5. Confirm the vehicle information is displayed in the lower right-hand corner. Do **NOT** take a photo at this time.

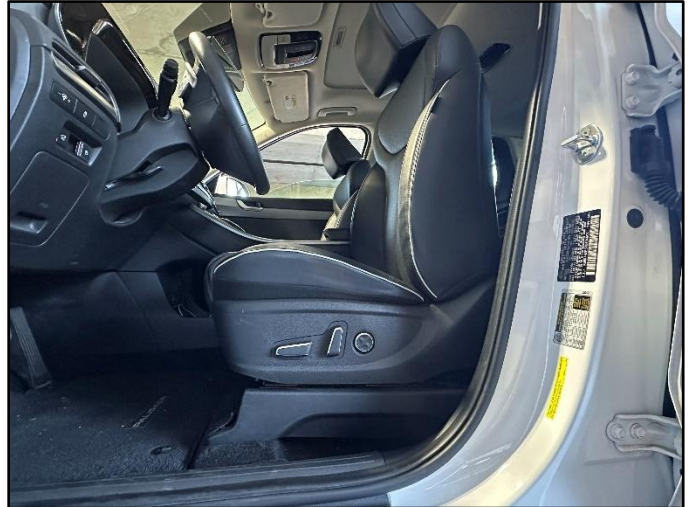
1. Adjust the front driver and passenger seatback to the upmost position and the seat bottom to the middle position of the seat track.

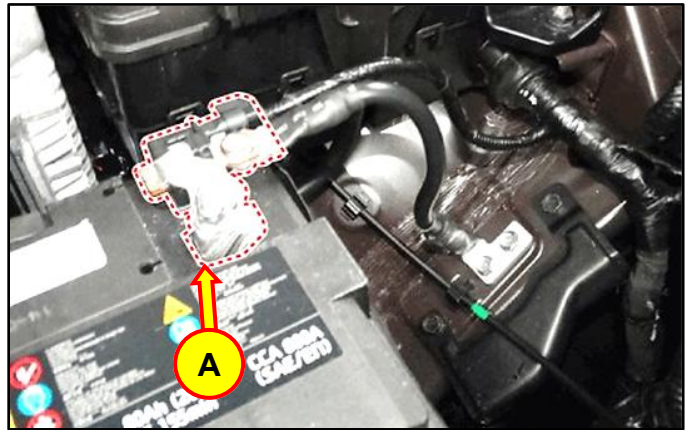
2. Disconnect the negative (-) battery terminal (A).

Tightening Torque:

| lb-ft | 6.5 |
| lb-in | 78 |
| N.m | 8.8 |

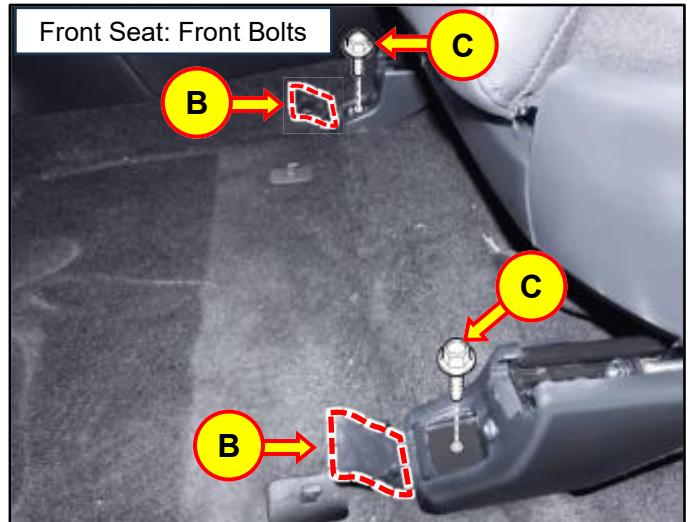
3. Open the front seat track mounting bolt covers (B) on the 1st row seat, then remove the mounting bolts (C).

Tightening Torque:

| lb-ft | 38 |
| N.m | 51 |

LH (driver) side shown. Procedure is the same for both LH and RH front seats.

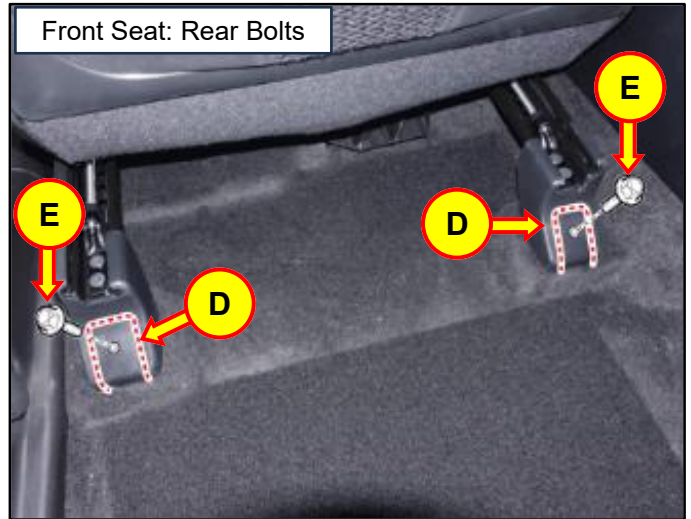
4. Open the rear seat track mounting bolt covers (D) on the 1st row seat, then remove the mounting bolts (E).

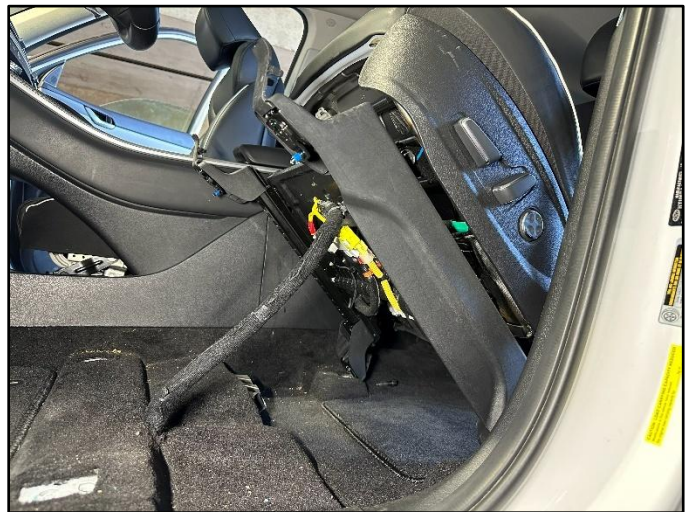
5. Tilt the seat backward as shown in the photo.

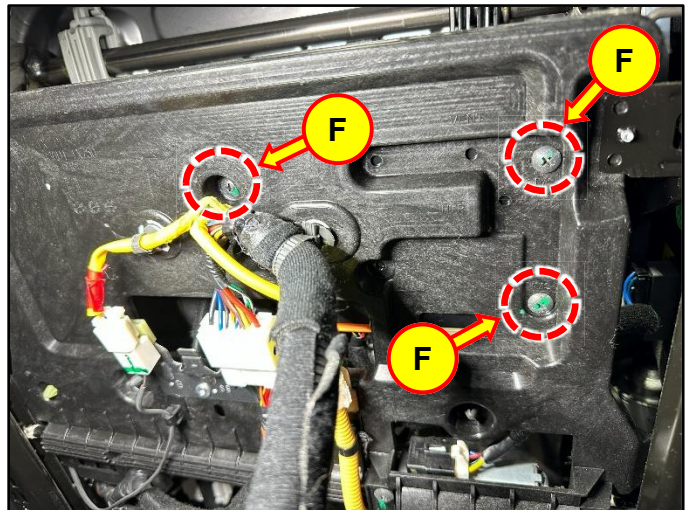
6. Remove the Phillips screws (F) holding the seat module.

Do **NOT** remove the seat module. The purpose of loosening the seat module is to access the SRS harness mounting clips.

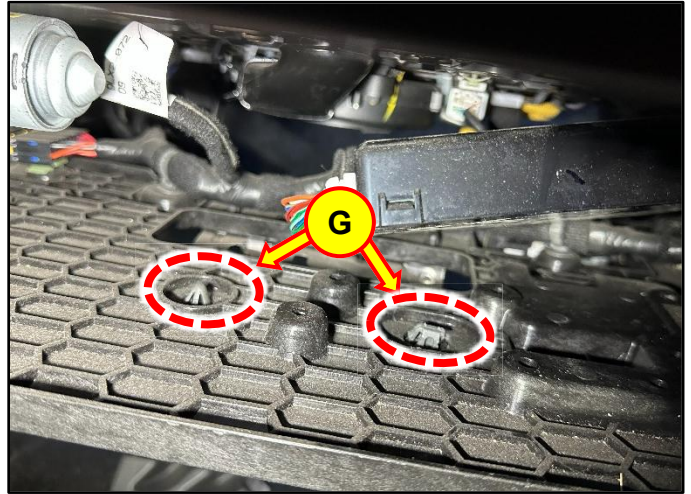
7. Use a small flathead screwdriver or needle-nose pliers to pinch the SRS connector mounting clips (G) and release them.

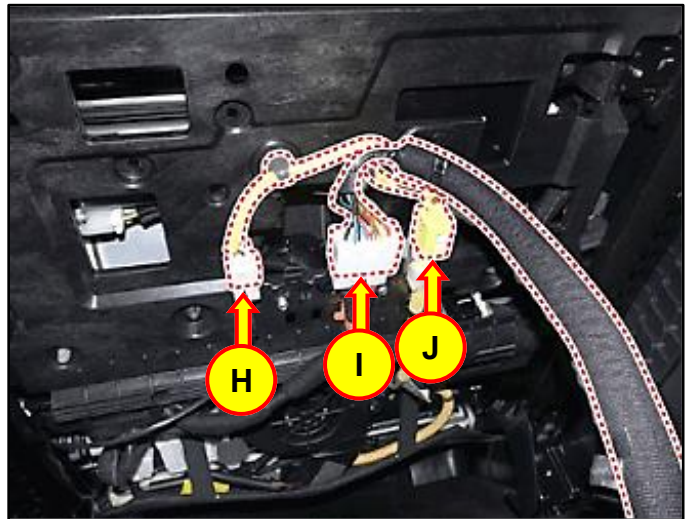
8. Press the lock pin and separate the main connector (H), side airbag connector (I), and front seat belt buckle connector (J).

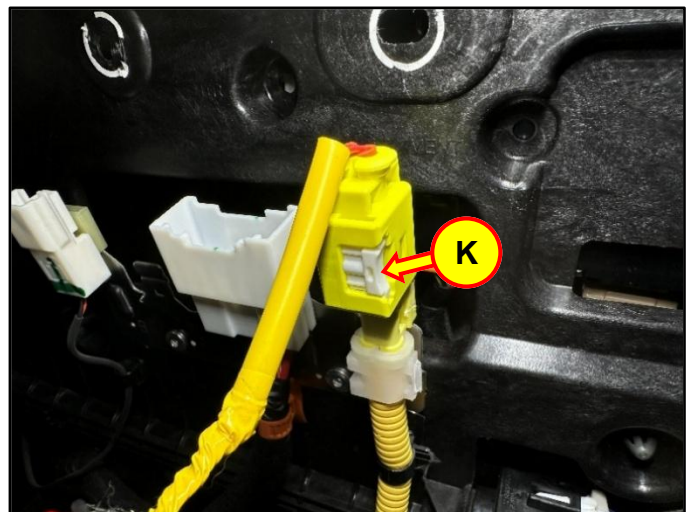
To release the front seat belt buckle connector, press the white locking tab (K) inward and then disconnect it.

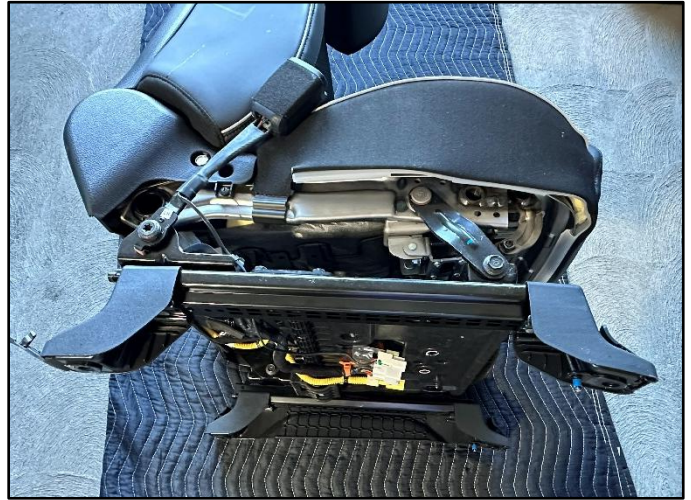
9. Remove both LH and RH front seat assemblies from the vehicle and place them on a clean non-scratching surface.

Ensure the door panel does **NOT** get scratched or damaged when removing the seats.

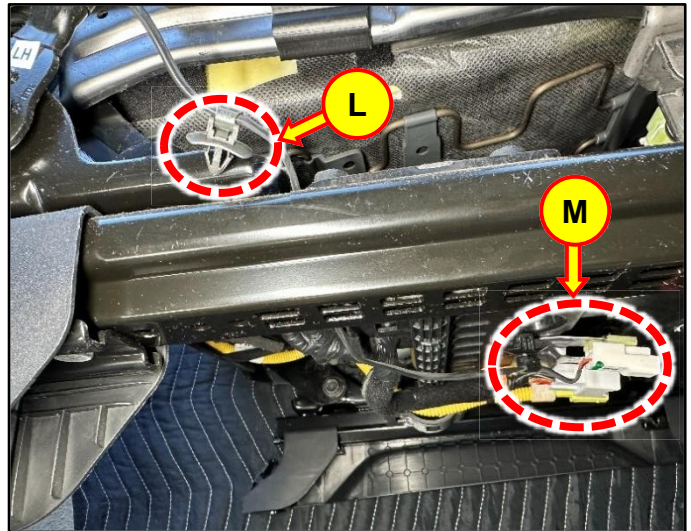
10. Release the seat belt buckle wire harness mounting clips (L) and connector (M).

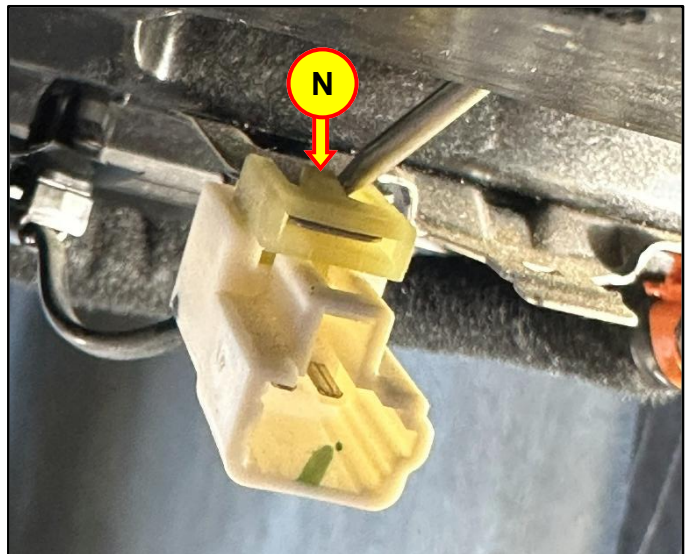
To release the seat belt connector, use a small flathead screwdriver to release the locking tab (N) and then slide outward.

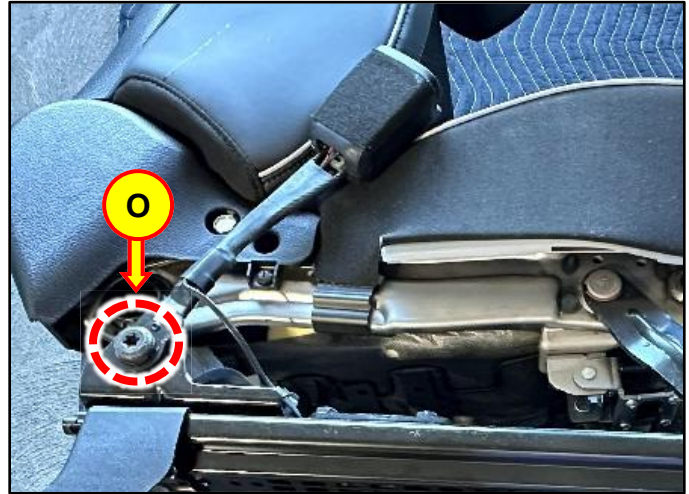
11. Use a Torx T50 to remove the mounting bolt (O), then remove the seat belt buckle.

Tightening Torque:

| lb-ft | 34 |
| N.m | 47 |

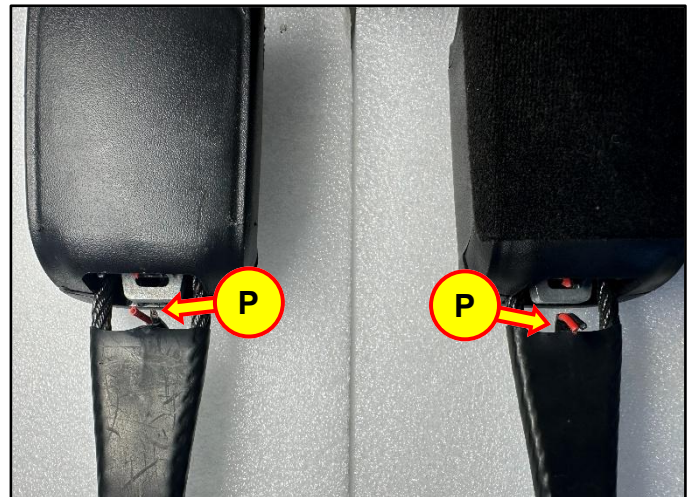
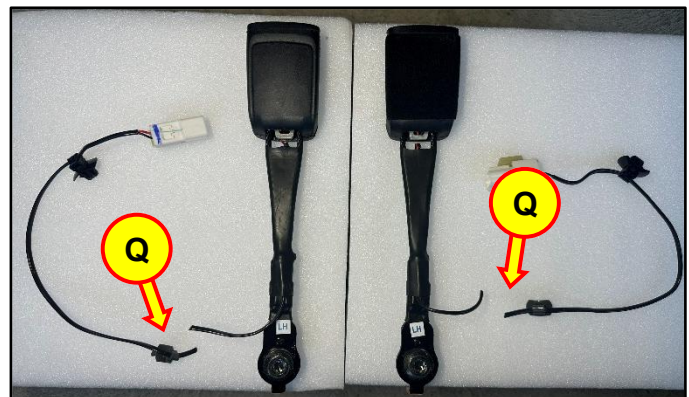
13. Disable the original seat belt buckles by cutting the wires (P) at the base, where they come out of the shrink wrap just above the mounting area and the harness (Q).

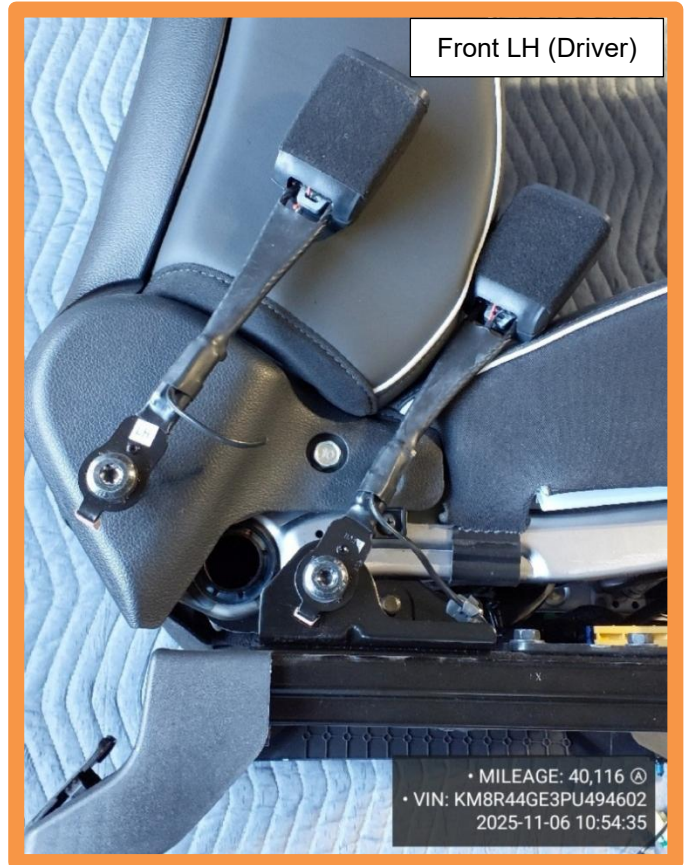
Using the STUI camera function, take a photo of each new seat belt buckle installed along with the original seat belt buckle laid nearby clearly showing the cut wires.

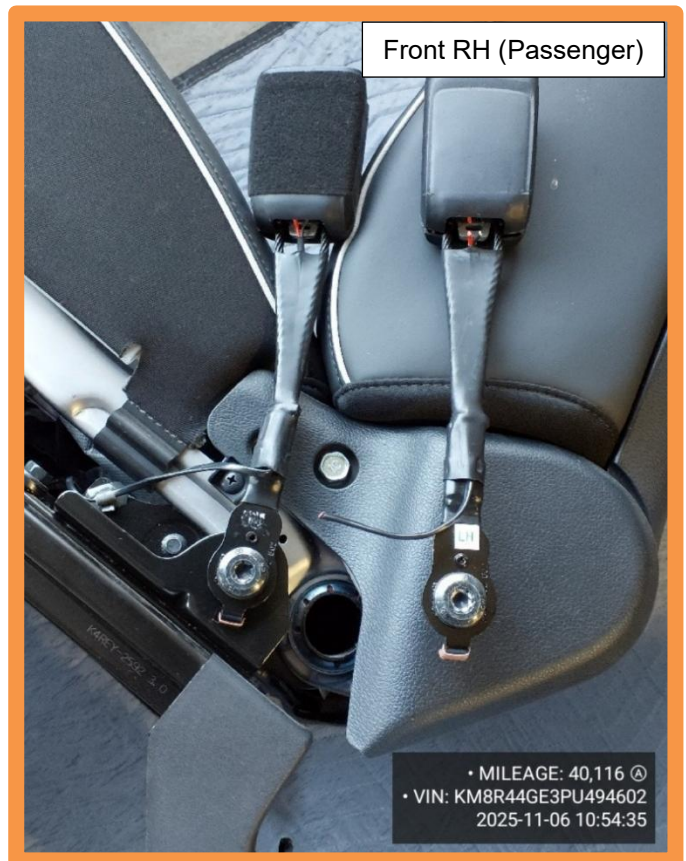
Using the STUI camera function, take a photo of each new seat belt buckle installed along with the original seat belt buckle laid nearby clearly showing the cut wires.

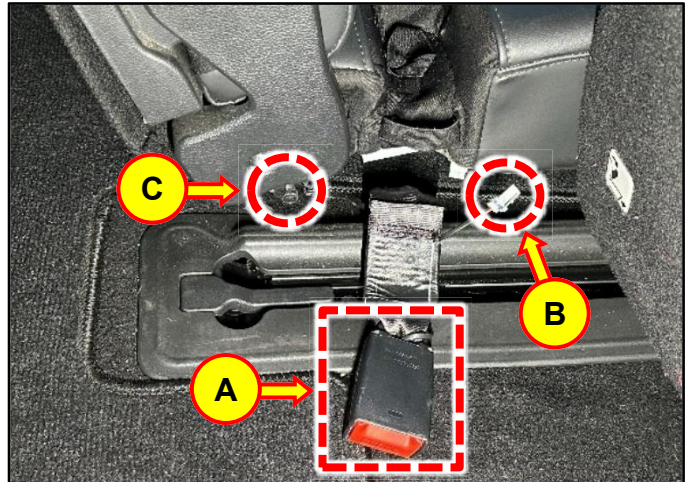
1. Move the 2nd row RH (passenger) seat to the most forward position and the LH (driver) seat to the rearmost position. Unloop the center seat belt buckle (A) from the elastic band.
2. Disconnect the center seat belt buckle connector (B), then remove the 10 mm bolt (C).

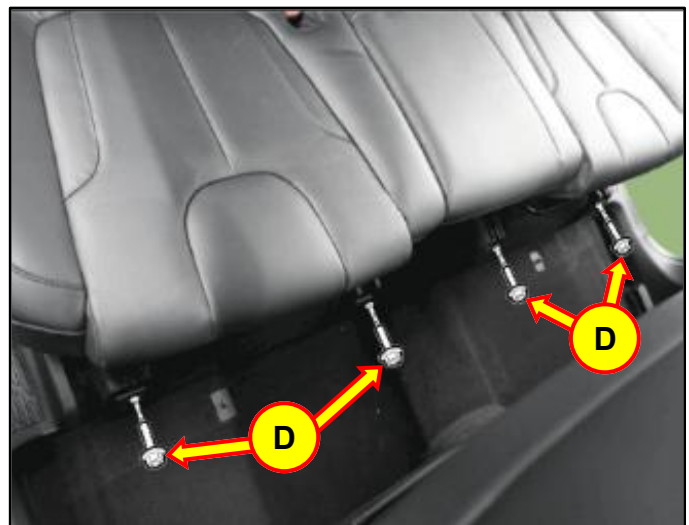
3. Open the mounting bolt covers at the front of the 2nd row seat, then remove the mounting bolts (D).

Tightening Torque:

| lb-ft | 38 |
| N.m | 52 |

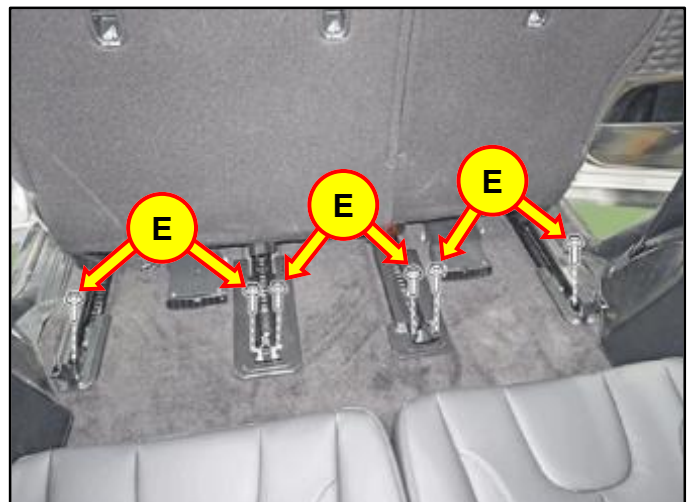
4. Open the mounting bolt covers at the rear of the 2nd row seat, then remove the mounting bolts (E).

Tightening Torque:

| lb-ft | 38 |
| N.m | 52 |

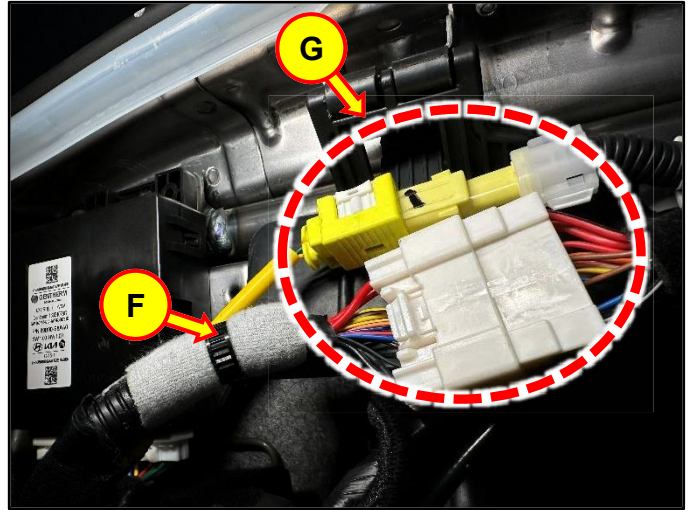
5. Release the harness mounting clip (F) and disconnect the connectors (G).

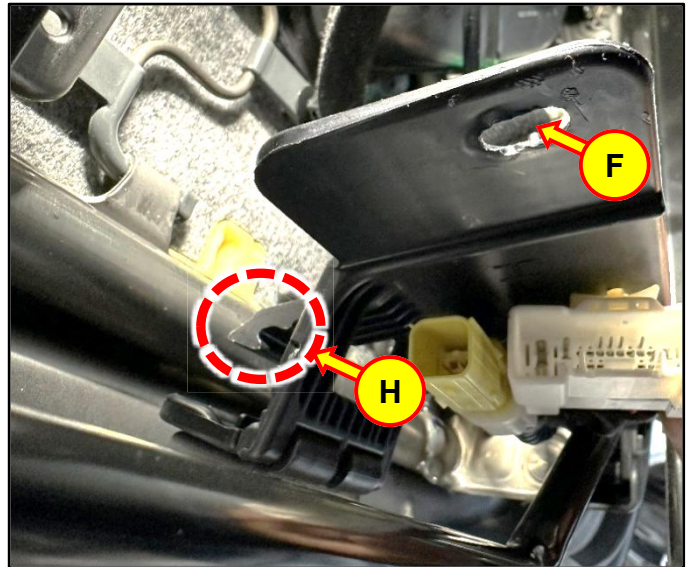
For easy access to the mounting clip (F), lower the harness plastic mounting pad by using a small screwdriver and pushing upward into the seat to release the locking hook (H).

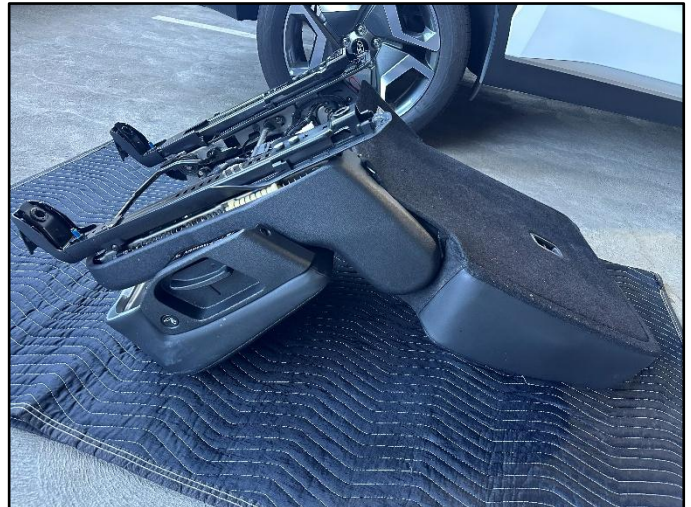
6. Remove both LH and RH 2nd row seat assemblies from the vehicle and place them upside down on a clean non-scratching surface.

The 2nd row LH and RH seat belt buckles are easily accessible from underneath the seat.

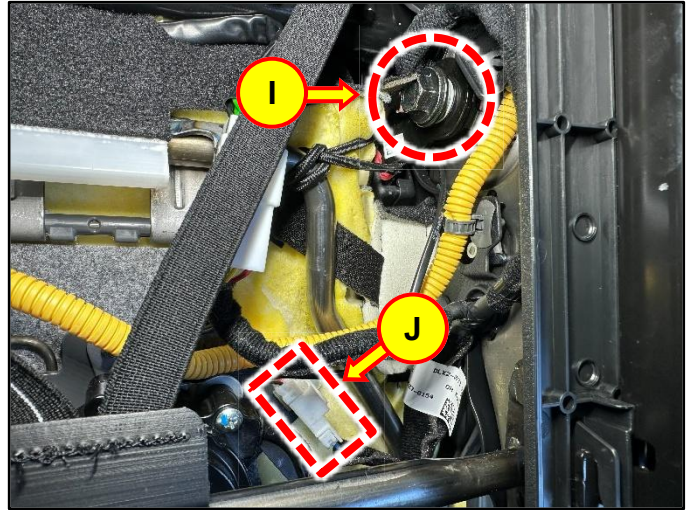
7. Remove the seat belt buckle by removing the **14 mm bolt (I)**, then disconnect the seat belt buckle connector (J), and unloop it from the elastic band. Pull the seat belt buckle out through the bottom of the seat cushion.

Perform the same procedure for both the LH and RH 2nd row seat.

Tightening Torque:

| lb-ft | 34 |
| N.m | 47 |

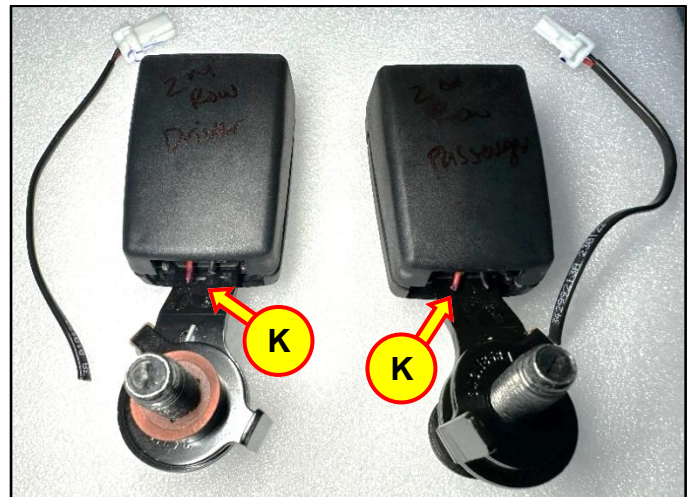
9. Disable the original seat belt buckle by cutting the wires (K) at the base, where they come out of the buckle just above the mounting area.

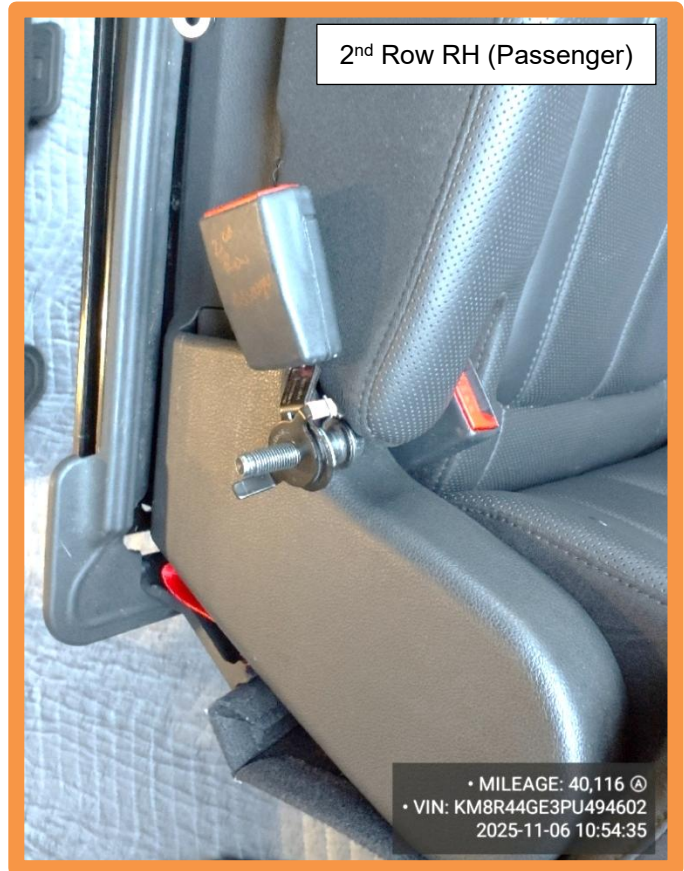
Using the STUI camera function, take a photo of each new seat belt buckle installed along with the original seat belt buckle nearby clearly showing the cut wires.

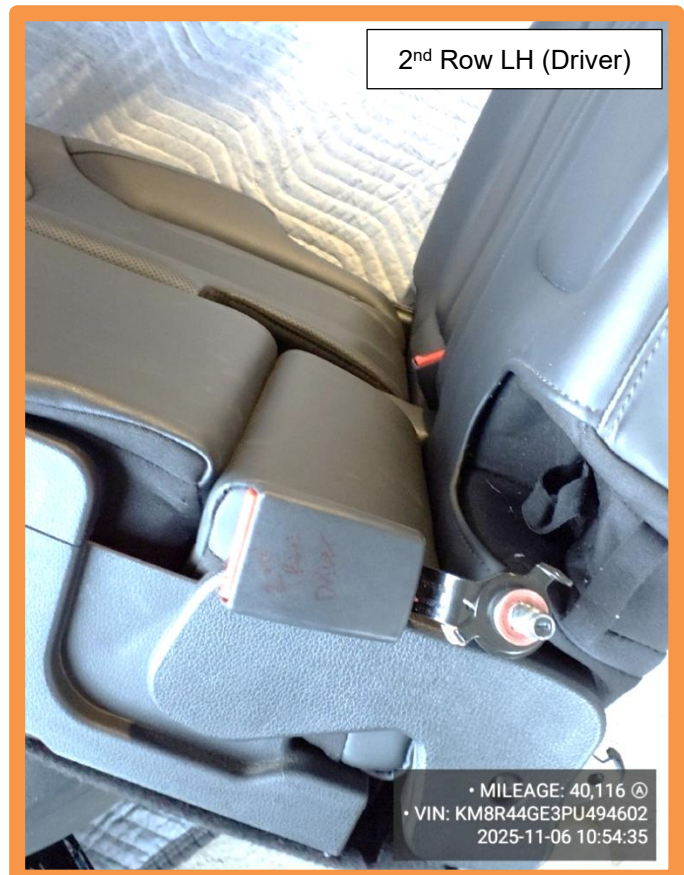
Using the STUI camera function, take a photo of each new seat belt buckle installed along with the original seat belt buckle nearby clearly showing the cut wires.

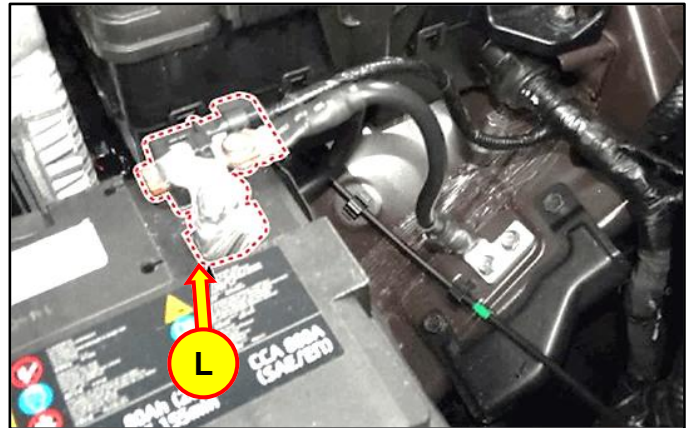
13. Reconnect the negative (-) battery terminal (L).

Tightening Torque:

| lb-ft | 6.5 |
| lb-in | 78 |
| N.m | 8.8 |

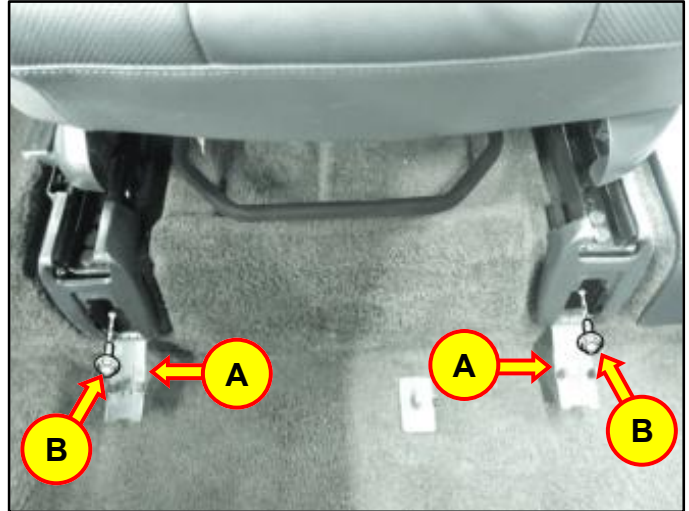
1. Open the seat block covers (A) at the front of the 2nd row seats, then remove the mounting bolts (B).

Tightening Torque:

| lb-ft | 38 |
| N.m | 51 |

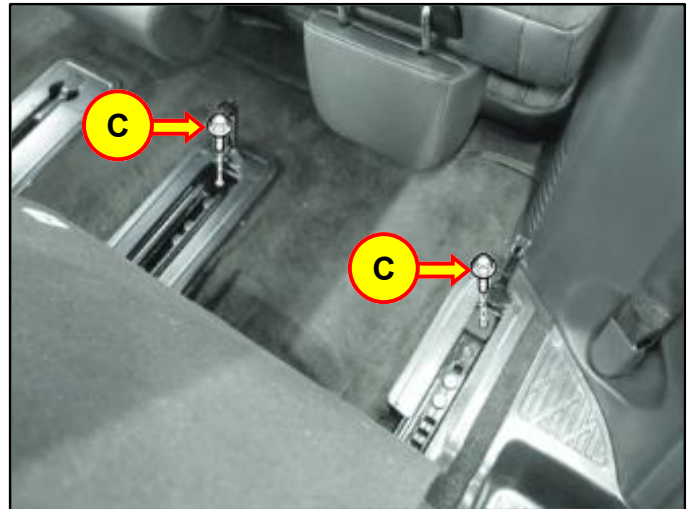
2. Remove the mounting bolts (C) at the rear of the 2nd row seats.

Tightening Torque:

| lb-ft | 38 |
| N.m | 52 |

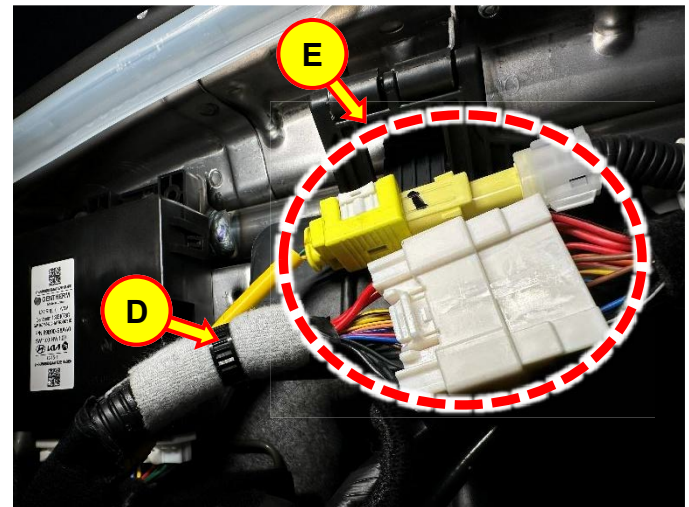
3. Release the harness mounting clip (D) and disconnect the connectors (E).

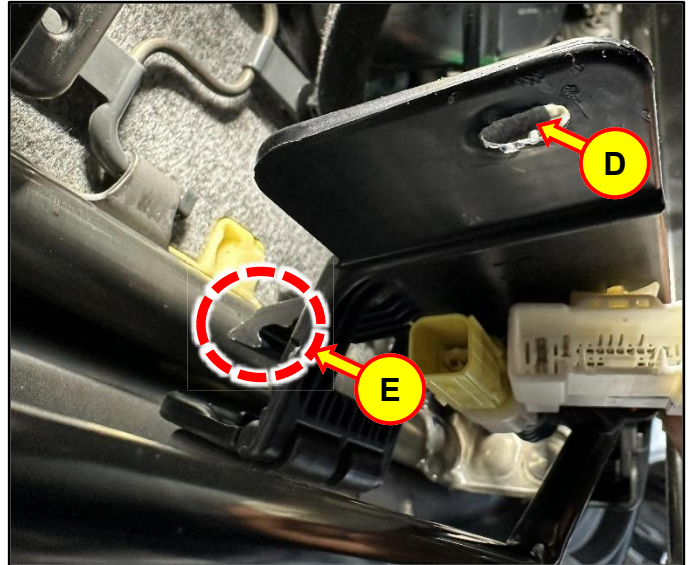
For easy access to the mounting clip (D), lower the harness plastic mounting pad by using a small screwdriver and pushing upward into the seat to release the locking hook (E).

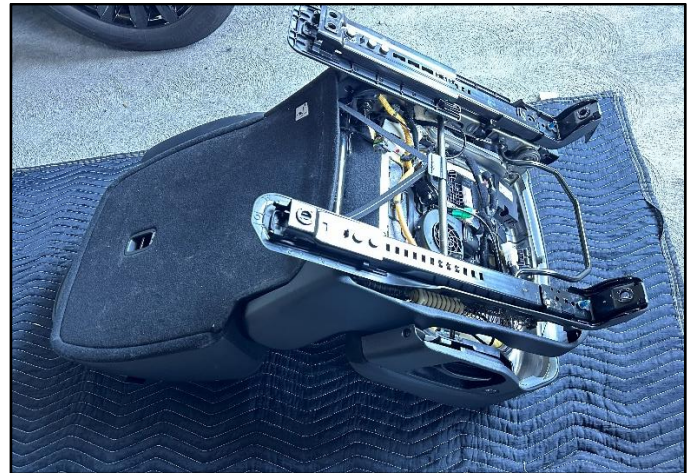
- 4. Remove both LH and RH 2nd row seat assemblies from the vehicle and place them upside down on a clean non-scratching surface.

The 2nd row LH and RH seat belt buckles are easily accessible from underneath the seat.

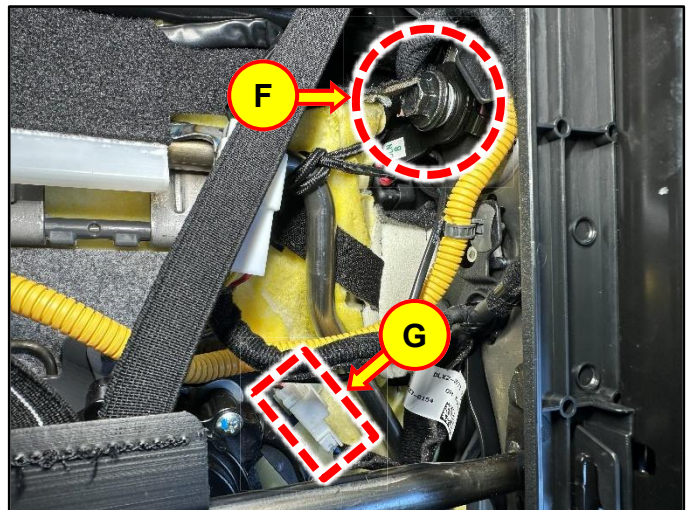
- 5. Remove the seat belt buckle by removing the **14 mm bolt (F)**, then disconnect the seat belt buckle connector (G), and unloop it from the elastic band. Pull the seat belt buckle out through the bottom of the seat cushion.

Perform the same procedure for both the LH and RH 2nd row seat.

Tightening Torque:

| lb-ft | 34 |
| N.m | 47 |

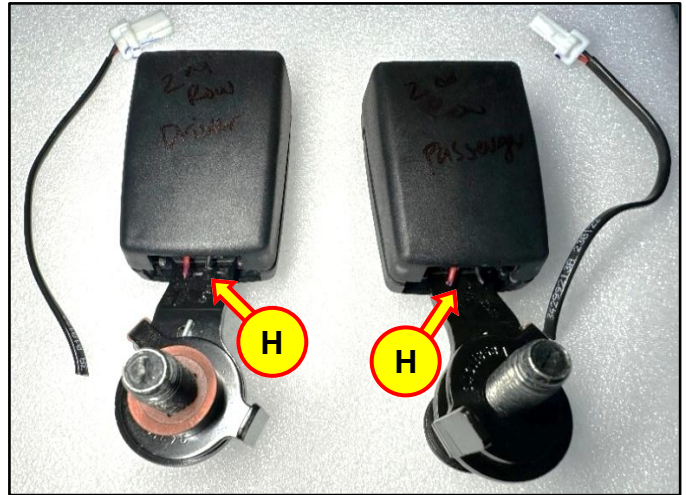
7. Disable the original seat belt buckle by cutting the wires (H) at the base, where the wires come out of the buckle just above the mounting area.

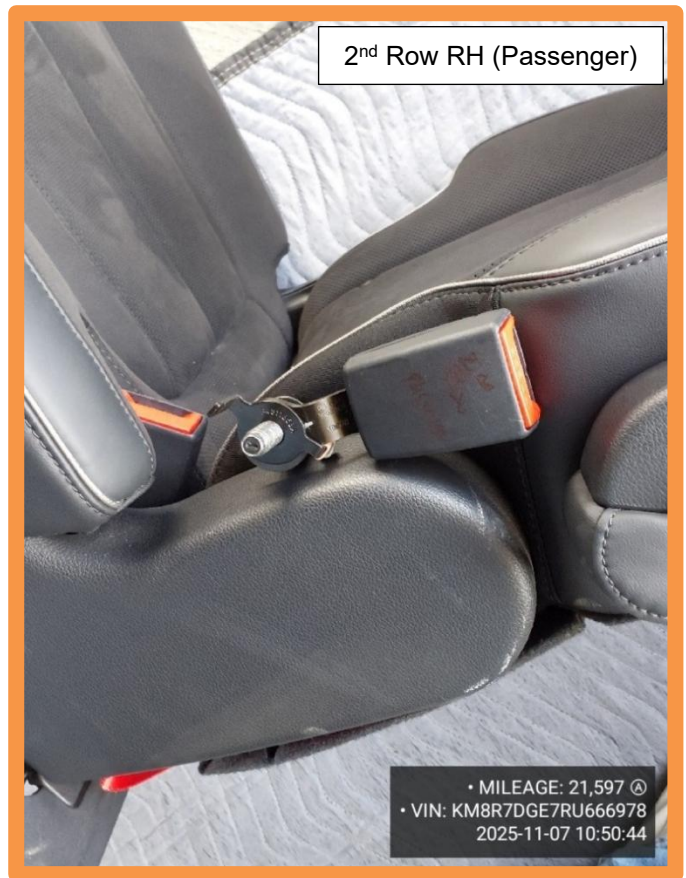
Using the STUI camera function, take a photo of each new seat belt buckle installed along with the original seat belt buckle laid nearby clearly showing the cut wires.

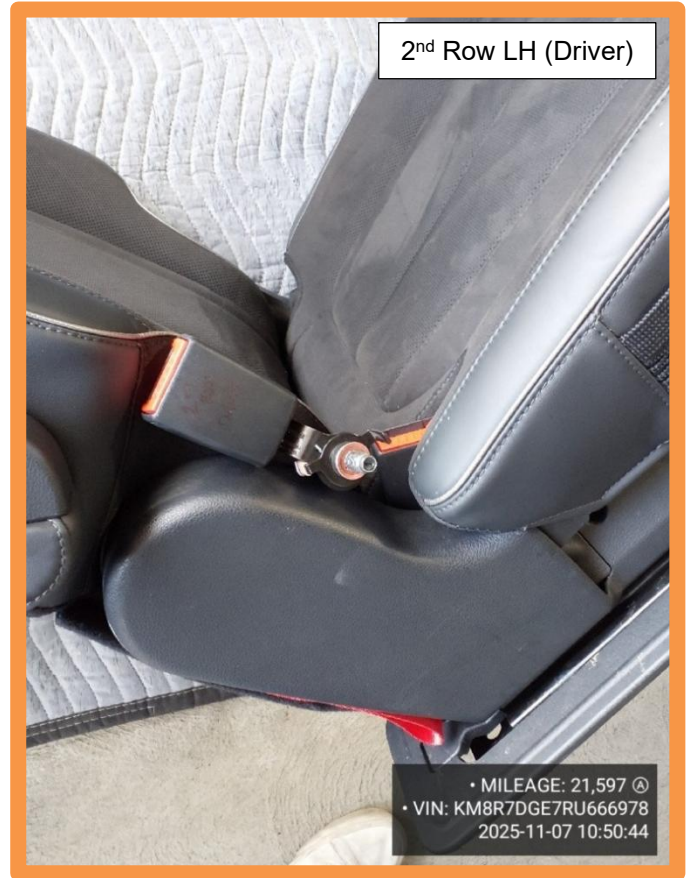
Using the STUI camera function, take a photo of each new seat belt buckle installed along with the original seat belt buckle laid nearby clearly showing the cut wires.

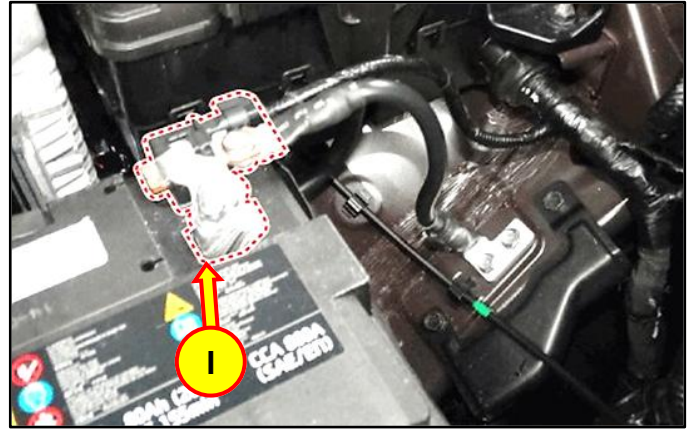
11. Reconnect the negative (-) battery terminal (I).

Tightening Torque:

| lb-ft | 6.5 |
| lb-in | 78 |
| N.m | 8.8 |
